RECOMMENDED SERVICE BULLETIN

RSB 62-013

Type: DA 62

Improved mounting of 2nd Alternator.

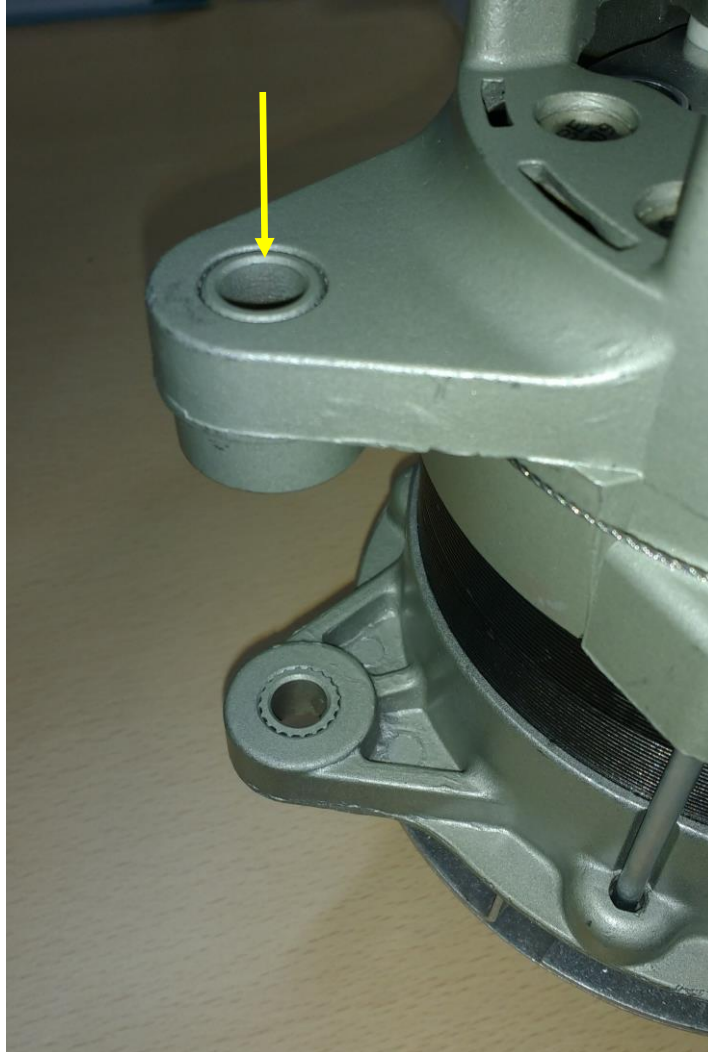
1	Remove engine cowlings i.a.w. AMM section 71-10.
2	Disconnect the battery and ECU backup batteries for maintenance i.a.w. AMM section 24-33.
3	Remove the additional alternator i.a.w. AMM section 61-10.
4	Check the engine mounting arm for excessive wear on the rear attachment point, if the mounting hole diameter is greater than 11 mm, replace the engine mounting arm i.a.w. AMM section 71-00.

Remove the lower rear mounting bushing from the alternator housing.
Note: Support the surrounding alternator housing from the opposite side to prevent damage.
