RECOMMENDED SERVICE BULLETIN RSB 62-018

Type: DA 62

I.6 Inspection of rear Rudder Cable Pulley.

WORK INSTRUCTION WI-RSB 62-018

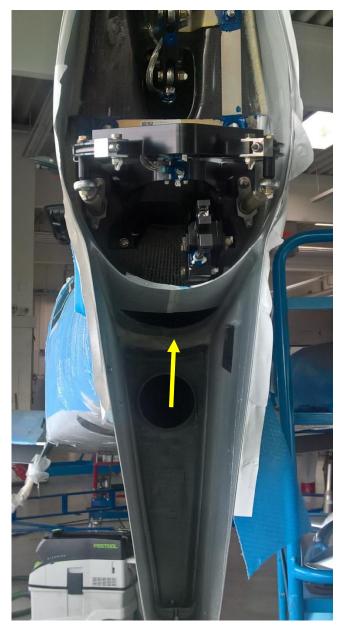
On some airplanes excessive wear on the LH and RH rudder cable pulley on the rear vertical tail spar was found. This is caused by pulley brackets that have been switched during the production process. This Service Bulletin describes the inspection of potentially affected airplanes and the correction of the installation, if necessary.

- 1 Remove the Rudder in accordance with (i.a.w.) AMM Section 55-40.
- 2 Examine the rear ruder cable pulley for wear through the maintenance hole i.a.w. the pictures below.
