**MANDATORY SERVICE BULLETIN NO. MSB 62-026 REV. 0**

Type: DA 62

Inspection of bonding cables in engine installation.

**WORK INSTRUCTION WI-MSB 62-026 REV. 0**

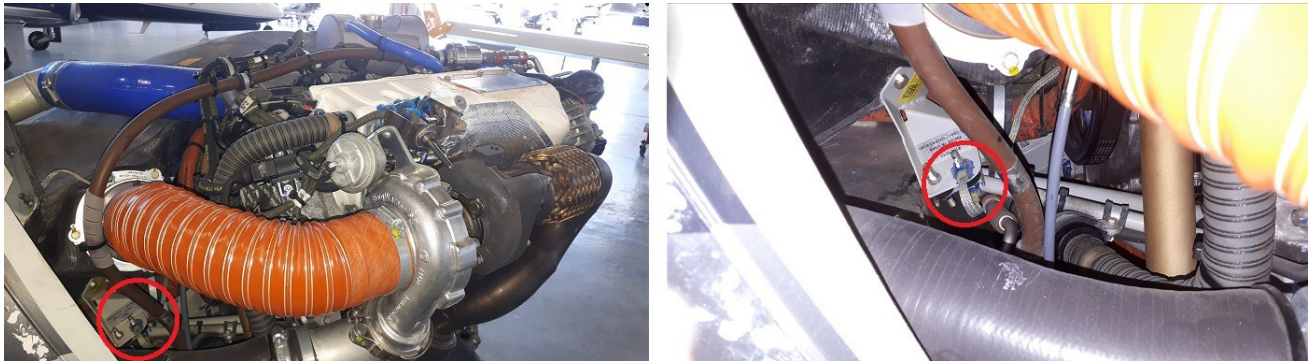
It has come to DAI's attention during maintenance actions that some DA 62s may be missing electrical bonding cables P/N BW1-B12-RY6-RY6-100. This service bulletin provides instructions for inspecting the engine installation to confirm the BW1-B12-RY6-RY6-100 bonding cables are installed.

Figure1 - Left: general location of bonding cable at right rear of engine. Right: zoomed view.

1. Check the bonding cable as shown in Figure 1, below.

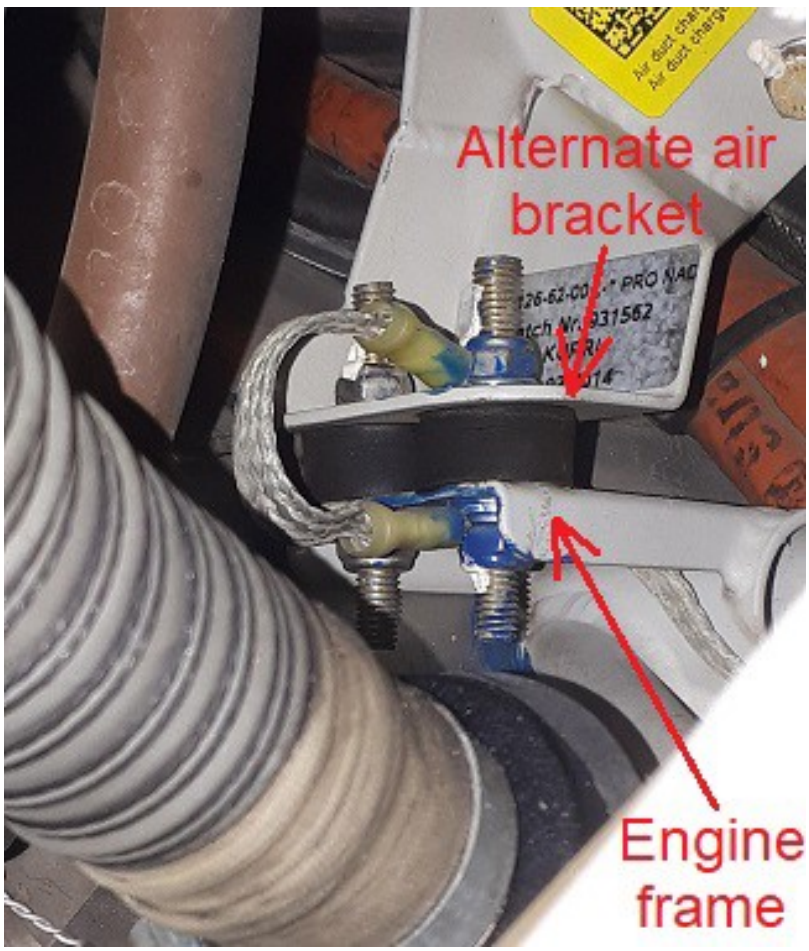
Figure2 - Bonding cable installation.

2. If the bonding cable is missing, install a new BW1-B12-RY6-RY6-100 bonding cable as shown in Figure 2. One end of the cable is attached to the engine frame P/N D64-7126-10-00\_04, and the other end is attached to the alternate air valve bracket P/N D67-8126-62-00.
3. Repeat steps 1 and 2 for the other engine.
4. Clean working areas, and check for foreign objects.
5. Make all necessary entries in the airplane logs.
6. Fill in the execution report, and send it to [Techpubs@diamondair.com](mailto:Techpubs@diamondair.com).
