MANDATORY SERVICE BULLETIN NO. MSB 62-035

Type: DA 62

Installation of bonding cables.

WORK INSTRUCTION WI-MSB 62-035

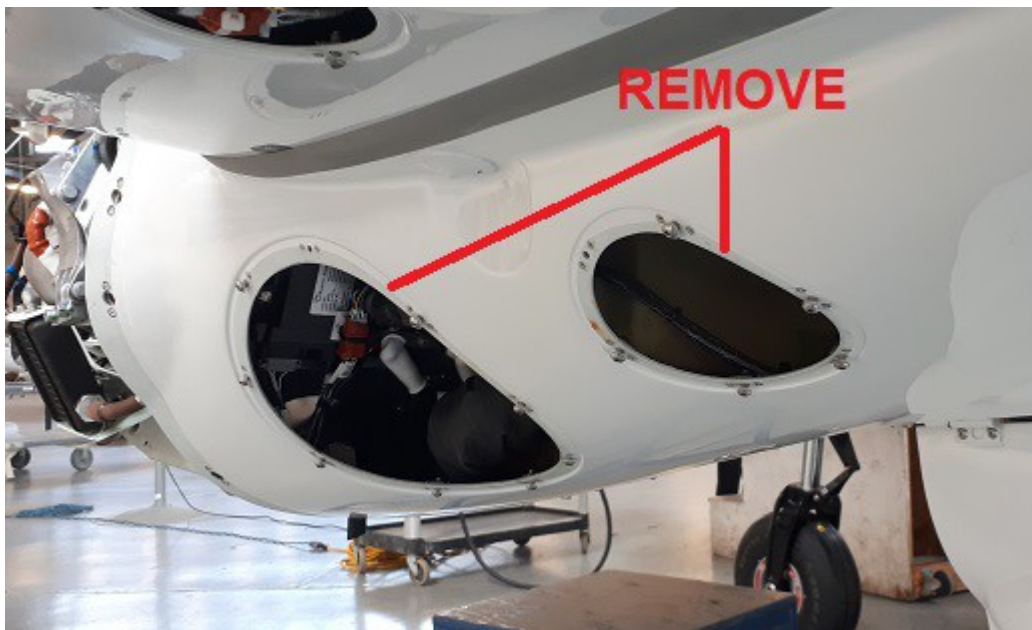
Figure 1. Access panels to remove.

1. Pull the starter circuit breaker.
2. Prepare the bonding cables:
 - A. Cut item 1 to 900 mm.
 - B. Crimp item 2 onto one end of item 1.
 - C. Crimp item 3 onto the other end of item 1.
 - D. Repeat for the other bonding cable.
3. Open the access panels as shown in Figure 1.

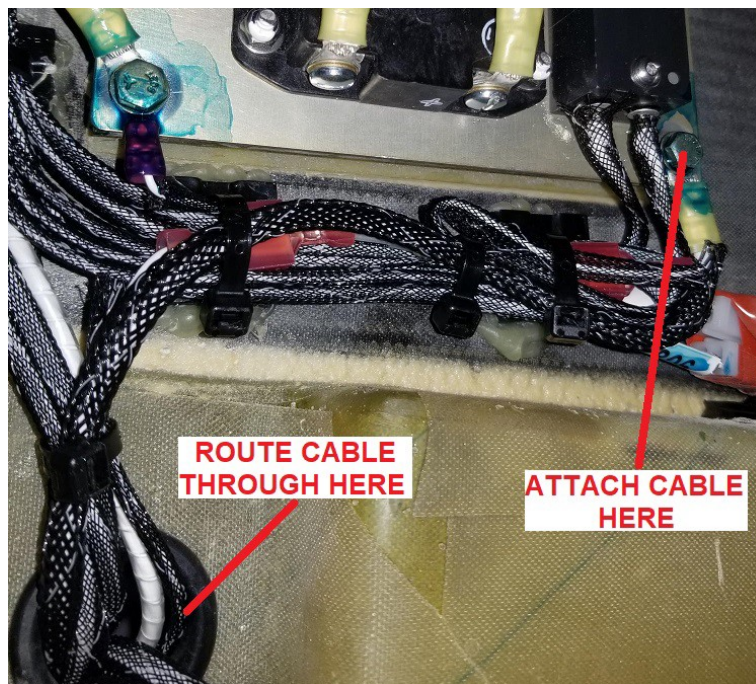
Figure 2. Suppressor plate seen looking forward into the nacelle through the aft access panel.

4. Install the end of the bonding cable with item 2 to the location shown in Figure 2, i.e. the smaller ring terminal attaches to the suppressor plate. Use Nycote 7-11 blue.
5. Route the bonding cable through the grommet shown in Figure 2.
6. Install the other end of the bonding cable to the location shown in Figure 3. Use Nycote 7-11 blue.
7. If there is excess length in the bonding cable, tie it into a bundle.
8. Install the access panels.

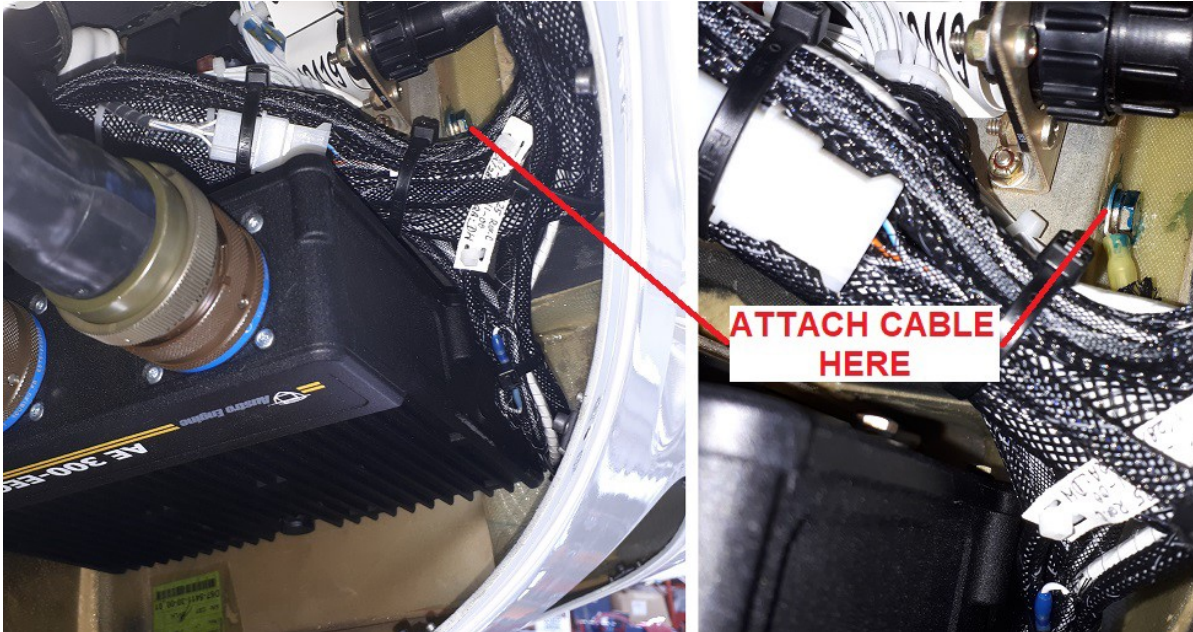
Figure 3. Left: relay panel seen looking aft into the nacelle through the forward access panel. Right: zoomed view.
