MANDATORY SERVICE BULLETIN NO. MSB 62-042 REV. 1 **SUPERSEDES MSB 62-042 REV. 0**

Model: DA 62

Rudder rib hole size correction.

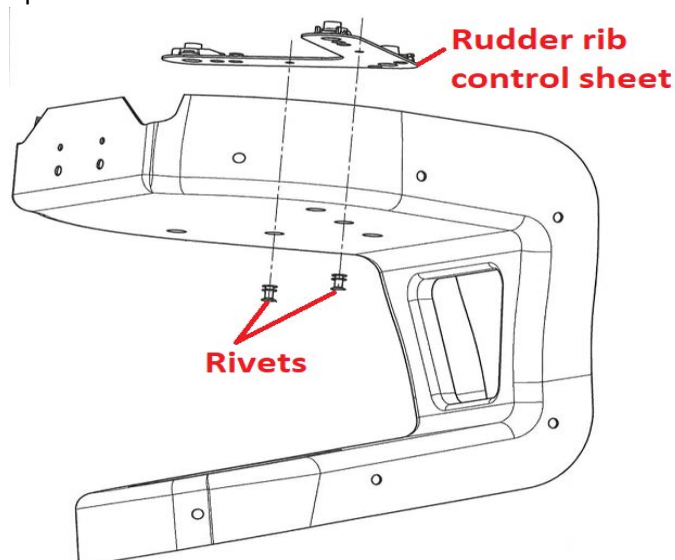
It has been observed on some aircraft that some hole sizes on the rudder rib were too large. This Service Bulletin describes the procedures to add a bushing to the holes to correct the hole sizes.

1. Remove the Rudder Assembly. Refer to AMM Section 55-40.
2. Measure the diameter of the 3 holes in the rudder rib layup. If the measurement is within 6-6.2 mm, proceed to step 11. If not, proceed to step 3.
3. Drill out the rivets that attach the rudder rib control sheet.
4. Remove and keep the rudder rib control sheet.

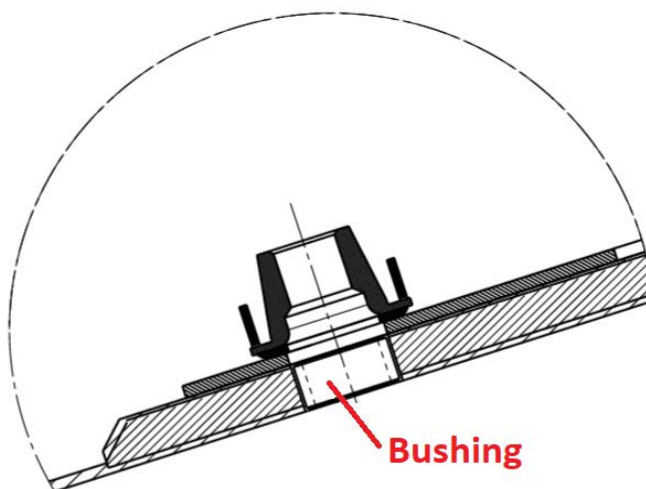
Rudder rib section view with bushing installed

6. Measure the composite thickness.
7. Adjust the length of the bushing (Item 1 or fabricated) to be 0.4-0.8 mm shorter than the composite thickness.
8. Prepare the surfaces for bonding as follows:
 - A. Lightly abrade the holes and bushings bonding surfaces.
 - B. Clean the surfaces from dirt or any contaminant. Surface should be solvent wiped and then wiped dry. Refer to AMM Section 51-30.
9. Bond the bushings (Item 1 or fabricated) inside the holes using one of the options below:

NOTE: Make sure the bushing is bonded 0.0-0.8 mm from surface on one of the sides of the composite. No protruding is allowed.

10. Reinstall the rudder control sheet using rivets (Item 3 or 3a).

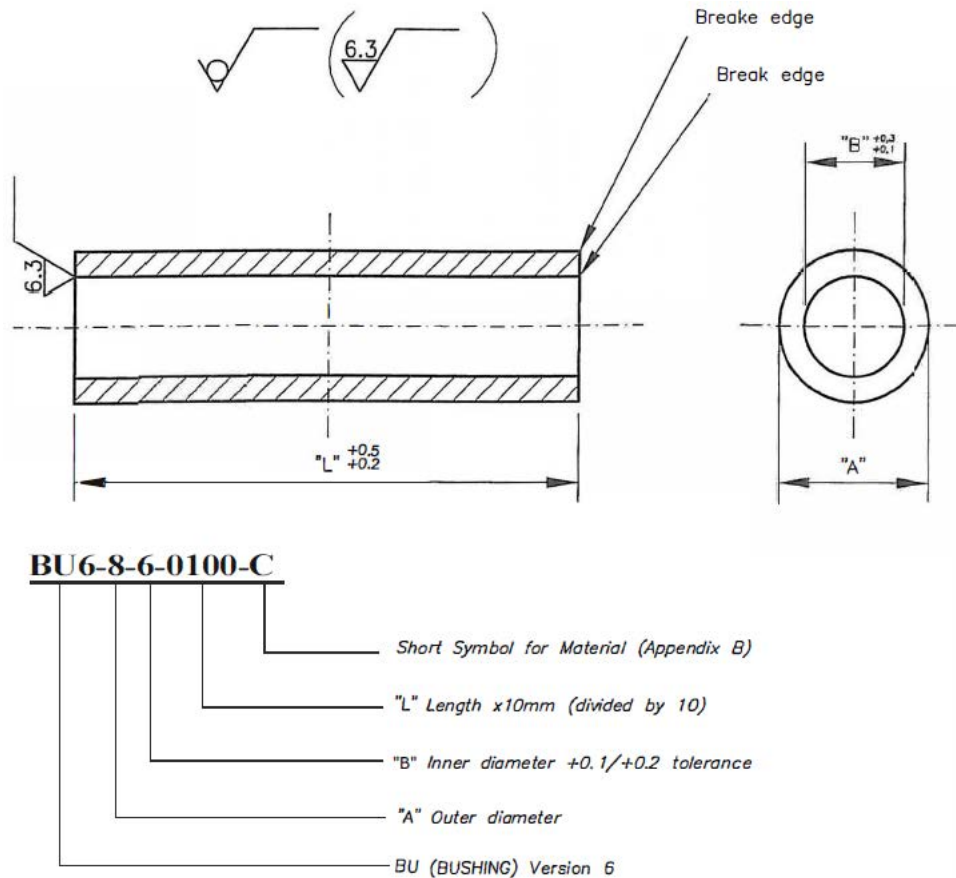
Bushing specs (dimensions in metric system)

17. Follow the bushing specs below for fabrication:
