## **MANDATORY SERVICE BULLETIN NO. MSB 62-045 REV. 2** **SUPERSEDES MSB 62-045 REV. 1**

Model: DA 62

Inspection of starter wiring connection.

**WORK INSTRUCTION WI-MSB 62-045 REV. 2**  
**SUPERSEDES WI-MSB 62-045 REV. 1**

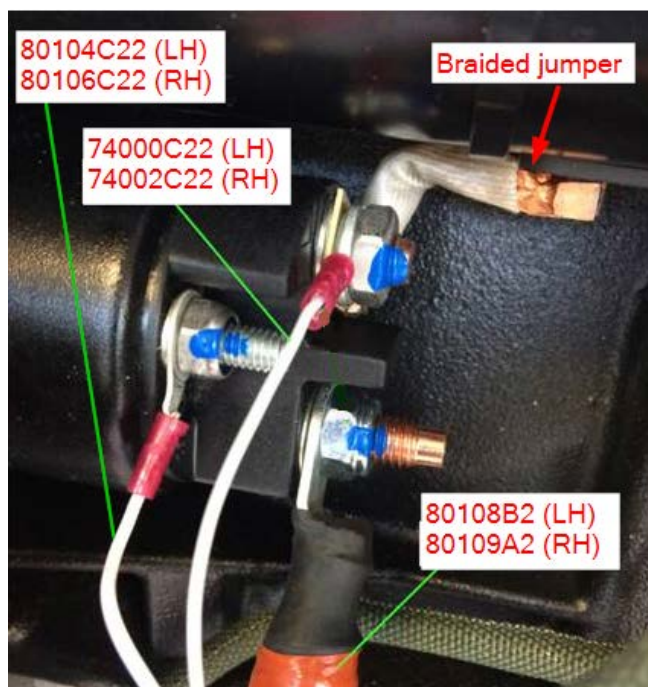
1. Disconnect the main battery for maintenance. Refer to AMM Section 24-31.
2. Remove the LH top cowling. Refer to AMM Section 71-10.
3. Inspect the starter wirings for correct connection. Refer to Figure 1.
  - The terminal 74000C22 or 74002C22 must be connected along with the braided jumper.

Figure 1 - Correct starter wiring connection.

4. If the wire 74000C22 or 74002C22 is connected to the same attachment as the braided jumper as shown in Figure 1, that means that the connection is correct and you can proceed to step 8.
5. If the wire 74000C22 or 74002C22 is not connected to the same attachment as the braided jumper, the connection is incorrect and you must proceed to the next step.

6. Remove wire 74000C22 or 74002C22 from the incorrect location, and reinstall it in the correct location. Refer to Figure 1.
7. Clean the working areas and check for foreign objects.
8. Connect the main battery after maintenance. Refer to AMM Section 24-31.
9. Check all altered, replaced, repaired parts for proper function.
10. Install the LH top cowling. Refer to AMM Section 71-10.
11. Do an engine ground run-up. Refer to AMM Section 71-00.
12. Repeat the steps 1 through 11 for the other engine.
13. Make all necessary entries into the logbooks.
14. Submit the execution report to [Techpubs@diamondaircraft.com](mailto:Techpubs@diamondaircraft.com).
