Model DA 62

OPTIONAL SERVICE BULLETIN NO. OSB 62-048 REV. 0

Installation of Alternate Electric Fuel Pump.

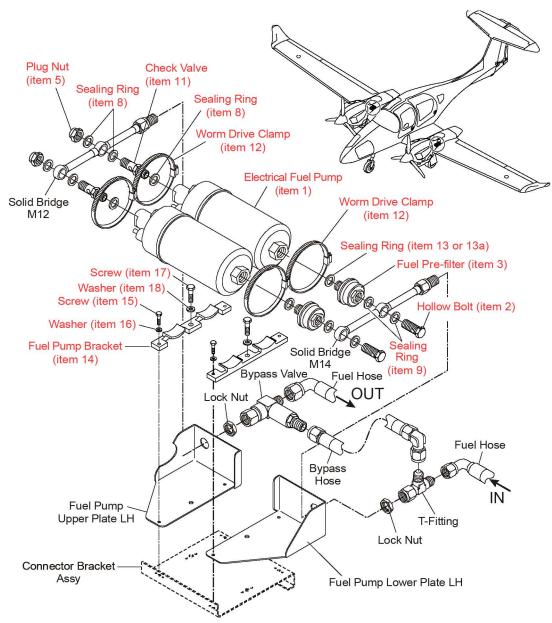
Figure 1. Fuel pump installation

NOTE: Items to be replaced are highlighted in red colour.

- 1. Incorporate AMM-TR-MÄM 62-1083 into the Airplane Maintenance Manual or use an AMM revision in which AMM-TR-MÄM 62-1083 has been incorporated.
- 2. Incorporate AFM-TR-MÄM 62-1083 into the Airplane Flight Manual or use an AFM revision in which AFM-TR-MÄM 62-1083 has been incorporated.
- 3. Remove the existing fuel pumps. Refer to AMM Section 28-20.
- NOTE: Keep the bypass valve, the bypass fuel line, the T-fitting and the solid bridges to reuse on step 6.
 - 4. Remove the existing fuel pump brackets with their screws and washers.
 - 5. Install the new fuel pump brackets (item 14) using screws (items 15 and 17) and washers (items 16 and 18). Refer to Figure 1 for installation and orientation of the brackets (item 2).

- 6. Install the new electrical fuel pump (item 1) as follows: Refer to Figure 1.
 - A. If the existing pre-filters (item 3) are in serviceable condition and being reused, clean them according to AMM Section 28-20.

- B. Install the sealing rings (item 9) and (item 13 or 13a), the two pre-filters (item 3), the solid bridge (reuse) and the hollow bolts (item 2) at the bottom of the fuel pump assembly. Hollow bolts torque: 18 ± 2 Nm (13.3 ± 1.5 lbf.ft.).
 Pre-filter torque: 30 35 Nm (22.1 25.8 lbf.ft.). (Hold by pump hexagon, not by pump body!)

- C. Install the sealing ring (item 8), the two check valves (item 11), the solid bridge (reuse), and the two plug nuts (item 5).
 Check valve torque: 18 ± 2 Nm (13.3 ± 1.5 lbf.ft.).
 Plug nuts torque: 18 ± 2 Nm (13.3 ± 1.5 lbf.ft.).
