MANDATORY SERVICE BULLETIN NO. MSB-62-051 REV. 0

Model: DA 62

Replacement of Main Landing Gear and Nose Landing Gear retaining rings.

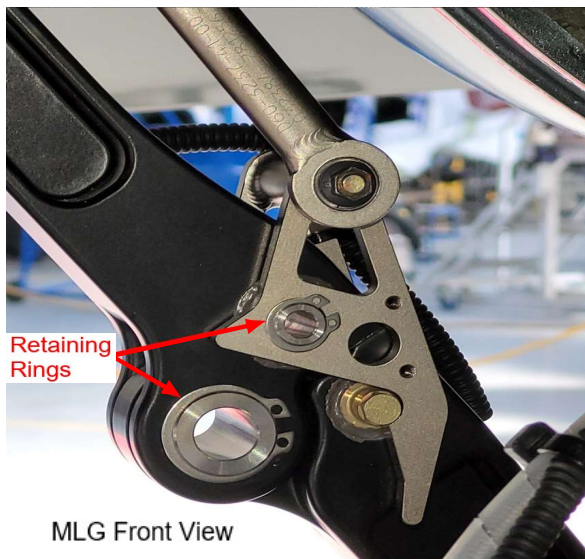
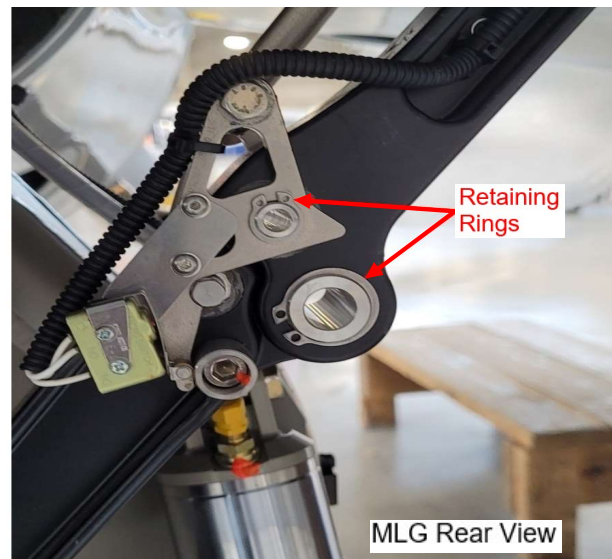
Figure 1. MLG Retaining rings.

It was discovered that the main and nose landing gear braces of some DA 62 aircraft had retaining rings with insufficient level of corrosion resistance being installed. This may cause the retaining rings to corrode, sustain damage, or fail (crack). If not corrected, this may lead to failure of the landing gear. This Service Bulletin describes the replacement of those retaining rings.

3. Remove the retaining rings from the MLG legs and NLG leg as per figures above (Refer to Figures 1 and 2 for location).
4. Clean the grooves of the bearing shafts. Inspect the folding stay and bearing shafts for general condition before installing the new retaining rings.

5. Install the new retaining rings (items 1 and 2 for front and rear of the MLG and items 1 and 3 for left and right side of the NLG). Make sure the retaining rings properly engage into the grooves of the bearing shafts.
