MANDATORY SERVICE BULLETIN NO. MSB 62-055 REV. 0

Drilling of blocked drain holes.

WORK INSTRUCTION WI-MSB 62-055 REV. 0

Unblocking of drain holes underneath the center wing.

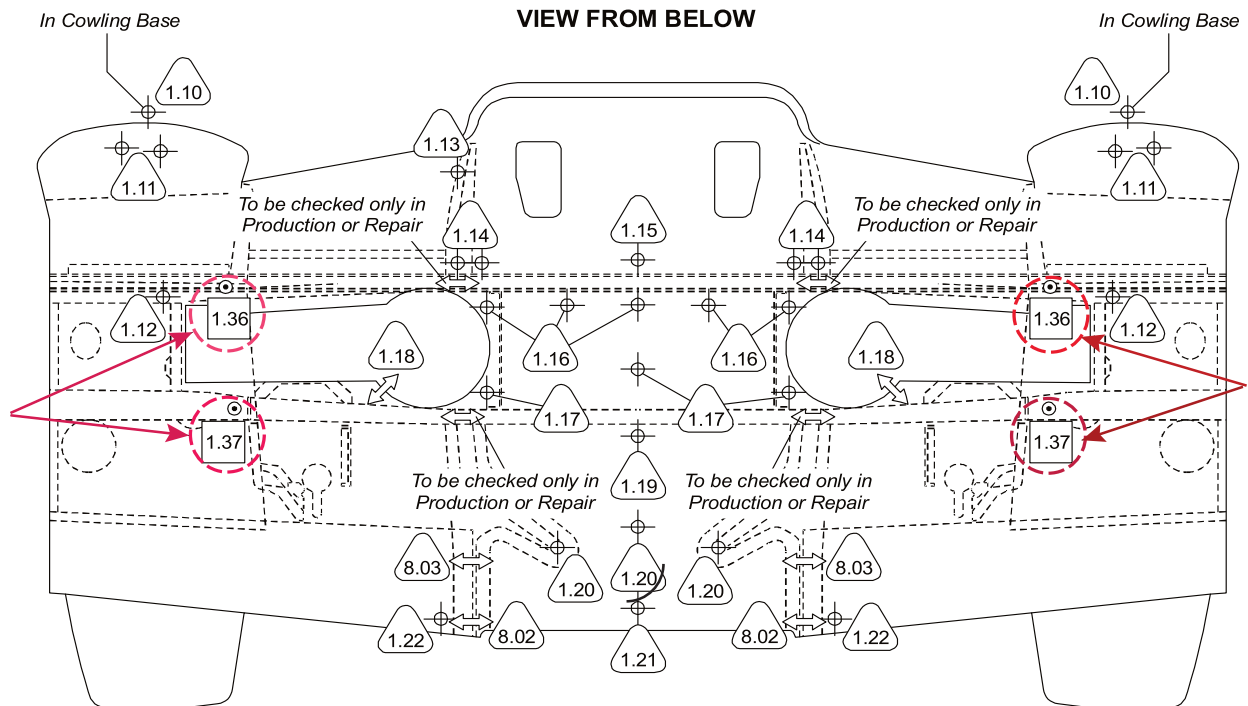
Figure 1: Drain Hole Locations

It has come to Diamond's attention that some DA 62 aircraft may have drain holes in the center section lower shell blocked, thereby preventing draining of some enclosed spaces within the fuselage. This service bulletin describes the procedure for opening these blocked drain holes in the spar bridge.

Refer to Item 1.36 and 1.37 in Figure 1 for the drain hole locations.

DRAIN HOLES INSPECTION CHECKLIST§		
REF.§	DRAIN HOLE LOCATION§	HOURS§
1§	FUSELAGE§	§
1.36§	In the front box spar, to the engine nacelle fuel compartment, (LH and RH).§	200§
1.37§	In the rear box spar, to the engine nacelle maintenance cap. (LH and RH).§	200§

If the drain hole is visible on the outside surface of the spar assembly and is blocked, unblock the drain hole in accordance with the instruction provided in Section III.2.

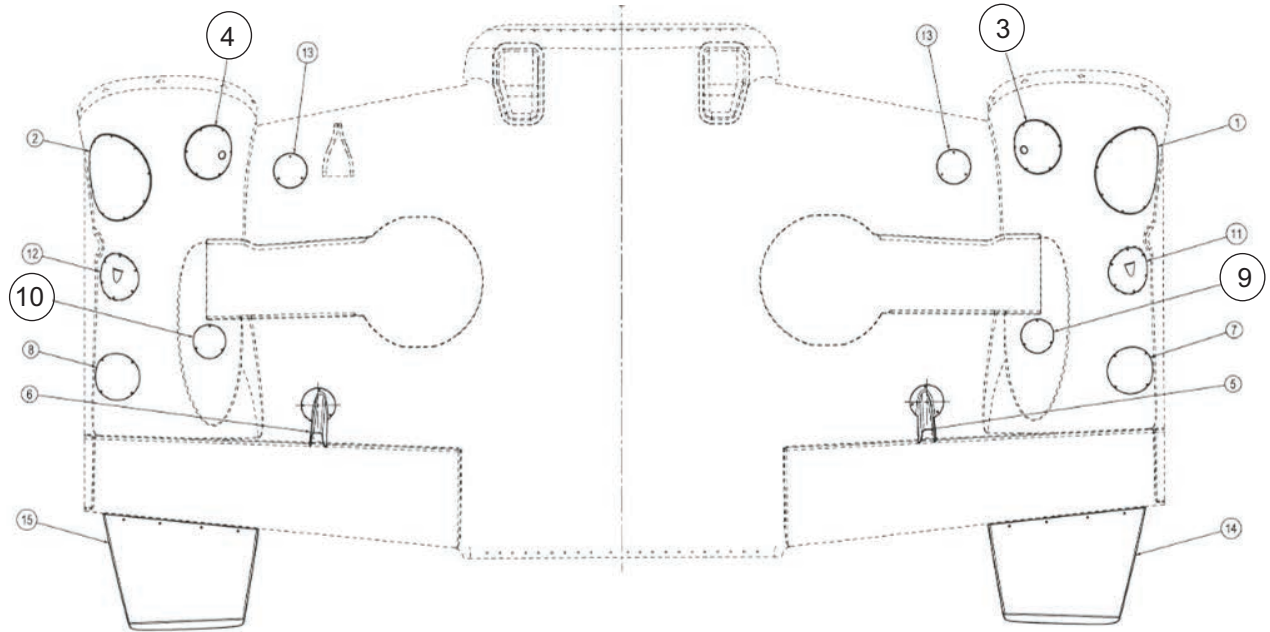
Figure 2: Panels and Drain Holes

Panels (3, 4, 9 & 10) for removal to locate the drain holes

3. Refer to Figure 1
Remove all components or equipment to gain access to the repair area.
Remove the panels for access to the drain hole locations. Refer to Figure 2.
