SERVICE INFORMATION LETTER NO. SI62-012

All DA62 airplanes

Air Filter

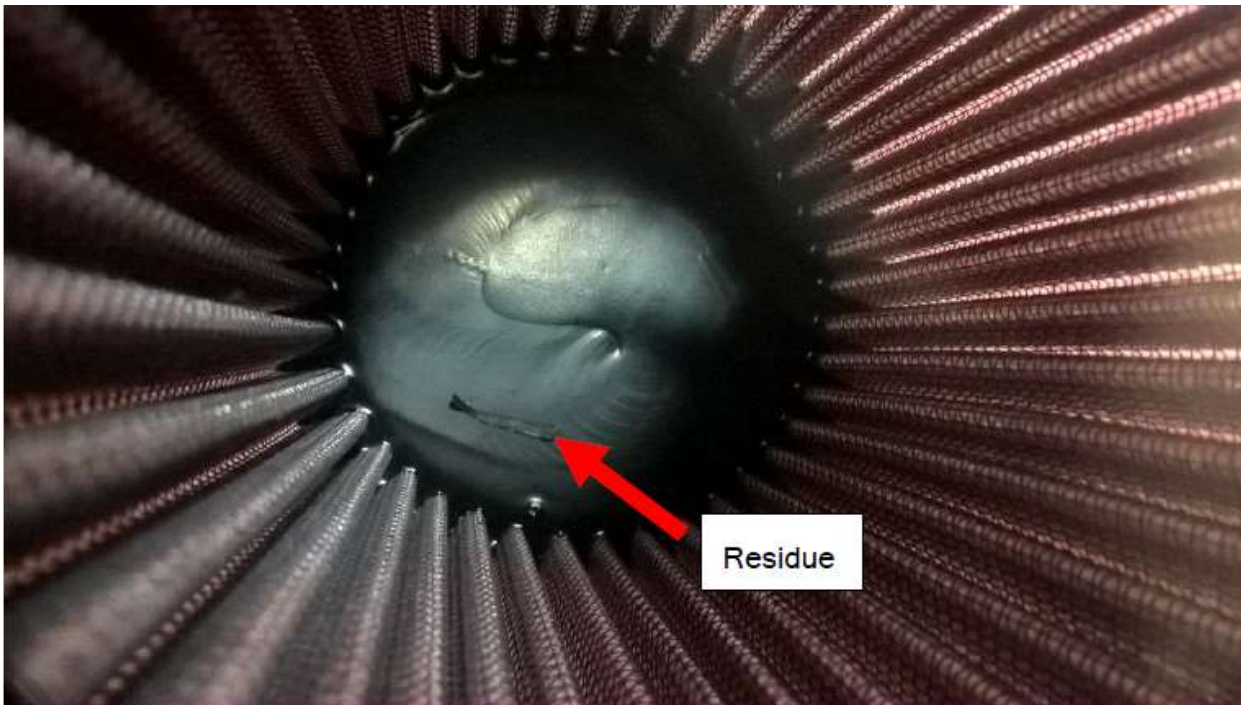
In the aircraft assembly, line residue from manufacturing of the air filter was found in the charged air system.

Diamond Aircraft Industries Inc. advises maintenance personnel to inspect the bag in which new air filters are delivered and inspect also the inside of new air filters for loose residue from manufacturing.

Undetected residue may enter the charged air system and damage the turbocharger.

If loose residue is detected, remove it carefully prior to installation of the air filter.

If there is any doubt that the removal of the residue will affect the filter function or all residue cannot be removed, replace the air filter with a new air filter.
