### **Diamond Aircraft Industries**

## **SERVICE INFORMATION LETTER NO. SI62-025**

Inspection of engine safety ropes on all DA 62 aircraft.

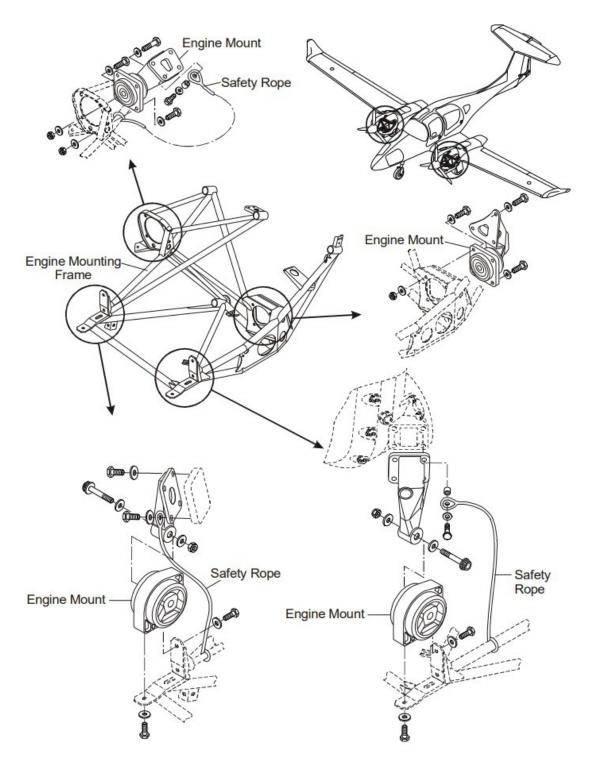
Diamond Aircraft has received numerous reports regarding DA 62s where the engine safety ropes have been chafing against various parts in the engine installation such as the engine mount, the oil pan and the gearbox. If left uncorrected, the security of the engine following a failure of a shock mount cannot be ensured. The engine may also experience a loss of engine/gearbox oil if the oil pan or the gearbox has been penetrated.

Figure 1. Locations of the safety ropes.

- 1. Remove the cowlings. Refer to AMM Section 71-10.
- 2. Inspect the safety rope at the front left of the engine.
  - A. Check for sufficient clearance with all items in the vicinity of the safety rope.
  - B. Check for signs of chafing on the safety rope, and on items in the vicinity of the safety rope.
- 3. Repeat step 2 for the safety rope at the front right of the engine.
- 4. Repeat step 2 for the safety rope at the aft right of the engine.
- 5. Install the cowlings. Refer to AMM Section 71-10.
- 6. Repeat steps 1 through 5 for the other engine.
- 7. Contact Diamond Aircraft if signs of chafing are observed.
