**SERVICE INFORMATION LETTER NO. SI62-027**

EASA AD 2021-0055-E and Austro Engine Mandatory Service Bulletin MSB-E4-030 - Oil Pump Replacement

# MANDATORY SERVICE BULLETIN

**No. MSB-E4-030/1**  
**Supersedes MSB-E4-030**

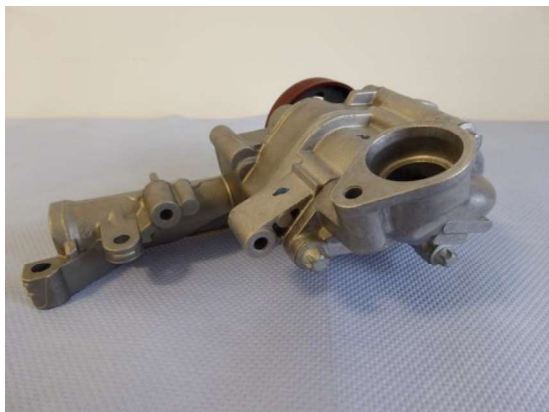
**Fig. 1**

Delivered oil pump

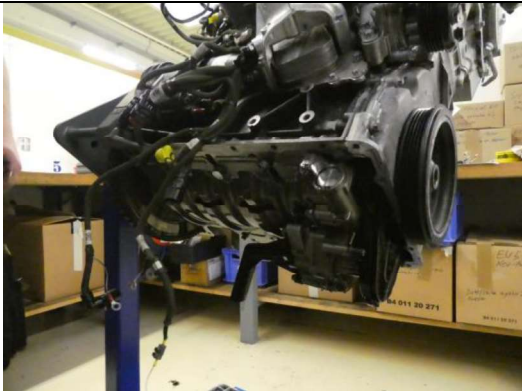
<p><b>Fig. 3</b></p>	<p>After removal of the oil sump</p>

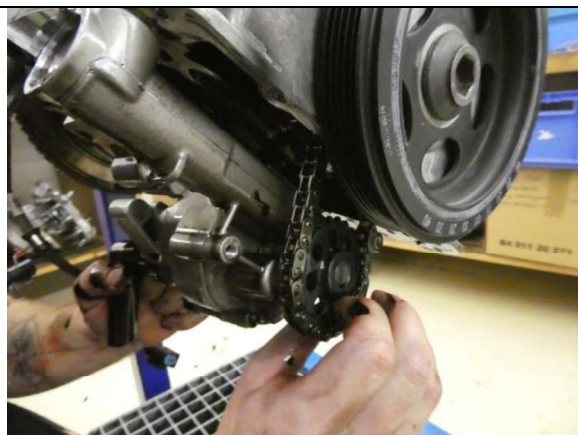
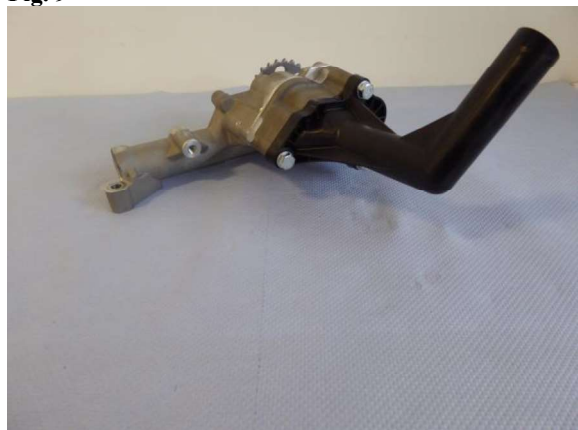
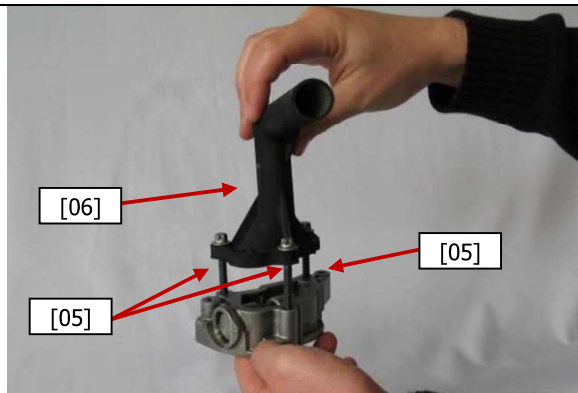
Examine the oil pump for blockage. Make sure that the pump gears move freely when turned by hand.

Removed oil pump (E4A-50-000-BHY)

After removal of the oil suction pipe, examine the oil pump gears for damage.

**In case of a blocked, and/or partially blocked, and/or damaged oil pump, please contact Austro Engine for further instructions.**

Loosen the oil pump chain gear from the oil pump chain.

Remove the oil pump.

Loosen three screws [05] of the oil pump and remove the oil suction pipe with the integrated oil strainer [06] (E4A-50-100-BHY) from the old oil pump.

Note: The oil suction pipe with oil strainer and the screws [05] must be reused for the new oil pump installation.
