## **SERVICE INFORMATION LETTER NO. SI62-028**

EASA AD 2021-0055-E and Austro Engine Mandatory Service Bulletin MSB-E4-030/3 - Oil Pump Replacement with updated serial number effectivity.

Mandatory Service Bulletin  
No. MSB-E4-030/3

Oil pump replacement

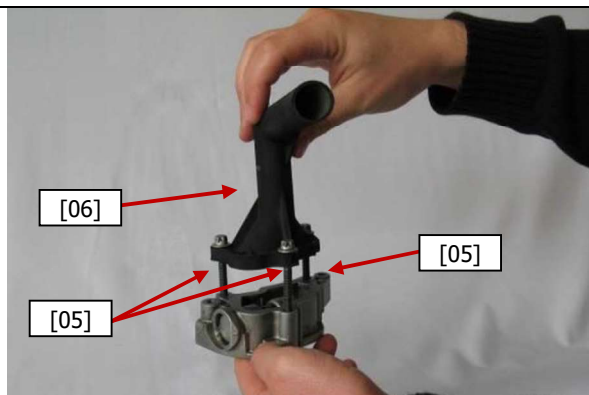
Fig. 11

Examine the oil pump for blockage.  
Make sure that the pump gears move freely when turned by hand.

After removal of the oil suction pipe, examine the oil pump gears for damage.

**In case of a blocked, and/or partially blocked, and/or damaged oil pump, please contact Austro Engine for further instructions.**

Loosen the oil pump chain gear from the oil pump chain.

Remove the oil pump.

Loosen three screws [05] of the oil pump and remove the oil suction pipe with the integrated oil strainer [06] (E4A-50-100-BHY) from the old oil pump.

**Note:** The oil suction pipe with oil strainer and the screws [05] must be reused for the new oil pump installation.
