SERVICE INFORMATION LETTER NO. SI62-044

Aircraft: DA 62.

1.2 Subject

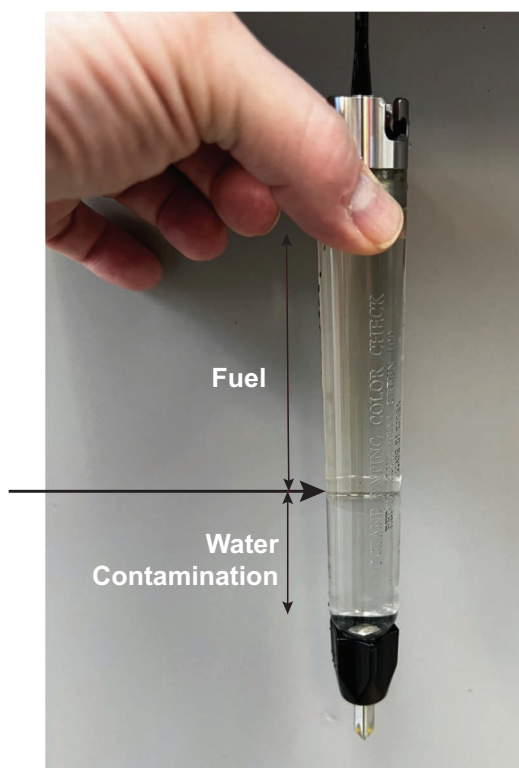
Diamond Aircraft Industries have had occurrences reported of water contamination of the fuel in the DA 62. The source of contamination could be water entering via the fuel filler cap, condensation inside the fuel tank, or the presence of water from the fuel supplied.

Fuel Sample (contaminated)

- Make sure to use anti-microbial additives in the fuel, as per Section 2.14 of the Airplane Flight Manual (AFM). Document # 11.01.05-E, latest revision.
- Before each flight, make sure to check for water in the fuel from the left wing tank drain, the right wing tank drain, and the gascolators (at the left and right engine nacelles). Refer to Section 4A.6.1, II. Walk-around check, visual inspection, of the AFM, Document # 11.01.05-E, latest revision.
- Make sure to keep the fuel tanks full when the airplane is parked to reduce the effects of condensation in the fuel tanks.
- Make sure there is no damage to the O-rings or the fuel filler cap and that it seals the fuel tank securely when installed after refueling the airplane, as per Section 12-10 Para 3 of the Airplane Maintenance Manual Document # 7.02.25, latest revision.

- Replace the fuel filler cap seals (O-rings) for the left and right wings every year. Refer to AMM-TR-25-03 or latest revision of the Airplane Maintenance Manual (AMM) with AMM-TR-25-03 incorporated.
- Examine the fuel filler flange and spacer ring for damage and correct installation. Refer to AMM Section 28-10-00, Maintenance Practices, 3.A & C.
- Make sure that the fuel filler cap locking lever has enough friction force that it locks the fuel filler cap when closing it by hand, ensuring a tight seal. If necessary, tighten or loosen the locking nut at the bottom to adjust it. Make sure to keep a minimum of 1 thread protrusion for safety.

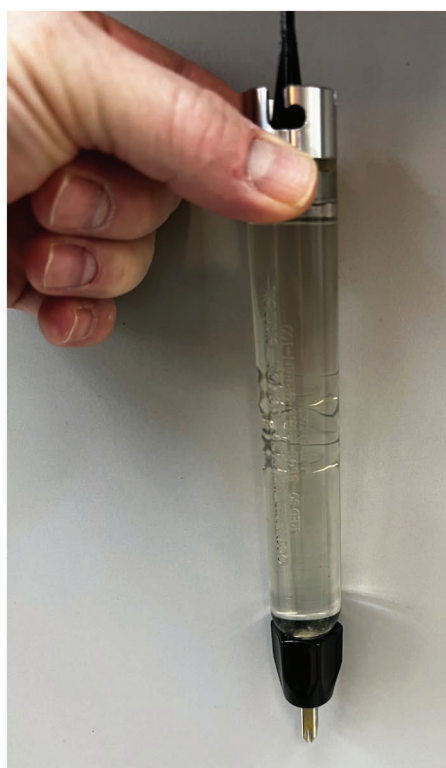
Fuel Sample (not contaminated)
