MANDATORY SERVICE BULLETIN

NO. MSB20-047

Alteration of coolant to EVANS NPG+, Rotax SB-912-043, Rotax SB-914-029

CHANGE OF COOLANT SPECIFICATION ON ROTAX® ENGINE TYPE 912 AND 914 (SERIES)

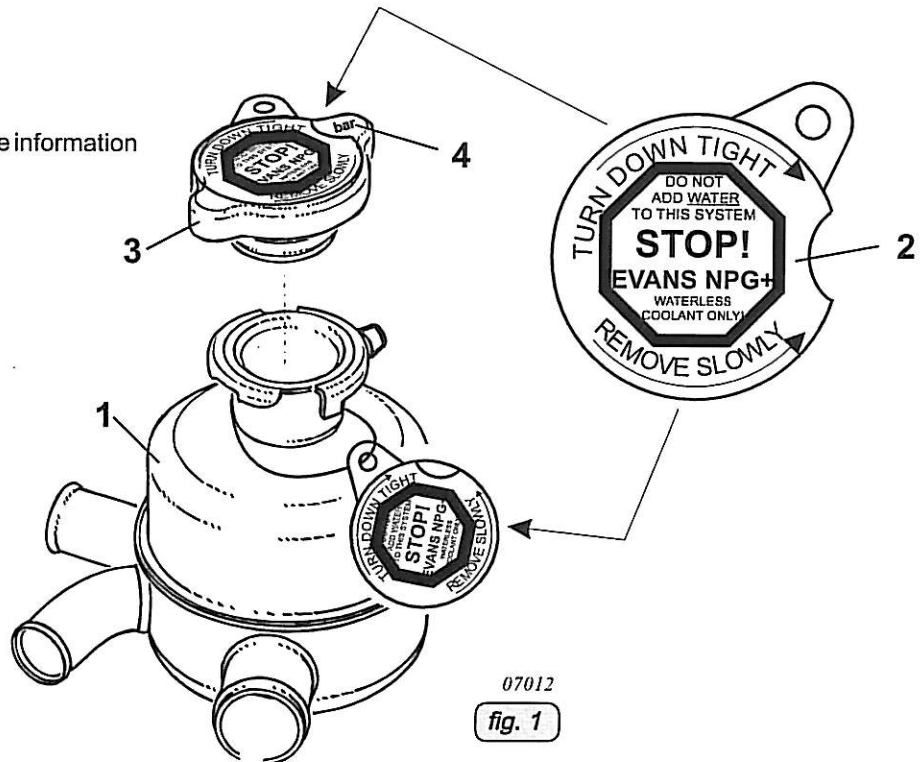
◆ **NOTE:** On the radiator cap (3), to identify the new coolant, the warning label (2) is to be affixed so that the opening pressure data (4) is visible.

- 1 Expansion tank
- 2 Warning sticker
- 3 Radiator cap
- 4 Excess-pressure information

- For new engine deliveries the sticker will be temporarily attached to the expansion tank.
- The sticker has to be affixed to the radiator cap in accordance to the aircraft manufacturer's instruction.
