SERVICE INFORMATION NO. SI 22-014

EASA AD No. 2007-0025
ATA-Code: 72-00

CHECKING OF THE CRANKCASE ON ROTAX® ENGINE TYPE 912 AND 914 (SERIES)

SB-912-029 R3

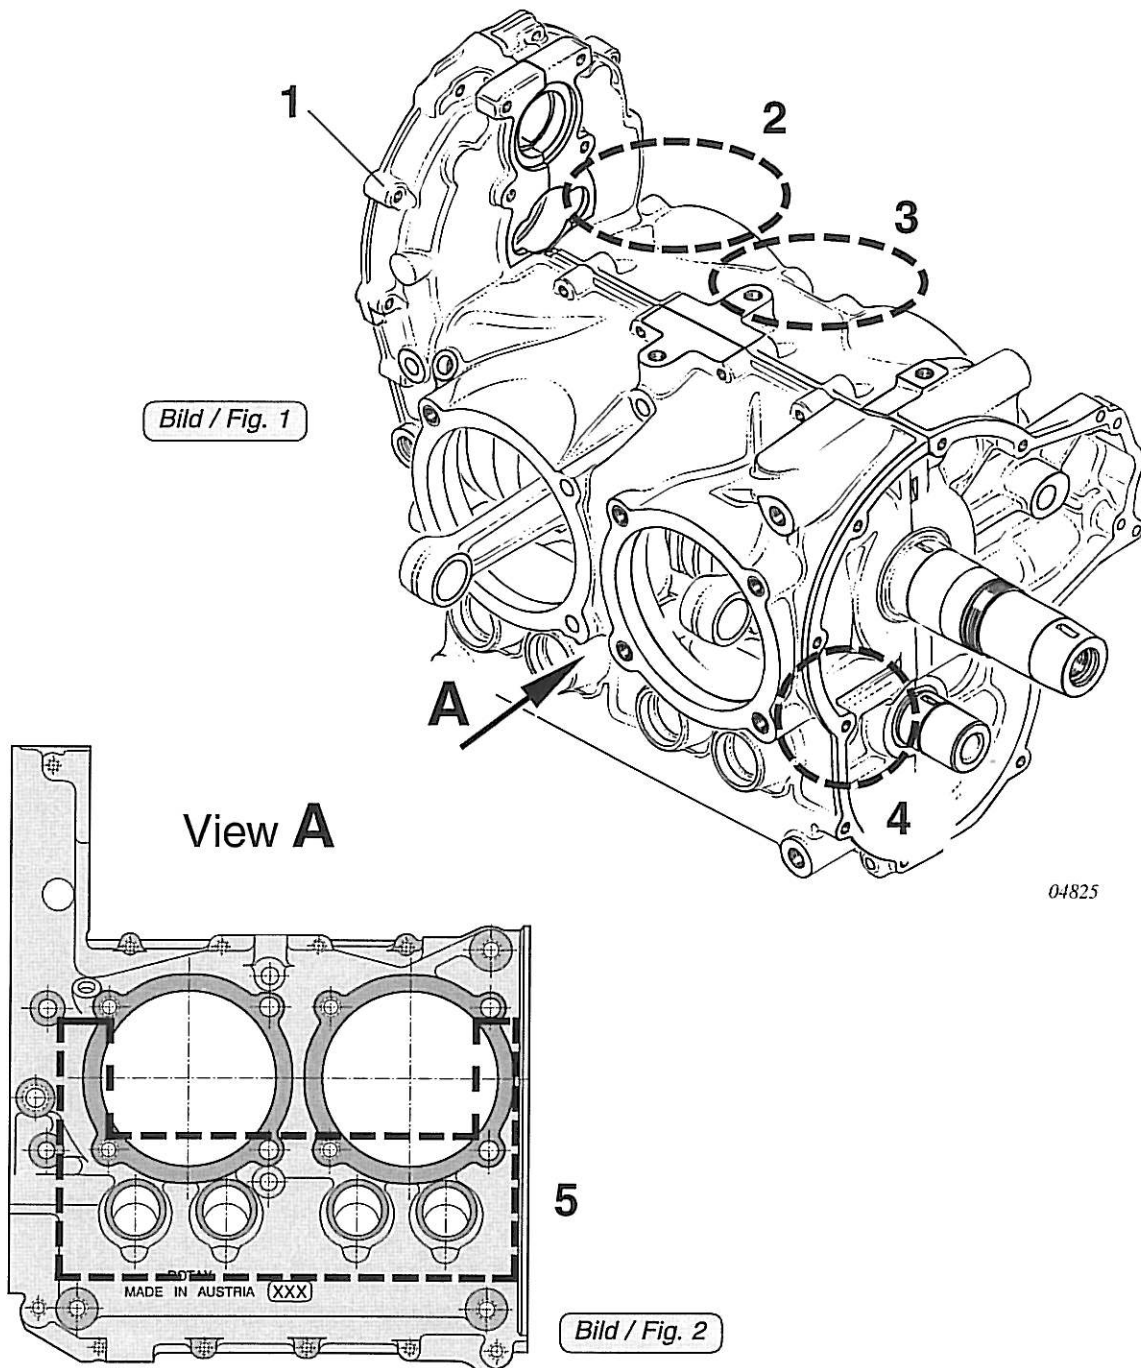
see fig. 1

- Visually inspect the crankcase (1) and engine suspension for cracks in accordance with the relevant Maintenance Manual.

Visually inspect the crankcase especially:

- in the area of cylinder 1 upper side (2)
- between cylinder 1 and 3 upper side (3)
- in the area of cylinder 4 lower right side (4) and
- detailed inspect in the area (5). See view **A** fig. 2.

For those engines using the ROTAX[®] cooling air baffle. Visually inspect for oil leaks in area (2) and (3). If leaks are found, then further investigation to determine the cause of the oil leak is required. If the exact origin of the leak can not be determined i.e. governor, then removal of the cooling air baffle must be required.

- If cracks are detected the nearest ROTAX[®] Authorized Distributor (see also our official ROTAX-Web-Site: www.rotax-aircraft-engines.com) has to be informed and if necessary the engines has to be removed from aircraft and must be returned to a ROTAX[®] Authorized Distributor.
- Reconnect negative terminal of aircraft battery (after installation of engine).
