SERVICE INFORMATION NO. SI 20-027

BRP-Rotax ASB-912-053
ATA-Code: 73

ALERT SERVICE BULLETIN
REPLACEMENT
OF FUEL PUMP
FOR ROTAX® ENGINE TYPE 912 (SERIES)
SB-912-053

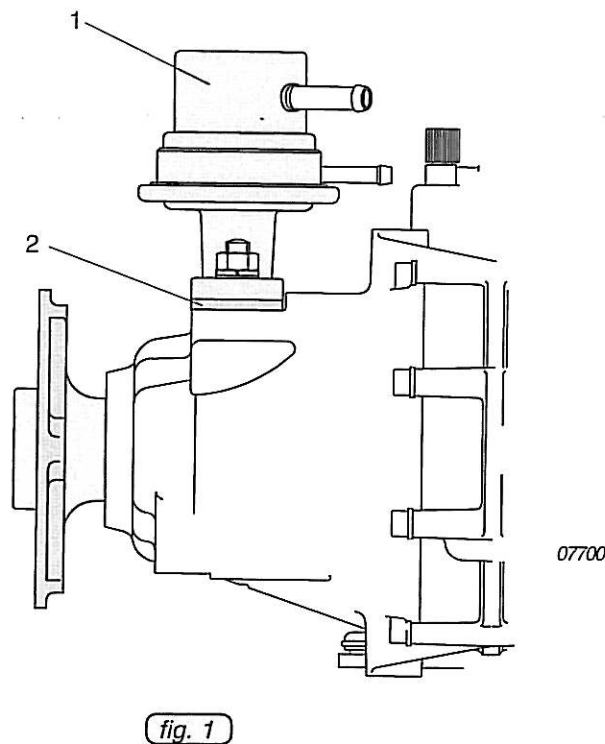
(see Fig.1)

Due to high fuel pressure, caused by exceeding pressure in front of the mechanical fuel pump (e.g. due to an electrical fuel pump), in limited cases a deviation in the fuel supply could occur. This can result in exceeding of the fuel pressure and might cause engine malfunction and/or massive fuel leakage.

1. Remove fuel pump (1).

2. Gasket (2) replaced by new part.

■ **CAUTION:** Install new gasket supplied with new fuel pump. The thickness is different.

3. Install fuel pump. Tightening torque 15 Nm (133 in.lb).

4. Install fuel line.
