SERVICE INFORMATION NO. SI 20-030

EASA AD 2007-0060R1-E
BRP Rotax 912 Series Engines – Fuel Pump Replacement
ATA-Code: 73

EASA	EMERGENCY AIRWORTHINESS DIRECTIVE

SERVICE BULLETIN
REPLACEMENT
OF FUEL PUMP
FOR ROTAX® ENGINE TYPE 912 (SERIES)
SB-912-053

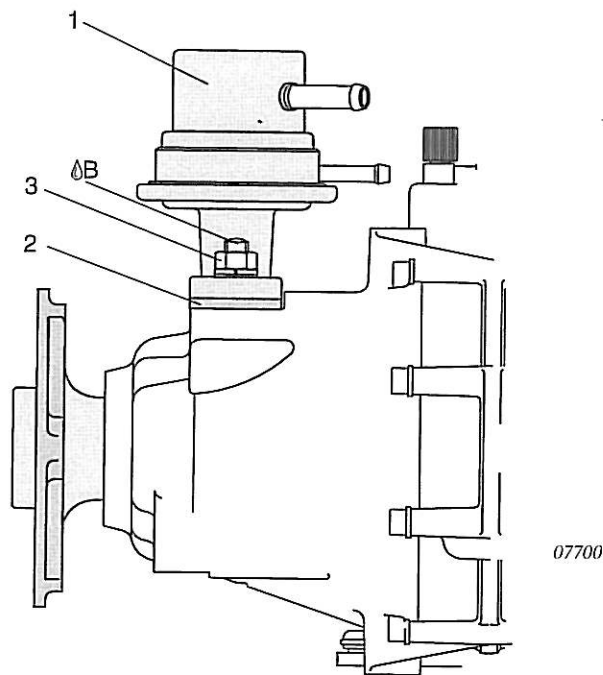
fig. 1

Due to high fuel pressure, caused by exceeding pressure in front of the mechanical fuel pump (e.g. due to an electrical fuel pump), in limited cases a deviation in the fuel supply could occur. This can result in exceeding of the fuel pressure and might cause engine malfunction and/or massive fuel leakage.

1. Remove fuel pump (1).
2. Gasket (2) replaced by new part.

3. Install fuel pump.

4. Tighten uniformly hex. nuts (3) with LOCTITE 243. Tightening torque 15 Nm (133 in.lb).
