SERVICE INFORMATION NO. SI 20-031

BRP-Rotax MSB-912-054

SERVICE BULLETIN
CHECKING OR REPLACEMENT
OF FLEXIBLE FUEL LINE
FOR ROTAX® ENGINE TYPE 912 (SERIES)
SB-912-054

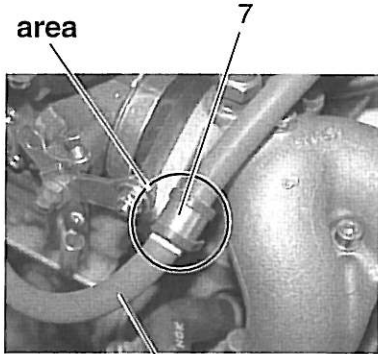
Due to a chemical reaction of the adhesive (in the area of the yellow position marks on the firesleeve) porosity and/or cracks on the firesleeve can occur.

Fuel leakage within this area is not an issue, as only the fireproof protection hose is affected and the fuel is routed in a wire braid reinforced teflon hose.

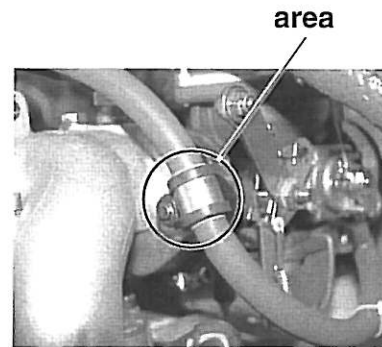
◆ NOTE: The relevant part number and S/N of the fuel line is attached and/or evident on the metal tag on the hose (see Fig. 4).

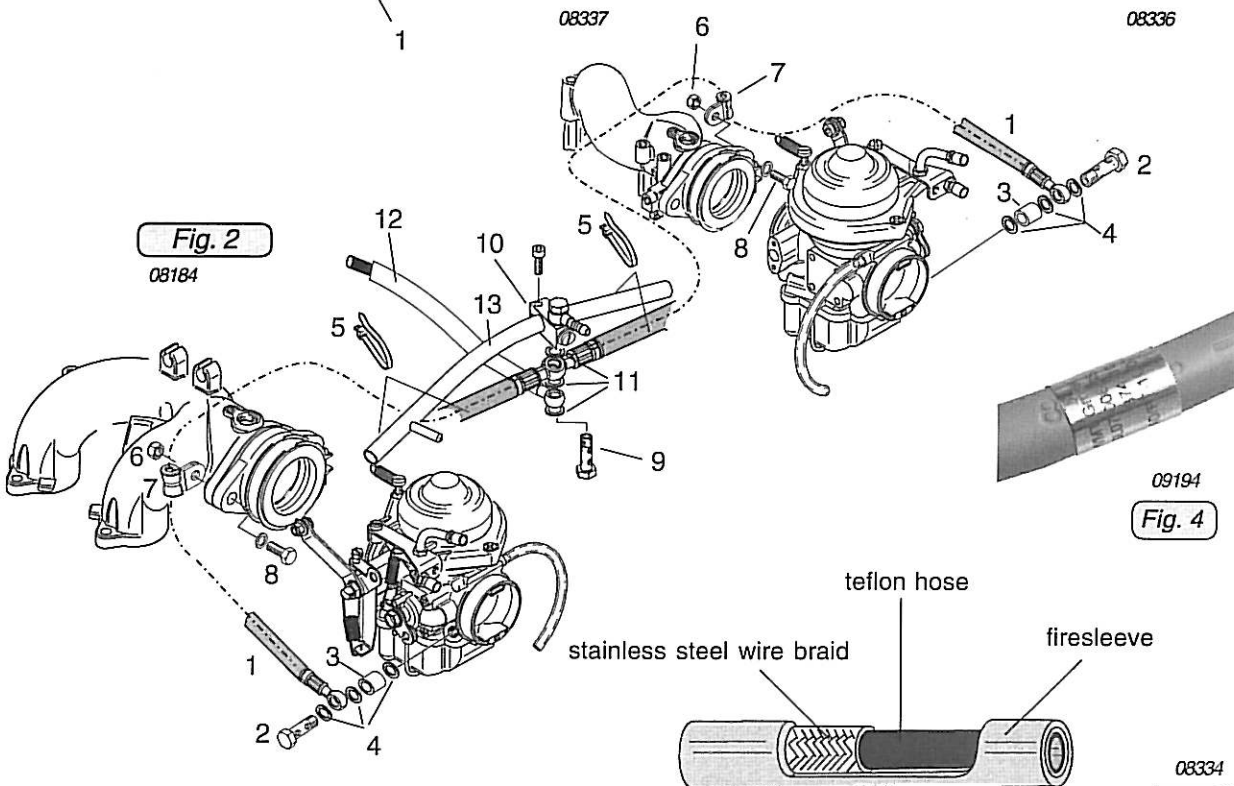
Visual inspection of the fuel line (1) in the area clamp (7) and both ends of the yellow protection cover. (see Fig. 1)

◆ **NOTE:** A possible crack can be observed by careful bending of the fuel line. If you notice cracks or porosity then you need to replace the fuel line in accordance section 3.1.2.

1. Unscrew the banjo bolt (2) with distance sleeve (3) and 3 gasket rings (4).

2. Cut the cable tie (5).

3. Remove hex. nuts M8 (6) together with clamp (7). Held in place by hex. screw (8).

4. Remove banjo bolt (9) from clamp block (10) together with 3 gasket rings (11).

5. Remove the fuel line (12).

1. Install flexible fuel line (1 and 12) and the banjo bolt (9) with new sealing ring (11) on the clamp block (10). Tightening torque of banjo bolt (9) 10 Nm (90 in.lb). Check that the fuel lines are not under strain or tension.

2. Install both cable clamp (7) in accordance with Fig.1 on the fuel line.

3. Install the fuel line (1) with distance sleeve (3) and sealing ring (4) on the carburetors. Tightening torque of banjo bolt (2) 10 Nm (90 in.lb). Place cable clamp (7) into position.

4. For proper support. Install the clamp (7) and hex. nut M8 (6) with LOCTITE 221. Tightening torque of hex. nut (6) 15 Nm (133 in.lb).
