## SERVICE INFORMATION NO. SI 20-035

BRP-Rotax Service Bulletin SB-912-051 and SB-914-034

**SERVICE BULLETIN**  
**CHECKING OF MAGNETIC PLUG**  
**ON ROTAX® ENGINE TYPE 912/914 (SERIES)**  
**SB-912-051**  
**SB-914-034**

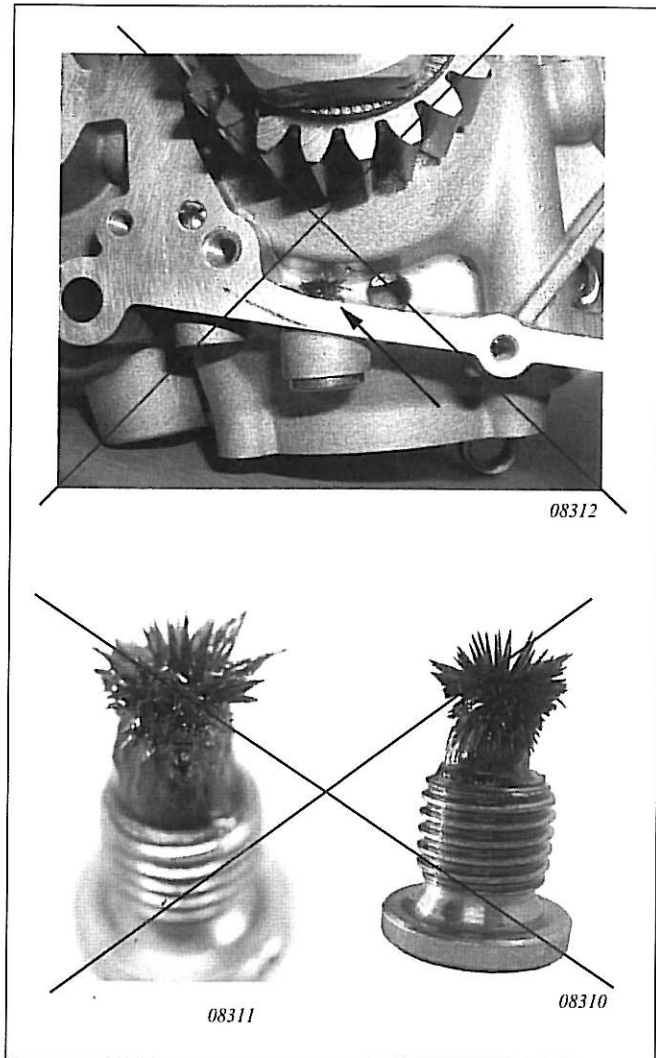
fig. 2

In limited cases increased wear of camshaft/hydraulic valve tappet can occur.

■ **CAUTION:** If a greater quantity of metal particles (more than 3 mm (1/8")) is detected, consultation of an authorized distributor regarding further action is necessary. The engine must not be taken into operation until the cause has been identified and eliminated.

not acceptable
