SERVICE INFORMATION NO. SI 20-037

BRP-Rotax Service Bulletin SB-912-056 R1 and SB-914-038 R1
ATA-Code: 72

REPLACEMENT OF THE PROPELLER GEARBOX FOR SOME ROTAX[®] ENGINES TYPE 912/914 (SERIES)

SB-912-056 R1

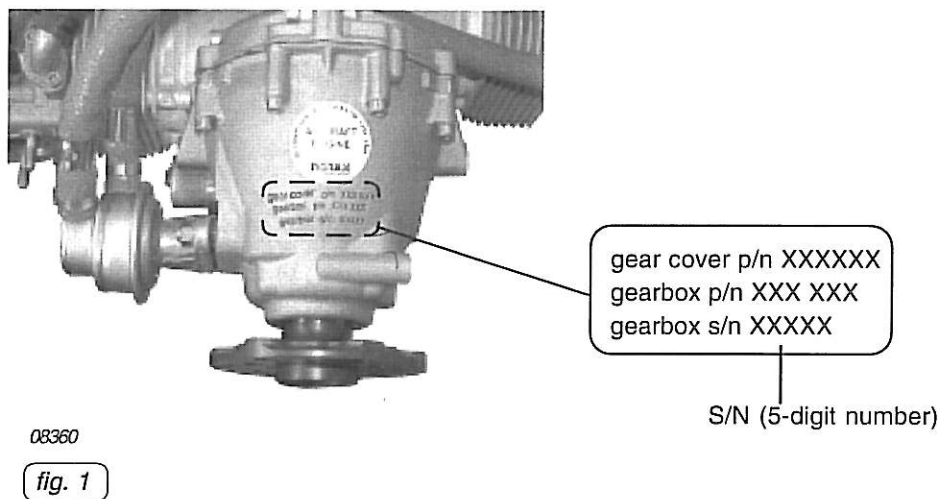
◆ **NOTE:** The relevant serial number of the gearbox is visible on the gearbox housing (see fig.1).
