SERVICE INFORMATION NO. SI-20-041

Rotax SI-912-021 and SI-914-023
ATA-Code: 72-00

INSPECTION OF CARBURETORS

FOR ROTAX® ENGINE TYPE 912 AND 914 (SERIES)

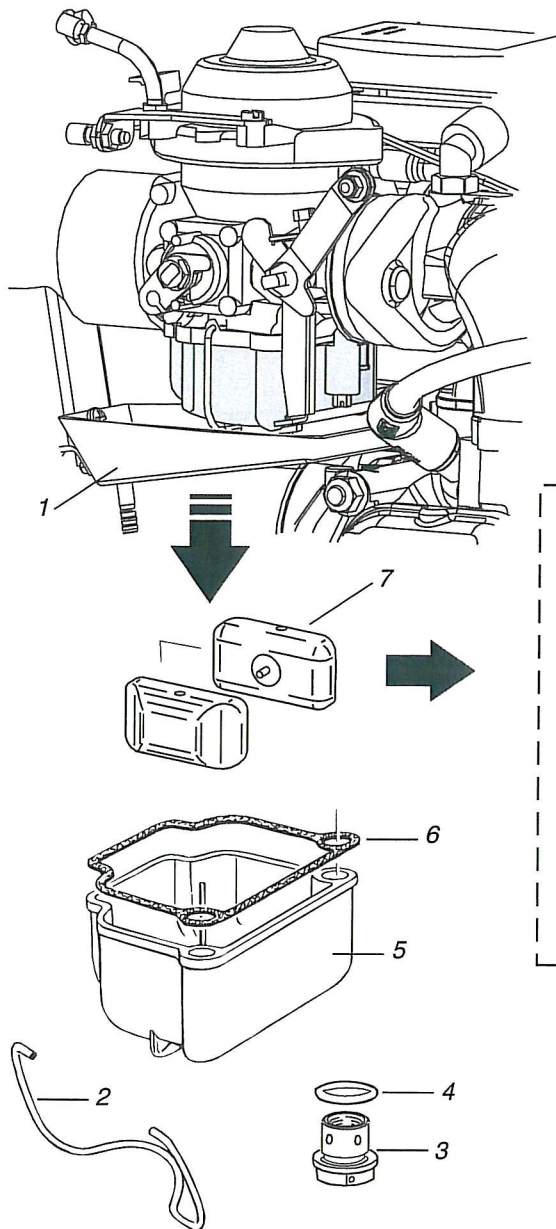
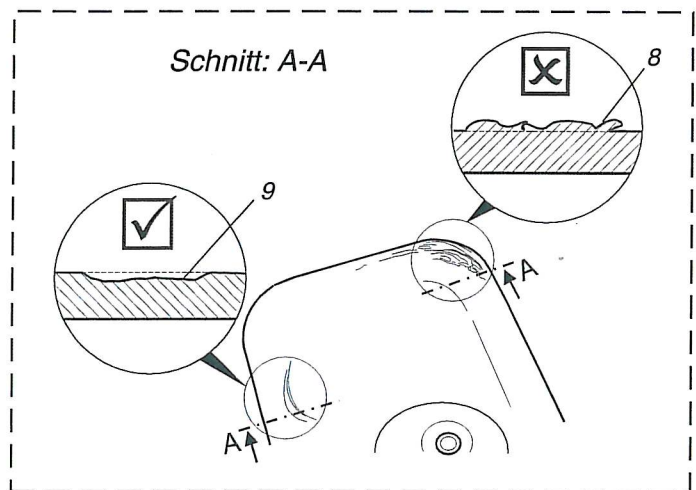
BILD 1 Vergaser

5. Beide Schwimmer sorgfältig auf lose Partikel untersuchen. Aufgrund seiner funktionalen Eigenschaften besteht der Schwimmer aus einem sehr leichten und porösen Kunststoff, welcher mittels Spritzverfahren hergestellt wird. Oberflächenbeschädigungen aufgrund der porösen Oberfläche z. B. kleine Ausbrüche bis max. 3 mm Ausdehnung und/oder produktionsbedingte Flusstellen (siehe Bild 1 Pos.9) sind zulässig. Diese optischen Merkmale z. B. offene Poren beeinflussen nicht die Funktion des Auftriebes d. h., die Schwimmer nehmen z. B. keine Flüssigkeit auf.

Materialüberlappungen und/oder Fehlstellen (siehe Bild 1 Pos. 8), welche nicht ausreichende Verbindung zum Schwimmer aufweisen, sind nicht zulässig und die Schwimmer sind zu erneuern. Fertigungsbedingte Flusstellen (siehe Bild 1 Pos. 9) sind jedoch zulässig.

■ **ACHTUNG:** Sollten die Schwimmer Materialüberlappungen oder lose Partikel aufweisen, so sind die Vergaser nach letztgültigem Wartungshandbuch zu demontieren, zerlegen, reinigen, überprüfen, zusammenbauen und erneut zu montieren.

■ **ACHTUNG:** Bei Verunreinigung der Schwimmergehäuse ist zuerst die Ursache festzustellen und die notwendigen Abstellmaßnahmen einzuleiten. Möglicherweise ist das gesamte Kraftstoffsystem inkl. Vergaser zu reinigen und zu kontrollieren.

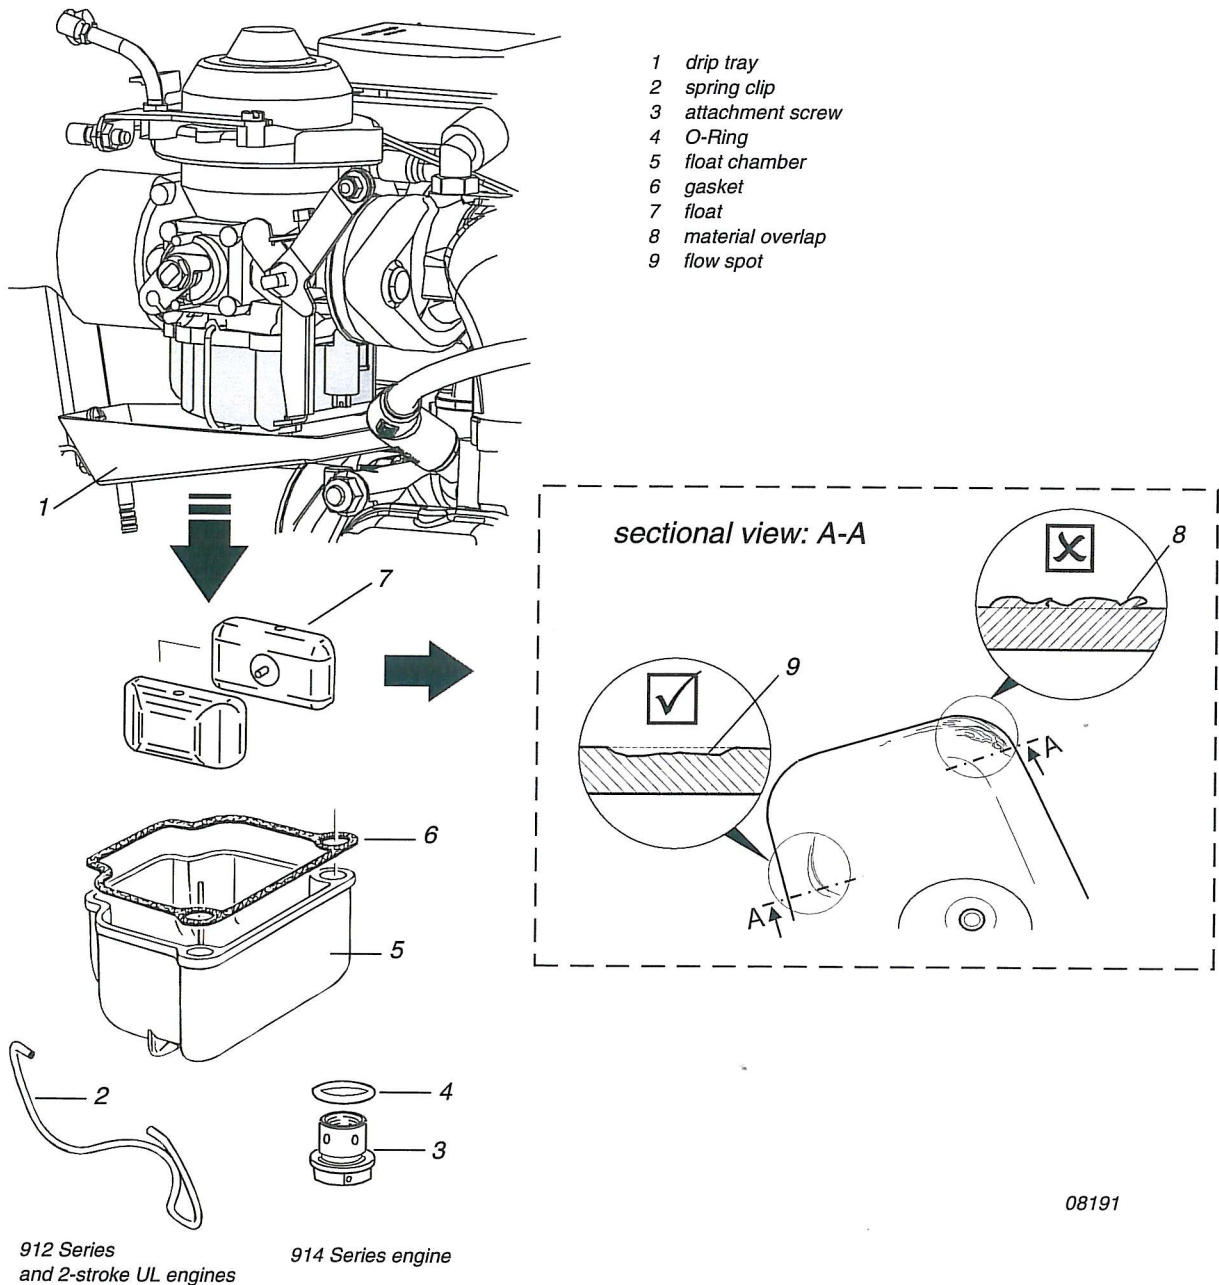
Fig. 1
Carburetor

5. Check both floats carefully for loose particles. By its functional characteristics a float consists of a lightweight and porous plastics, which is gained by a spraying method. Damages on the surface caused by the porosity e.g. small disruptions up to max. 3 mm (0.12 in) length and/or flow spots (see figure 1 pos. 9) caused by the production process are permitted. These optical characteristics e.g. open pore, do not cause the floats to sink or to absorb liquid.

Material overlaps and imperfections (see Figure 1 pos. 8), which do not have sufficient connection to the float, are not permitted and the floats need to be replaced. Flow spots caused in the production process (see Figure 1 pos. 9) are permitted.

■ **CAUTION:** If the floats show material overlaps or loose particles the carburetors need to be removed, disassembled, cleaned, checked, re-assembled and installed again.

■ **CAUTION:** In case of contaminations of the float chambers first the cause must be found and the relevant measures need to be taken. Possibly the whole fuel system including carburetors needs to be cleaned and checked.
