## SERVICE INFORMATION NO. SI 20-045

FAA Airworthiness Directive No 2011-14-09  
ATA-Code: 74 - Ignition

**Airworthiness Directives; Various Aircraft Equipped With Rotax Aircraft Engines 912 A  
Series Engine**

## REPLACEMENT OF WASHER PART NO. 944072 (FLY WHEEL HUB) FOR ROTAX® ENGINE TYPE 912 AND 914 (SERIES)

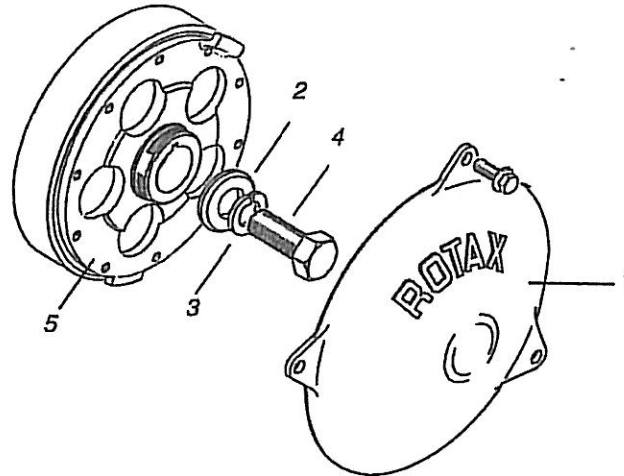
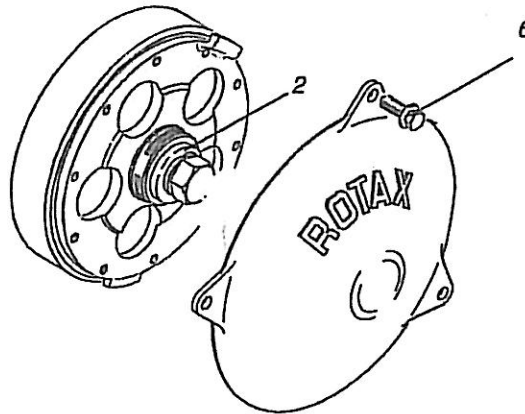
Fig. 1

A deviation in hardening process could cause an exceeding of hardness of certain washer. This deviation could lead to cracks in the washer and could cause loosening of fly wheel, ignition failure or engine damage.

See fig. 1.

1. Remove ignition cover (1).
2. Lock the crankshaft in accordance with the relevant Maintenance Manual (Line).
3. Remove hex. screw (4) in accordance with the relevant Maintenance Manual (Heavy).

4. Install hex. screw (4). Tightening torque 120 Nm (89 ft.lb).

■ CAUTION: During installation the new washer (2) part no. 944072 must be used.
