## SERVICE INFORMATION NO. SI 20-046

Rotax Alert Service Bulletin ASB 912-059  
ATA-Code: 72-20

# ALERT SERVICE BULLETIN

## CHECKING OF THE CRANKSHAFT JOURNAL (POWER TAKE OFF SIDE) FOR ROTAX® ENGINE TYPE 912 AND 914 (SERIES)

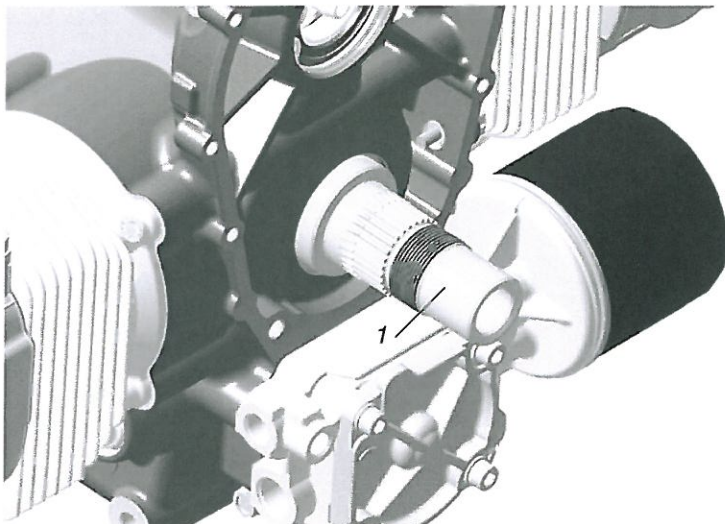
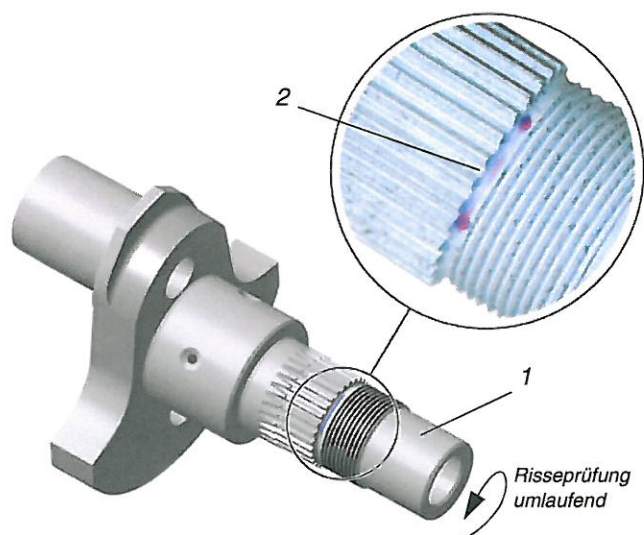
**BILD 1**

Aufgrund von Abweichungen beim Herstellprozess kann es bei einigen Kurbelwellen zur Rissbildung im Bereich des abtriebseitigen Kurbelwellenstummels kommen. Diese Risse können im Betrieb zu einem Bruch der abtriebseitigen Kurbelwellen-Stützlagerung und unter Umständen zu einem Motorstillstand führen.

6. Kurbelwellenfixierung lösen um eine Kontrolle am gesamten Umfang der Kurbelwelle durchführen zu können.
  - Detaillierte Rissprüfung im Bereich (2) des Gewindeauslaufes mittels Eindringverfahren. Diese Überprüfung ist in Übereinstimmung mit den Anforderungen der jeweiligen Luftfahrtbehörde in Ihrer Region für die zerstörungsfreie Prüfung und gemäß DIN EN 571 oder gleichwertig durchzuführen.

- 1 Kurbelwelle
- 2 Detaillierte Risseprüfung

- ACHTUNG: Bei Rissanzeichen oder etwaigen Unklarheiten ist umgehend der zuständige Luftfahrzeughersteller und der nächste autorisierte Vertriebs- und Servicepartner für ROTAX-Flugmotoren bezüglich weiterer Vorgangsweise zu kontaktieren. Der Motor muss für einen weiteren Betrieb, einer entsprechenden Instandsetzung unterzogen werden und darf nicht in Betrieb genommen werden.

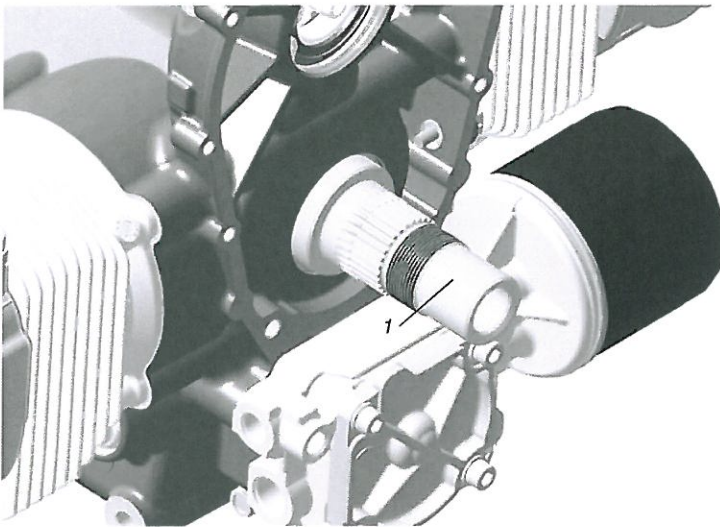
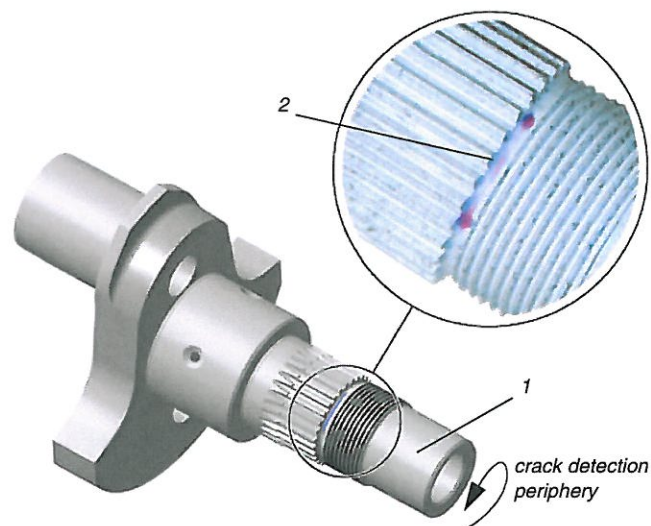
**Fig. 1**

Due to a deviation in the manufacturing process some crankshafts may have a crack formation occur on the power take off side. These cracks can cause a breakage of the crankshaft support bearing and may lead to engine stoppage.

6. Unlock the crankshaft to do the check on the entire periphery of the crankshaft.
  - Detailed crack detection in the area (2) of the thread runout using penetration test. Perform this test in accordance to the requirements of the applicable aviation authority in your region for non destructive testing (NDT) and according to DIN EN 571 or equivalent.

- 1 crankshaft
- 2 detailed crack detection

- CAUTION: In case of crack or doubt contact your aircraft manufacturer and your nearest authorized ROTAX aircraft engine distributor. The engine must not be taken into operation until the cause has been identified and eliminated.

7. If no cracks can be found, then the reassembly has to be conducted in accordance with following steps:
  - Lock the crankshaft in accordance with the relevant Maintenance Manual (Line).
  - Clean and degrease crankshaft journal, threads and splines.
  - Install the drive gear with a new friction washer in accordance with the relevant Maintenance Manual (Heavy).
  - Clean the sealing surface of crankcase and gear cover.
  - Install the propeller gear box.
  - Remove locking pin of crankshaft in accordance with the relevant Maintenance Manual (Line).
- Restore aircraft to original operating configuration.
- Connect negative terminal of aircraft battery.
