## SERVICE INFORMATION NO. SI 20-049

Rotax Service Bulletin SB 912-059  
ATA-Code: 72-20

## CHECKING OF THE CRANKSHAFT JOURNAL (POWER TAKE OFF SIDE) FOR ROTAX® ENGINE TYPE 912 AND 914 (SERIES)

SB-912-059

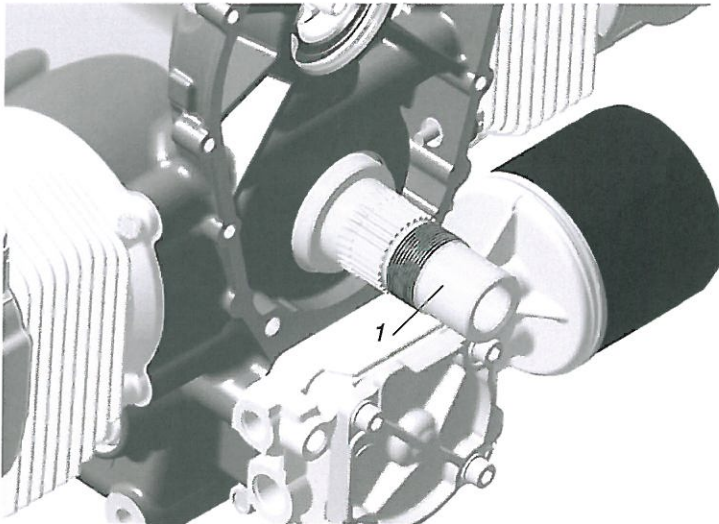
**BILD 1**

Aufgrund von Abweichungen beim Herstellprozess kann es bei einigen Kurbelwellen zur Rissbildung im Bereich des abtriebseitigen Kurbelwellenstummels kommen. Diese Risse können im Betrieb zu einem Bruch der abtriebseitigen Kurbelwellen-Stützlagerung und unter Umständen zu einem Motorstillstand führen.

6. Kurbelwellenfixierung lösen um eine Kontrolle am gesamten Umfang der Kurbelwelle durchführen zu können.
  - Detaillierte Rissprüfung im Bereich (2) des Gewindeauslaufes mittels Eindringverfahren. Diese Überprüfung ist in Übereinstimmung mit den Anforderungen der jeweiligen Luftfahrtbehörde in Ihrer Region für die zerstörungsfreie Prüfung und gemäß DIN EN 571 oder gleichwertig durchzuführen.

- 1 Kurbelwelle
- 2 Detaillierte Risseprüfung

- ACHTUNG: Bei Rissanzeichen oder etwaigen Unklarheiten ist umgehend der zuständige Luftfahrzeughersteller und der nächste autorisierte Vertriebs- und Servicepartner für ROTAX-Flugmotoren bezüglich weiterer Vorgangsweise zu kontaktieren. Der Motor muss für einen weiteren Betrieb, einer entsprechenden Instandsetzung unterzogen werden und darf nicht in Betrieb genommen werden.

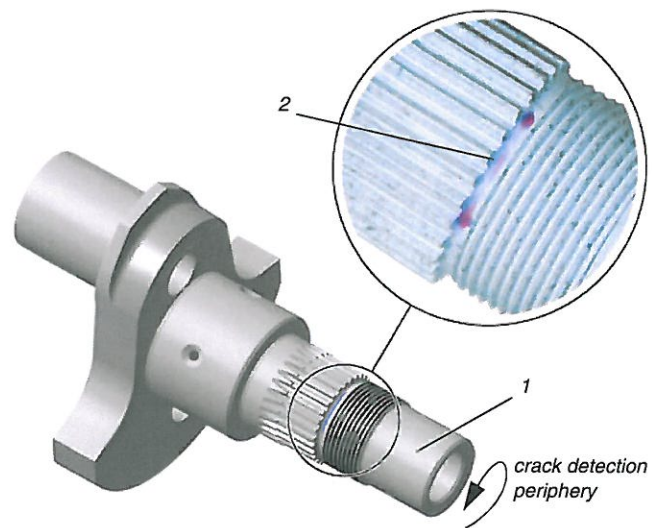
**Fig. 1**  
**crankshaft journal**

Due to a deviation in the manufacturing process some crankshafts may have a crack formation occur on the power take off side. These cracks can cause a breakage of the crankshaft support bearing and may lead to engine stoppage.

6. Unlock the crankshaft to do the check on the entire periphery of the crankshaft.
  - Detailed crack detection in the area (2) of the thread runout using penetration test. Perform this test in accordance to the requirements of the applicable aviation authority in your region for non destructive testing (NDT) and according to DIN EN 571 or equivalent.

- 1 crankshaft
- 2 detailed crack detection

■ CAUTION: In case of crack or doubt contact your aircraft manufacturer and your nearest authorized ROTAX aircraft engine distributor. The engine must not be taken into operation until the cause has been identified and eliminated.
