SERVICE INFORMATION NO. SI 20-054

Rotax Alert Service Bulletin ASB-912-061
ATA-Code: 73-00

Replacement of the pressure side fuel hose at fuel pump part no. 893114 for ROTAX® Engine Type 912 (Series)

ATA System: 73-00-00 Fuel system

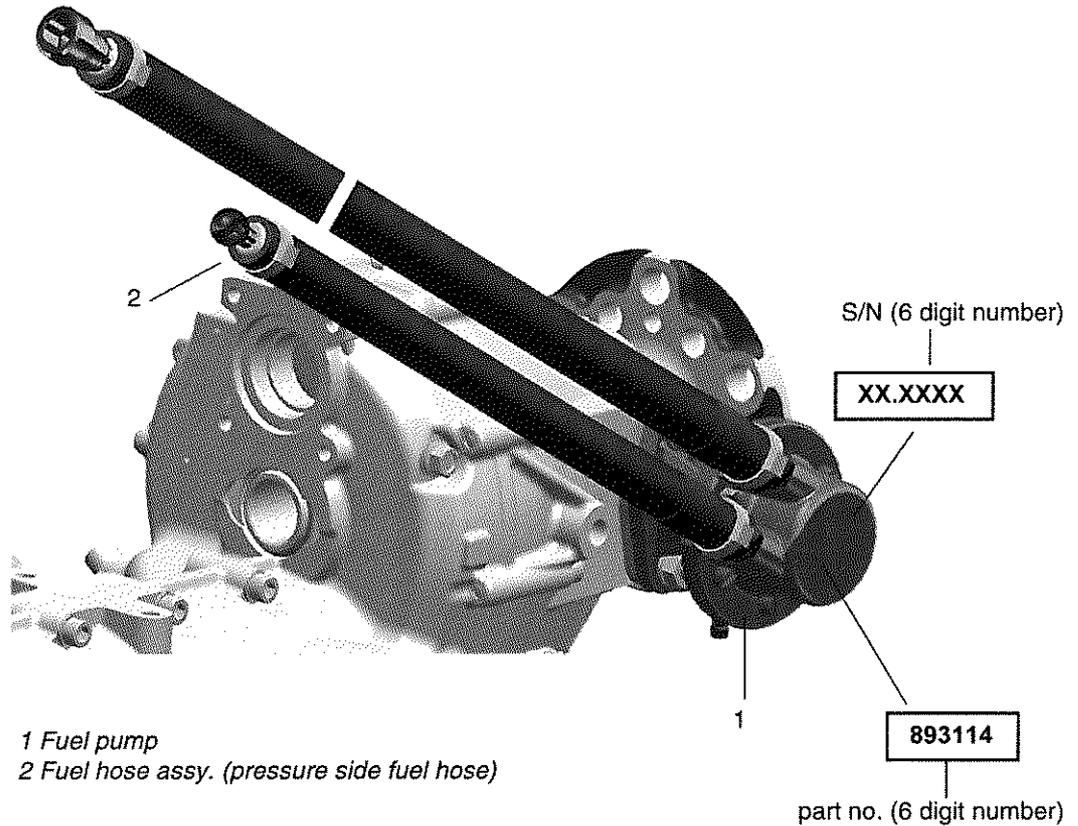
Fig. 1
Fuel pump

if they are equipped with the genuine ROTAX® fuel pump part no. 893114.
See Fig. 1

Due to variations in the manufacturing of the fuel hose, rubber particles may become detached. These particles can interfere or suppress the fuel mixture in the carburetor. This disturbance in the fuel mixture may lead to rough engine operation, engine misfire and can cause an engine shut down.

1 Fuel pump
2 Fuel hose assy. (pressure side fuel hose)

Replacement of the pressure side fuel hose at fuel pump part number 893114 for ROTAX® engine type 912 (Series).

- **Required before the next flight, the "replacement of the pressure side fuel hose" identified by the engine or fuel pump serial number (S/N) listed in section 1.1) must be conducted according to the following instructions in section 3.**

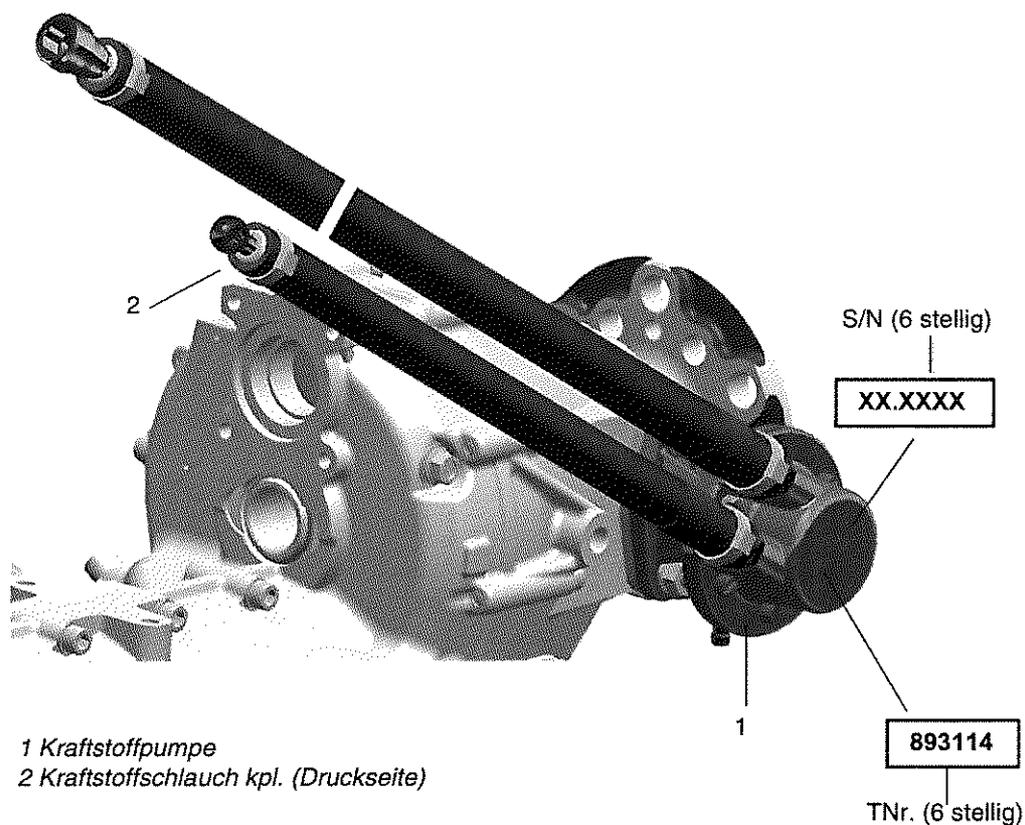
Bild 1
Kraftstoffpumpe

sofern diese mit der ORIGINAL ROTAX® Kraftstoffpumpe TNr. 893114 ausgestattet sind. Siehe dazu Bild 1.

Aufgrund von Abweichungen im Herstellprozess des betroffenen Kraftstoffschlauchs, kann es zu Ablösungen von Gummipartikeln kommen. Diese Partikel können die Gemischaufbereitung im Vergaser behindern bzw. unterbinden. Diese Störung in der Gemischbildung führt unter Umständen zu rauen Motorlauf, Motoraussetzer und eventuell zum Motorstillstand.

Austausch des druckseitigen Kraftstoffschlauches der Kraftstoffpumpe TNr. 893114 für ROTAX® Motor Type 912 (Serie).

- **Vor dem nächsten Flug, ist ein „Austausch des druckseitigen Kraftstoffschlauches“, der unter Betreff 1.1 angeführten Motoren bzw. Kraftstoffpumpen, gemäß machstehender Arbeitsanweisung Kap. 3 durchzuführen.**
