SERVICE INFORMATION NO. SI 20-056

Rotax Alert Service Bulletin ASB-912-061R1
ATA-Code: 73-00

Replacement of the pressure side fuel hose at fuel pump part no. 893114 for ROTAX® Engine Type 912 (Series)

ATA System: 73-00-00 Fuel system

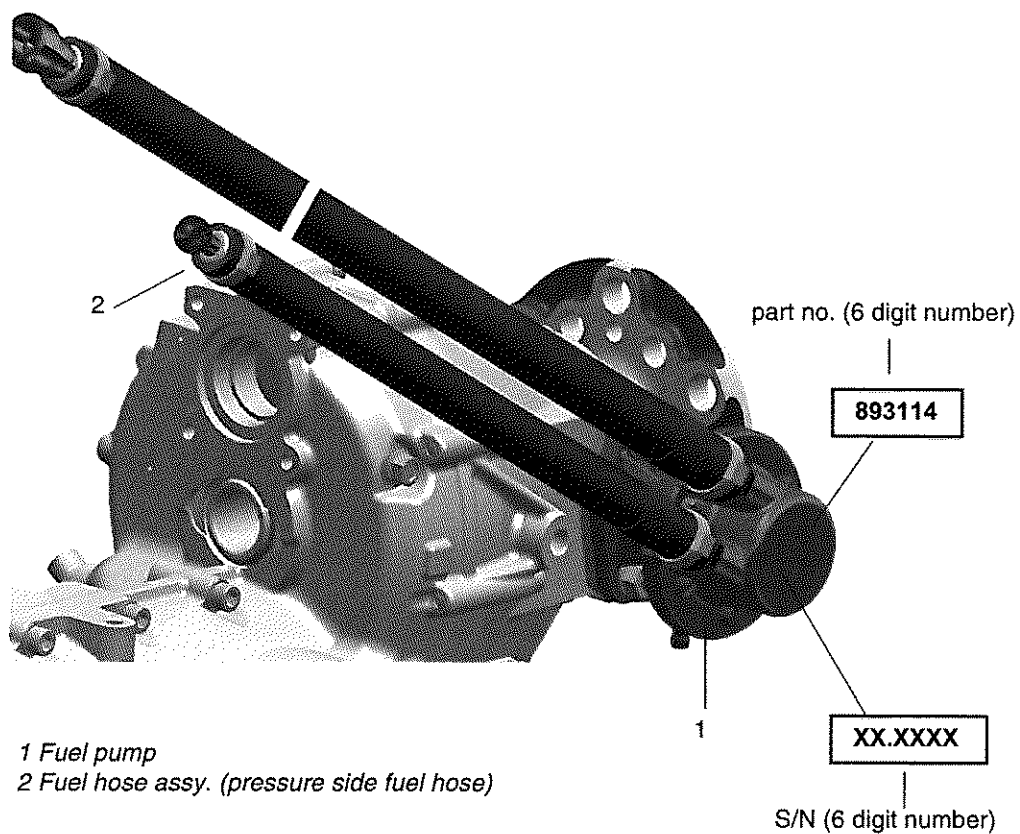
Fig. 1
Fuel pump

if they are equipped with the genuine ROTAX® fuel pump part no. 893114.
See Fig. 1

Due to variations in the manufacturing of the fuel hose, rubber particles may become detached.
These particles can interfere or suppress the fuel mixture in the carburetor. This disturbance in the
fuel mixture may lead to rough engine operation, engine misfire and can cause an engine shut
down.

- **Required before the next flight, the "replacement of the pressure side fuel hose" identified by the engine or fuel pump serial number (S/N) listed in section 1.1) must be conducted according to the following instructions in section 3.**

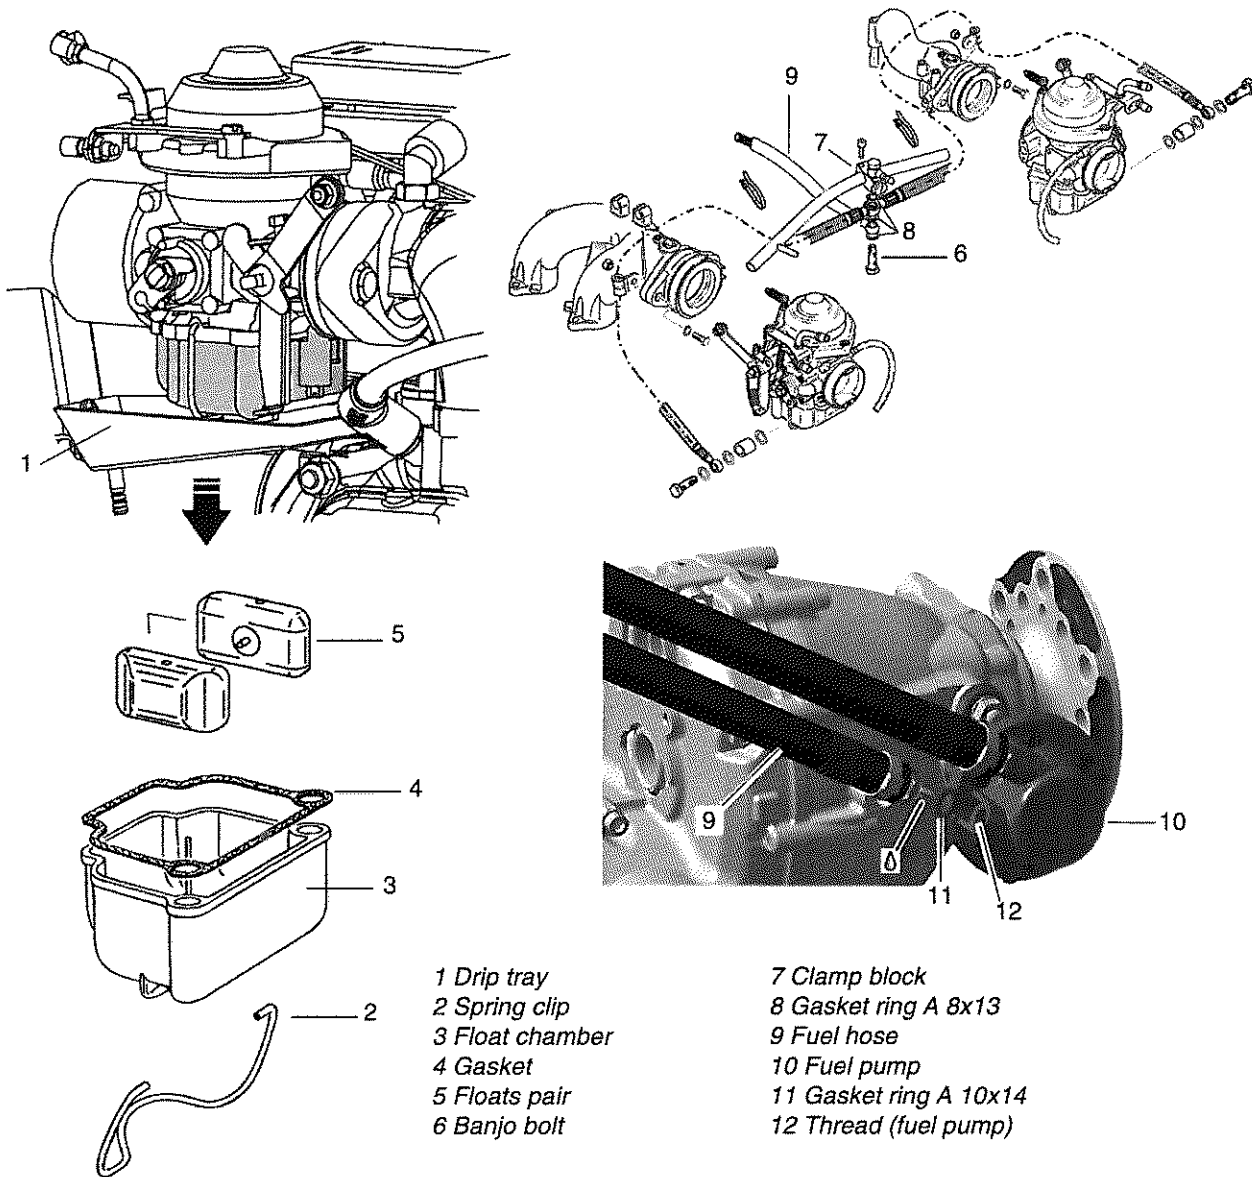
Fig. 2
Carburetor, Fuel pump

Several carburetors have been found with contamination (dirt, remains of rubber from fuel lines etc.) in the float chamber.

WARNING This contamination could possibly cause a partial or complete blockage of the idle or main jet or of other ducts vital for operation, leading to poor performance or stoppage of engine.

In case of contaminations of the float chambers first the cause must be found and the relevant measures need to be taken. Possibly the whole fuel system including carburetors needs to be cleaned and checked.

Step	Procedure
1	Remove banjo bolt (6) from clamp block (7) together with 3 gasket rings (8).
2	Remove the fuel hose (9).
3	Remove the fuel hose (9) from the fuel pump (10) together with gasket ring (11).

Step	Procedure
1	Inspection of the thread (12) from the fuel pump and remove possible sealing materials.
2	Clean and degrease thread (12) of the fuel pump.

Step	Procedure
1	Install the new fuel hose (9) and new gasket ring A 10x14 (11) with LOCTITE 243 on the fuel pump. Tightening torque 10 Nm (90 in.lb).
2	Install fuel hose (9) and the banjo bolt (6) with new gasket ring (8) on the clamp block (7). Tightening torque of banjo bolt (6) 10 Nm (90 in.lb). Check that the fuel hose is not under strain or tension.

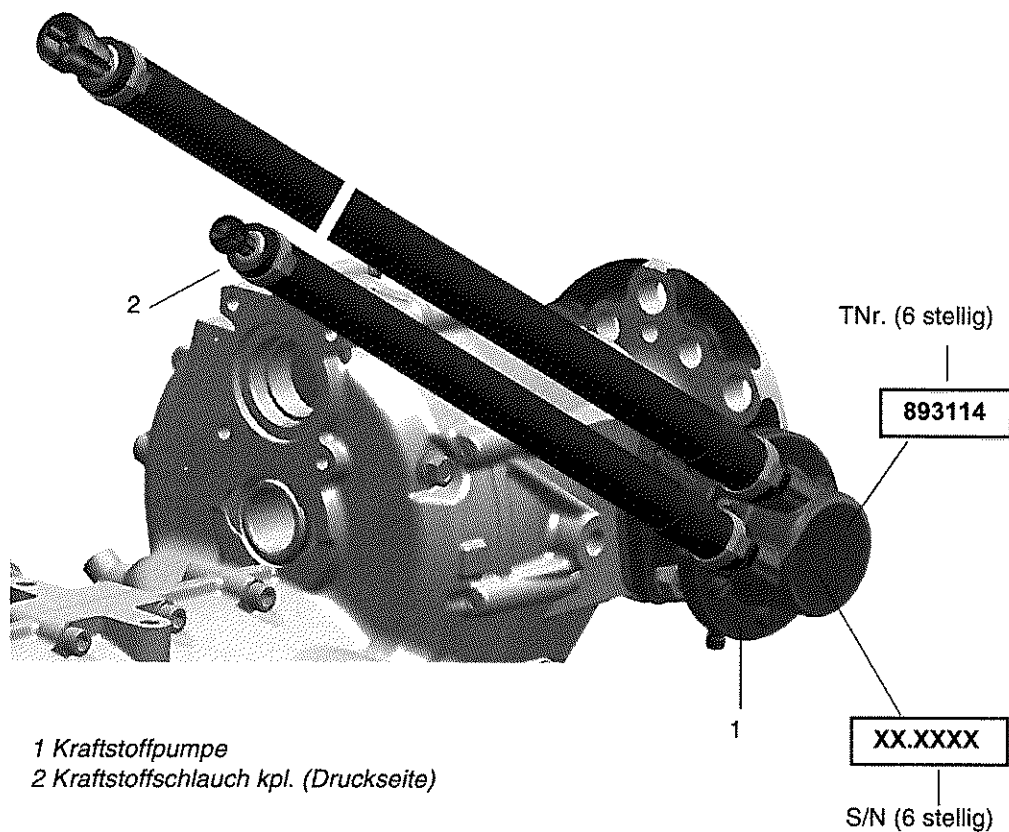
Bild 1
Kraftstoffpumpe

sofern diese mit der ORIGINAL ROTAX® Kraftstoffpumpe TNr. 893114 ausgestattet sind.
Siehe dazu Bild 1.

Aufgrund von Abweichungen im Herstellprozess des betroffenen Kraftstoffschlauchs, kann es zu
Ablösungen von Gummipartikeln kommen. Diese Partikel können die Gemischaufbereitung im
Vergaser behindern bzw. unterbinden. Diese Störung in der Gemischbildung führt unter Umstän-
den zu rauen Motorlauf, Motoraussetzer und eventuell zum Motorstillstand.

- **Vor dem nächsten Flug, ist ein „Austausch des druckseitigen Kraftstoffschlauches“, der unter Betreff 1.1 angeführten Motoren bzw. Kraftstoffpumpen, gemäß nachstehender Arbeitsanweisung Kap. 3 durchzuführen.**

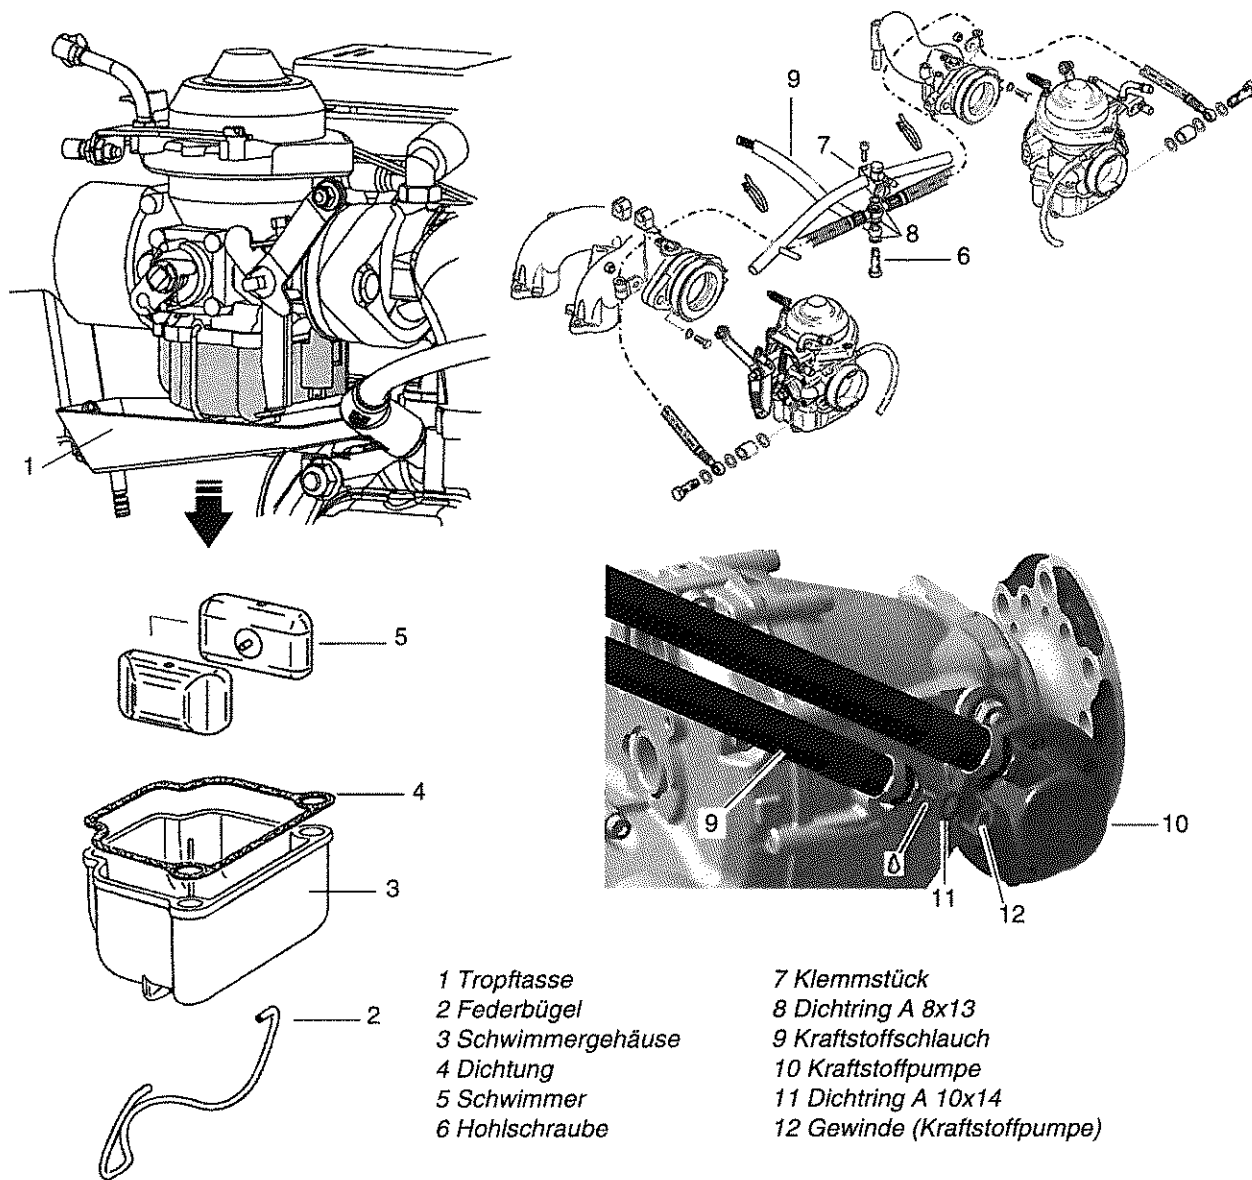
Bild 2

Allgemein Bei einigen Vergasern wurde Verunreinigung (Schmutz, Gummireste von Benzinleitungen usw.) in der Schwimmerkammer festgestellt.

Diese Ablagerungen können möglicherweise Leerlauf- oder Hauptdüse, sowie andere funktionswichtige Kanäle teilweise oder komplett blockieren und zu Leistungsverlust oder Motorstopp führen.

Bei Verunreinigung der Schwimmergehäuse ist zuerst die Ursache festzustellen und die notwendigen Abstellmaßnahmen einzuleiten. Möglicherweise ist das gesamte Kraftstoffsystem inkl. Vergaser zu reinigen und zu kontrollieren.

Schritt	Vorgehen
1	Untere Hohlschraube (6) vom Klemmstück (7) abschrauben und samt 3 Dichtungen (8) entfernen.
2	Kraftstoffschlauch (9) abnehmen.
3	Kraftstoffschlauch (9) von der Kraftstoffpumpe (10) samt Dichtring (11) abschrauben.

Schritt	Vorgehen
1	Anschlussgewinde (12) der Kraftstoffpumpe kontrollieren und gegebenenfalls Dichtungsreste entfernen.
2	Anschlussgewinde (12) der Kraftstoffpumpe entsprechend reinigen und entfetten.

Schritt	Vorgehen
1	An der Kraftstoffpumpe den neuen Kraftstoffschlauch (9) mit LOCTITE 243 sichern und mit einem neuen Dichtring A 10x14 (11) montieren. Anzugsdrehmoment 10 Nm.
2	Kraftstoffschlauch (9) spannungsfrei verlegen und mit Hohlschraube (6) samt neuen Dichtringen (8) am Klemmstück (7) montieren. Anzugsdrehmoment der Hohlschraube (6) 10 Nm.
