SERVICE INFORMATION NO. SI 20-062

Rotax Alert Service Bulletin ASB-912-062R1
ATA-Code: 72-30

ALERT SERVICE BULLETIN

Checking of the cylinder head assy. (2/3) for ROTAX® Engine Type 912 and 914 (Series)

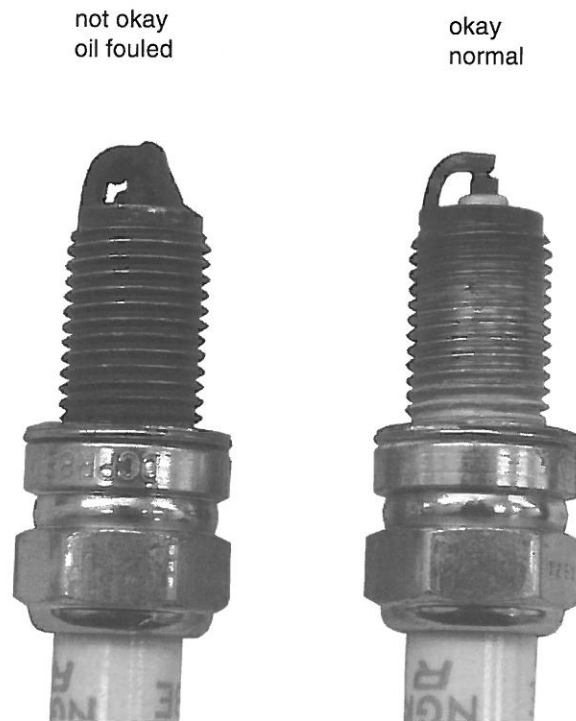
Fig. 1
spark plug

Due to a deviation in the manufacturing process some cylinder heads may have an oil leak in the intake channel in the area of the valve guide. There is a possibility of small machined through holes, which can increase the oil consumption which may result in an engine stoppage.

NOTE: Unusual deposits (excessive carbon or oil) on the spark plugs are an indication of a defective cylinder head which must be replaced. Figure 1 shows comparison between a used spark plug in normal condition and one that is not.

Affected spark plugs with such deposits shown in chapter 4 Fig. 1, have to be removed and can not be reinstalled.

If excessive deposits (oil or carbon) are found on the spark plugs the cylinder head must be replaced in accordance with the relevant Maintenance Manual (Heavy) and any relevant aircraft manufacturer instructions.

NOTE: At tightening the cylinder head with 2 collar cap nuts M8 and 2 hex. nuts M8 pay attention to the changed tightening torque. Tighten to 10 Nm (90 in.lb) and then in addition tighten further by applying a 120° rotation.

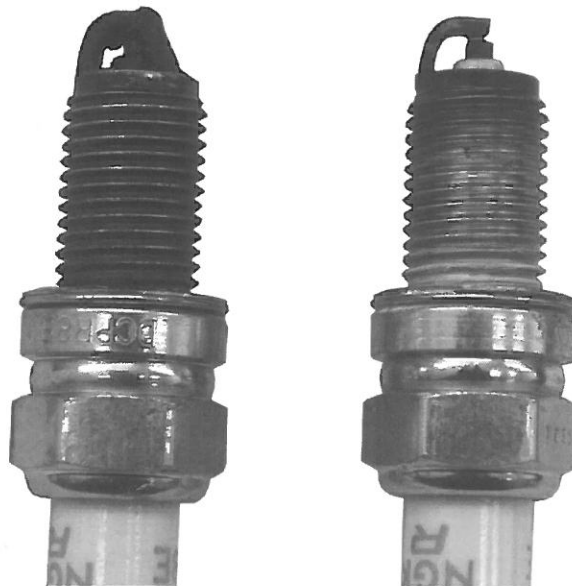
Bild 1
Zündkerzen

HINWEIS: Übermäßige Ablagerungen (Öl oder Kohle) an der Zündkerze sind ein Indikator für einen defekten Zylinderkopf, welcher getauscht werden muss. Das Bild 1 zeigt den Vergleich zwischen einer bereits gelaufenen aber als in Ordnung befundenen und einer als bereits gelaufenen aber nicht in Ordnung befundenen Zündkerze.

Betroffene Zündkerzen mit derartigen Ablagerungen wie im Anhang Bild 1 dargestellt, sind zu entfernen und dürfen nicht wieder eingebaut werden.

Nicht in Ordnung
Ölablagerungen

In Ordnung

Werden übermäßige Ablagerungen (Öl oder Kohle) an einer der beiden Zündkerzen festgestellt, so ist der Zylinderkopf entsprechend dem letztgültigen Wartungshandbuch (Heavy) sowie entsprechender Anweisungen des Luftfahrzeugherstellers auszutauschen.

HINWEIS: Beim Festziehen von Bundhutmutter und SK-Mutter M8 sind die geänderten Drehmomentvorgaben zu beachten. Anzugsdrehmoment 10 Nm +120° Drehung.
