SERVICE INFORMATION NO. SI 20-065

EASA EAD 2013-0117-E
Rotax Alert Service Bulletin ASB-912-062R2

Checking of the cylinder head assy. (2/3) for ROTAX® Engine Type 912 and 914 (Series)

ATA System: 72-30-00 cylinder head

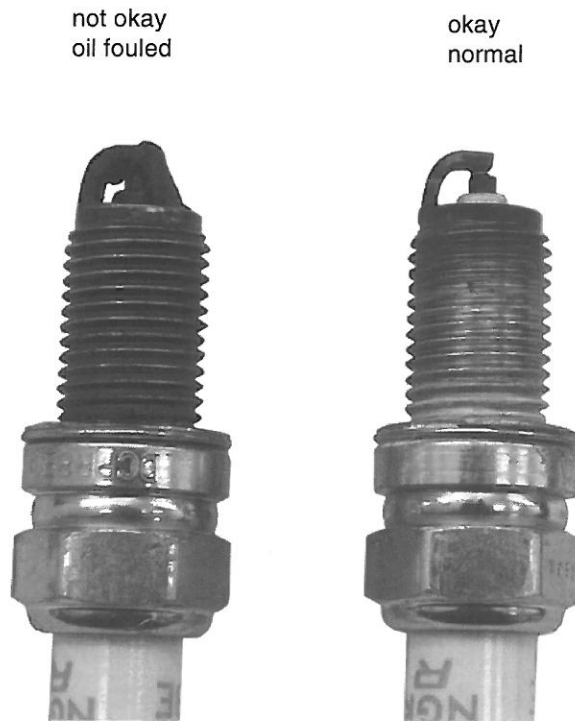
Fig. 1
spark plug

Due to a deviation in the manufacturing process some cylinder heads may have an oil leak in the intake channel in the area of the valve guide. There is a possibility of small machined through holes, which can increase the oil consumption which may result in an engine stoppage.

NOTE: Unusual deposits (excessive carbon or oil) on the spark plugs are an indication of a defective cylinder head which must be replaced. Figure 1 shows comparison between a used spark plug in normal condition and one that is not.

Affected spark plugs with such deposits shown in chapter 4 Fig. 1, have to be removed and can not be reinstalled.

If excessive deposits (oil or carbon) are found on the spark plugs the cylinder head must be replaced in accordance with the relevant Maintenance Manual (Heavy) and any relevant aircraft manufacturer instructions.

NOTE: At tightening the cylinder head with 2 collar cap nuts M8 and 2 hex. nuts M8 pay attention to the changed tightening torque. Tighten to 10 Nm (90 in.lb) and then in addition tighten further by applying a 120° rotation.
