SERVICE INFORMATION NO. SI 20-067

Rotax Service Bulletin SB-912-064R1
ATA-Code: 72-20

Periodic checking of the crankshaft journal (power take off side) for ROTAX® Engine Type 912 and 914 (Series)

ATA System: 72-20-00 Engine block

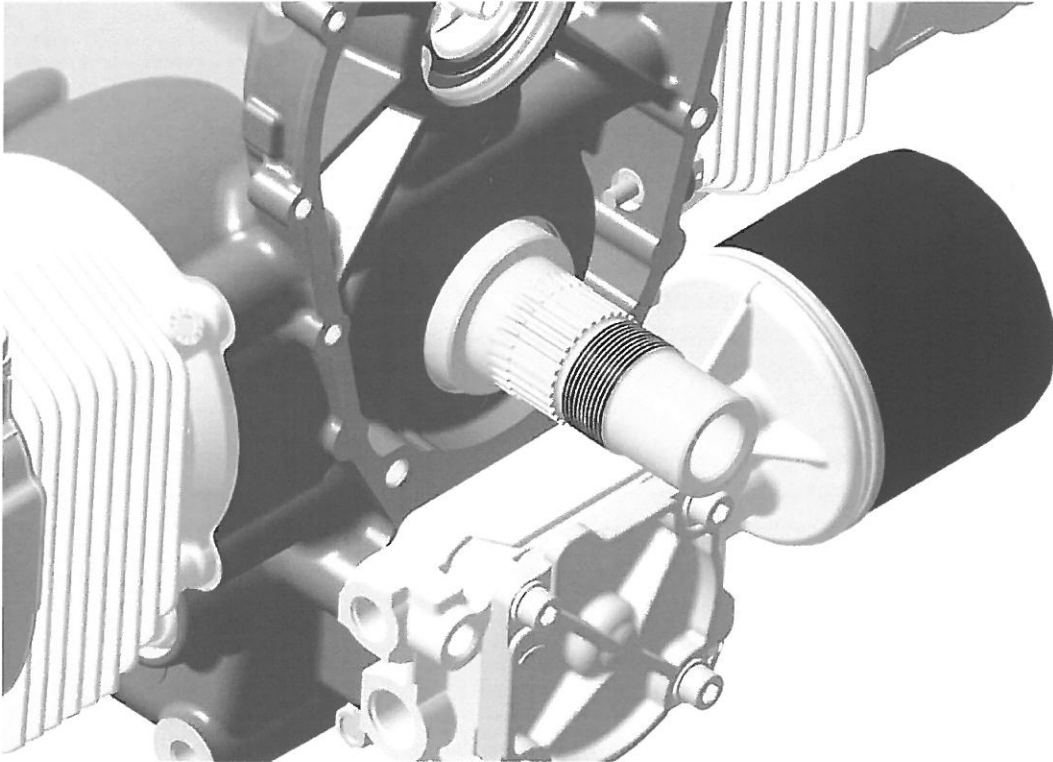
Fig. 1
Crankshaft journal

Due to a deviation in the manufacturing process some crankshafts may develop a crack on the power take off side. These cracks can cause breakage of the crankshaft in the support bearing during operation. In this case the function of the support bearings (consisting of 3 main bearings and 2 support bearings) is compromised. The operating reliability, however, is given until the next maintenance.

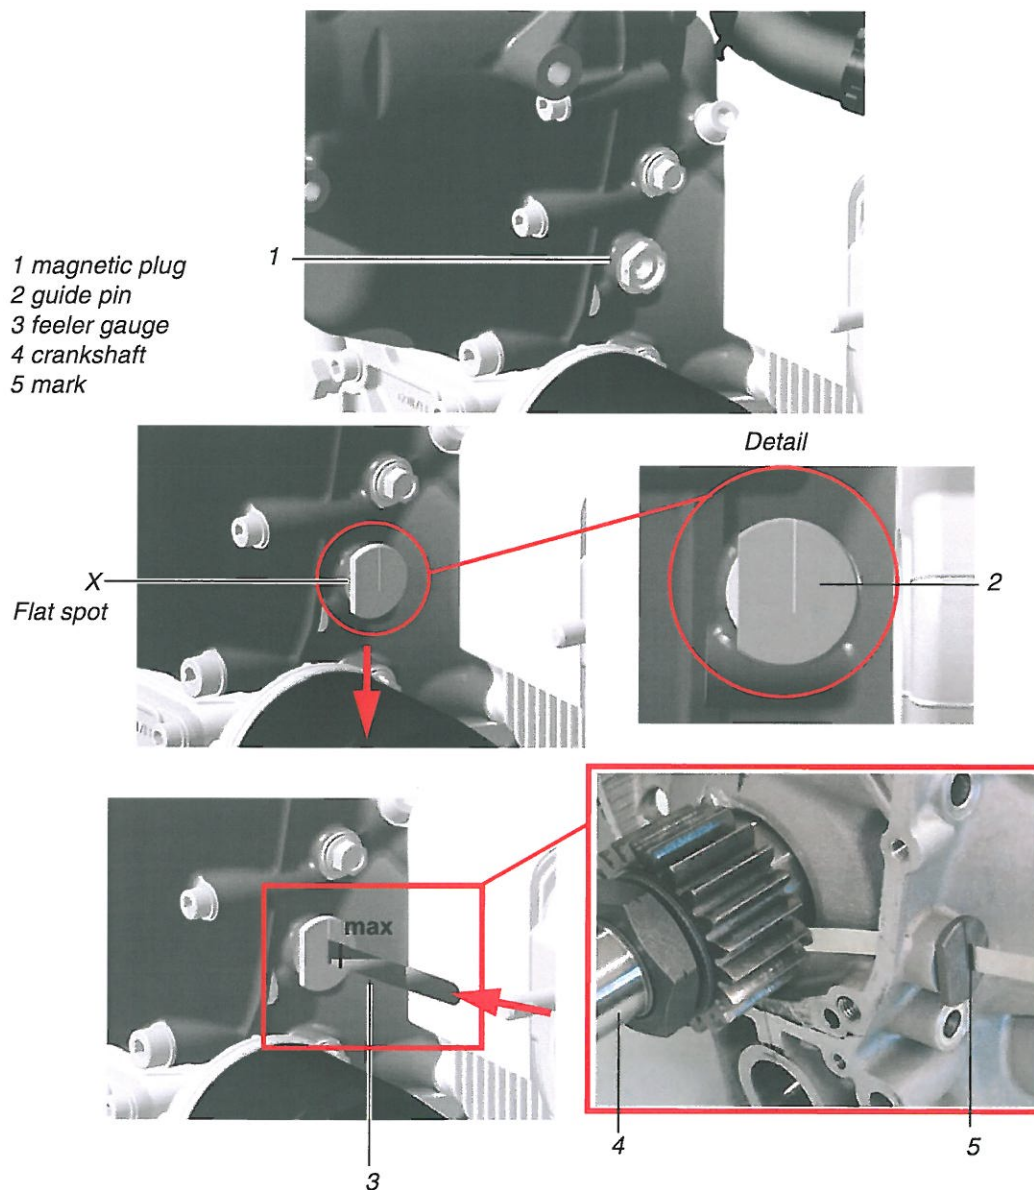
Fig. 2
Inspection with feeler gauge

Step	Procedure
6	Push the check gauge into the guide pin with increased force and make sure that the guide pin has not turned. If the drive gear is in correct position and cannot be moved the crankshaft is OK. The feeler gauge cannot be further moved in and the mark (5) remains visible outside the slotted screw.
Result = Crankshaft journal OK	
7	Remove the check gauge CS-PTO (feeler gauge and guide pin).
8	Install the magnetic plug in accordance with the relevant Maintenance Manual (Line).

Step	Procedure
6	Hold it in fixed position not allowing any rotation. If the feeler gauge can be pushed further in, so that the mark disappears in the slot, then the gearbox must be removed and the crankshaft must be checked (see Fig. 3, Pos. C).
Result = Crankshaft journal broken	
7	Please find further explanations if needed in this chapter 3.2).

Step	Procedure
1	Remove the magnetic plug in accordance with the relevant Maintenance Manual (Line).
2	Install guide pin (2) of the check gauge CS-PTO into the magnetic plug thread until stop. Adjust the guide pin with the flat spot (X) in the direction of the propeller and parallel to the gearbox/housing contact surfaces. Hold it in fixed position not allowing any rotation. Pliers or an open-end spanner can be used.
3	Insert feeler gauge of check gauge CS-PTO into the guide pin. NOTE: The feeler gauge is symmetrical, both sides can be used.
4	Insert feeler gauge until a first resistance can be felt. Now the feeler gauge faces the cylindrical crankshaft journal (see Fig. 3, Step. 1).
5	With slightly elevated force you can push the feeler gauge about 2 mm (.078 in.) further in, until it touches the plan surface of the pinion gear (see Fig. 3, Step. 2). NOTE: The mark on the feeler gauge is still visible outside the slot.

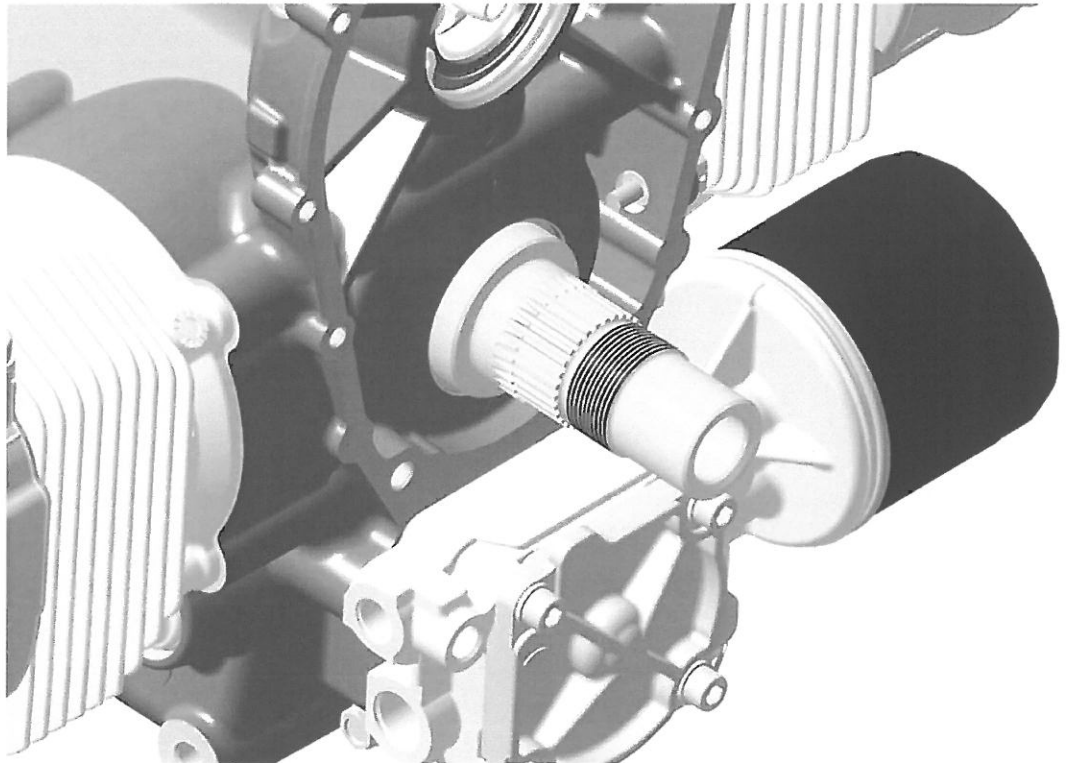
Bild 1
Kurbelwellenstummel

Aufgrund von Abweichungen beim Herstellprozess kann es bei einigen Kurbelwellen zur Rissbildung im Bereich des abtriebseitigen Kurbelwellenstummels kommen. Dies kann im Betrieb zu einem Bruch der abtriebseitigen Kurbelwellen-Stützlagerung führen. Damit ist die Stützlagerfunktion (der aus 3 Hauptlagern und 2 Stützlagern bestehenden Kurbelwellenlagerung) nicht mehr sichergestellt. Die Betriebssicherheit ist jedoch bis zum nächsten Wartungsintervall gegeben.

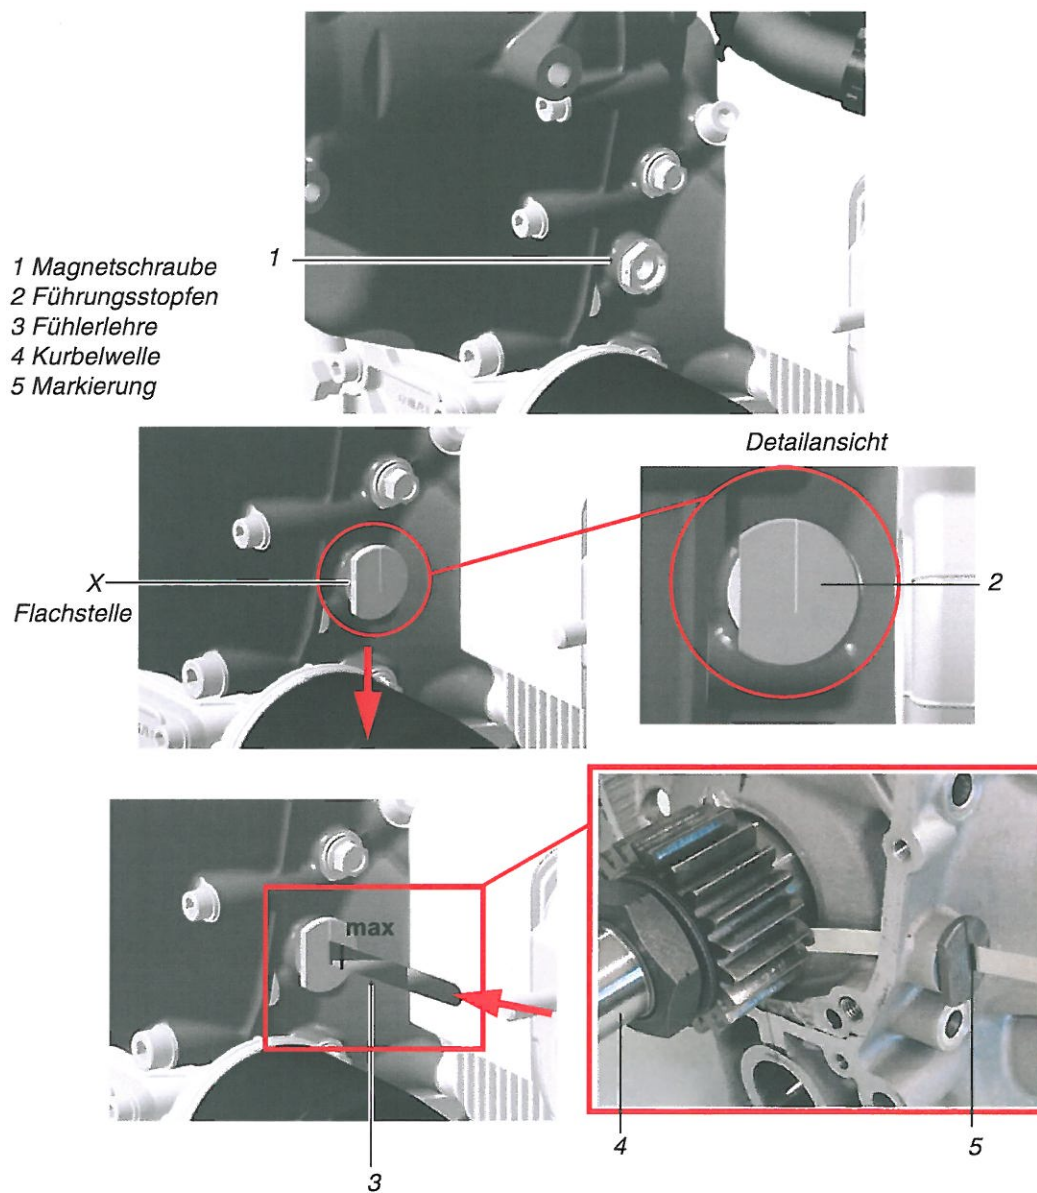
Bild 2
Prüfen mit Fühlerlehre

Schritt	Vorgehen
6	Mit gesteigerter Kraft die Prüflöhre in den Führungsstopfen schieben und darauf achten, dass sich der Führungsstopfen nicht verdreht. Wenn sich das Antriebsrad in korrekter Position befindet und nicht verschieben lässt, dann ist die Kurbelwelle in Ordnung. Die Fühlerlehre lässt sich nicht weiter einschieben und die Markierung (5) bleibt sichtbar.
Ergebnis = Kurbelwellenstummel in Ordnung	
7	Prüflöhre KW-AS (d. h. Fühlerlehre und Führungsstopfen) wieder entfernen.
8	Magnetschraube gemäß entsprechendem Wartungshandbuch (Line) montieren.

Schritt	Vorgehen
6	Den Führungsstopfen nicht verdrehen und in Position halten. Sollte sich die Fühlerlehre weiter einschieben lassen, sodass die Markierung im Schlitz verschwindet, dann muss das Getriebe abgebaut und die Kurbelwelle kontrolliert werden (Bild 3, Pos. C).
Ergebnis = Kurbelwellenstummel gebrochen	
7	Weitere notwendige Erklärungen sind im vorliegenden Kapitel 3.2) zu finden.

Schritt	Vorgehen
1	Magnetschraube demontieren gemäß entsprechendem Wartungshandbuch (Line).
2	Führungsstopfen (2) der Prüflöhre KW-AS in die Magnetschraubengewindebohrung bis auf Anschlag einsetzen. Führungsstopfen so ausrichten, dass die Flachstelle (X) in die Propellerrichtung zeigt und parallel zur Getriebe/Gehäusetrennfläche positioniert ist. Den Führungsstopfen nicht mehr verdrehen und in Position halten. Dazu können auch Hilfsmittel wie Zangen oder Maulschlüssel usw. verwendet werden.
3	Fühlerlehre der Prüflöhre KW-AS in den Schlitz des Führungsstopfens einführen. HINWEIS: Da die Prüflöhre symmetrisch ist, können beide Seiten verwendet werden.
4	Fühlerlehre so weit einführen, bis ein erster merklicher Widerstand zu spüren ist. Die Lehre steht dann am zylindrischen Kurbelwellenstummel an (Bild 3, Schritt 1).
5	Mit leicht erhöhter Kraft lässt sich die Fühlerlehre dann noch ca. 2 mm weiter einführen, bis sie an der Planfläche des Antriebsrades ansteht (Bild 3, Schritt 2). HINWEIS: Die Markierung an der Fühlerlehre ist dann noch außerhalb des Schlitzes sichtbar.
