# **SERVICE INFORMATION NO. SI 20-077**

EASA AD 2016-0144 Rotax 912 engines - float inspection/replacement ATA-Code: 73-00

# Airworthiness DirectiveAD No.:2016-0144Issued:19 July 2016

## ATA 73 – Engine Fuel and Control – Float – Inspection / Replacement

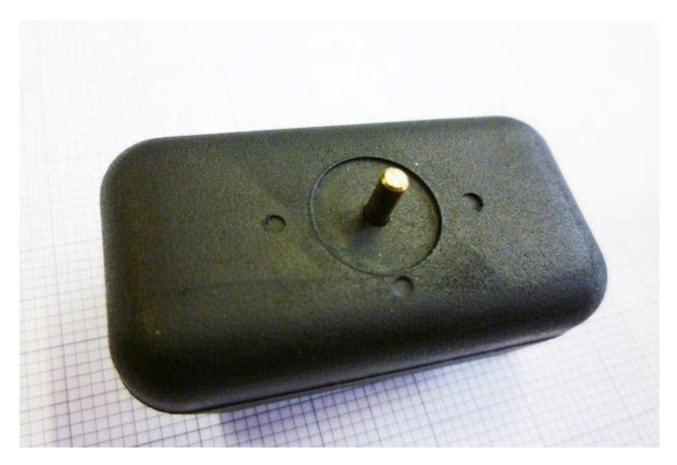
### Appendix 3 – Float with 3 dots

Note 2: For the purpose of this AD, an affected float is float having P/N 861185, that has been initially delivered on a date between 09 May 2016 and 17 July 2016 (inclusive), and that does not have 3 dots. Certification documents (e.g., Form 1), delivery document or record of previous installation of the float are acceptable to determine an initial delivery on or before 08 May 2016. An example of a serviceable float having 3 dots is shown in Appendix 3 of this AD.

- (2) For any affected engine, before next flight after the inspection as required by paragraph (1) of this AD, replace any affected float with a serviceable float (see Note 2 and Appendix 3 of this AD) in accordance with the instructions of the ASB.
