SERVICE INFORMATION

NO. SI 20-093

BRP-Rotax GmbH & Co KG Service Bulletin SB-912-080
ATA-Code: 75-20

Inspection and/or replacement of expansion tank assy. for ROTAX® 912, 914, 912 i, 915 i and 916 i (Series) Aircraft Engines

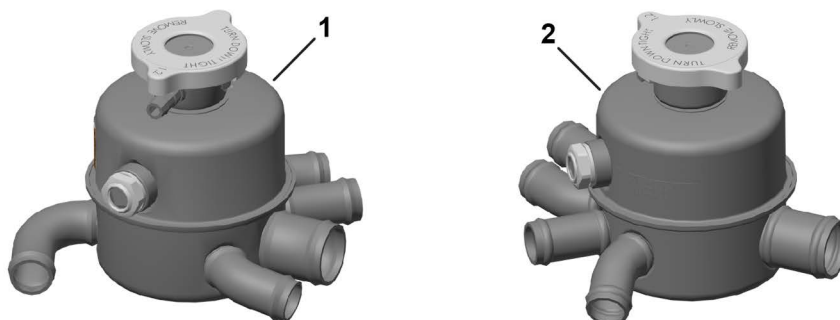
Fig. 1

Fig.1/ pos.	part no.	Qty/ engine	Description
1	922668	(1)	EXPANSION TANK ASSY.
2	922666	(1)	EXPANSION TANK ASSY.
-	-	AR	COOLANT (as specified in the latest Service Instruction SI-912-016, SI-914-019, SI-912 i-001, SI-915 i-001,SI-916 i-001)

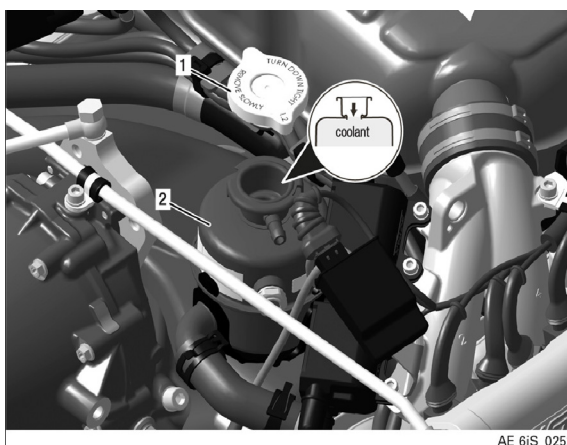
Fig. 3

Step	Procedure
1	If necessary, clamp closed the hose to the coolant overflow bottle.
2	Remove the radiator cap from the expansion tank.
3	Drain coolant until bottom of the expansion tank assy. is clearly visible.
4	Perform an internal visual inspection of the expansion tank assy. using a bore-scope or similar optical device.
5	If the visual inspection shows consistent welding, the expansion tank assy. is serviceable (See Fig. 5), continue with step 7.
6	If any connection has inconsistent or missing welds, the expansion tank assy. is unserviceable and must be replaced (See Fig. 6), continue with section 3.5.2).
7	Refill coolant into the expansion tank. See Maintenance Manual Line Chapter 12-10-00 section Coolant check/replenish. See also SI-912 i-001,SI-912-016,SI-914-019, SI-915 i-001,SI-916 i-001, current issue. NOTE: If the engine is equipped with a thermostat valve, follow the manufacturer's instructions.

8	Apply small amount of coolant to rubber surfaces inside radiator cap (provides lubrication to prevent binding). Tighten the radiator cap by hand.
9	Perform an engine test run and check for leaks. Replenish with clean coolant as required. See Maintenance Manual Line Chapter 12-10-00 section Coolant check/replenish.
10	Make an entry in the engine logbook stating the execution of this Service Bulletin and the inspection findings. Continue with section 3.6)

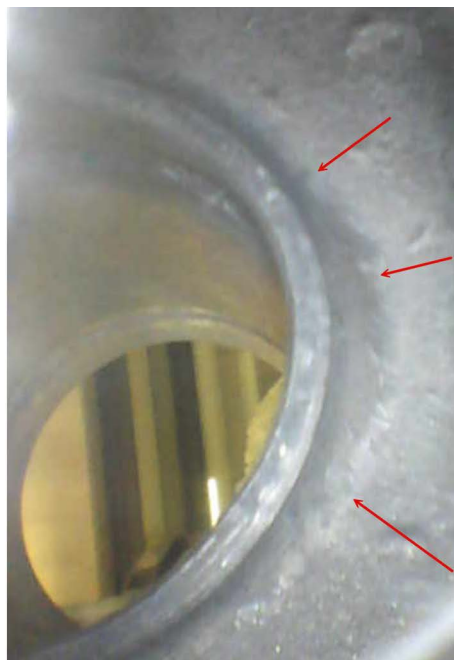
Fig. 5: GOOD Welding – total view / GOOD Welding – side view

Step	Procedure
1	Remove the radiator cap from the expansion tank.
2	Perform an internal visual inspection using a bore-scope or similar device.
3	If the visual inspection shows consistent welding, the expansion tank assy. is serviceable (See Fig. 5), continue with section 3.6). NOTE: Welding must be present and contiguous around every connection.
4	If the visual inspection shows any connection with inconsistent or missing welds, the expansion tank assy. is unserviceable and must be replaced (See Fig. 6).
5	Apply small amount of coolant to rubber surfaces inside radiator cap (provides lubrication to prevent binding). Tighten the radiator cap by hand.

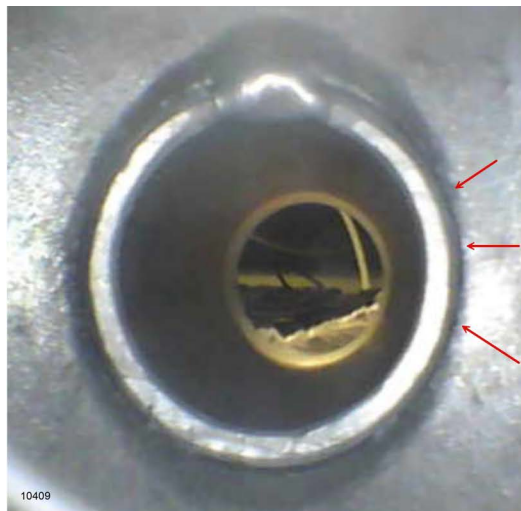
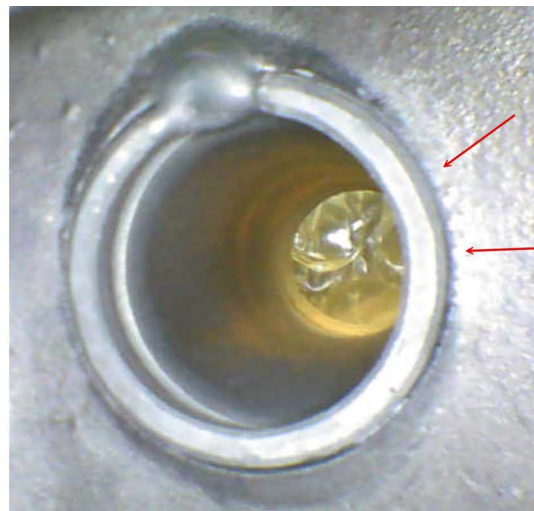
Due to a deviation in the manufacturing process, the individual components of the expansion tank assy. may not be sufficiently welded. Sealing of the assy. may be compromised and coolant leakage and subsequently an overheating of the engine may occur.

Fig. 6: BAD Welding – total view / BAD Welding – side view
