# HOFFMANN AIRCRAFT

## Service Bulletin 2E

Affected Aircraft: All SNo's of type H 36 DIMONA until SNo  
3619

Subject: Aileron, elevator and wing.

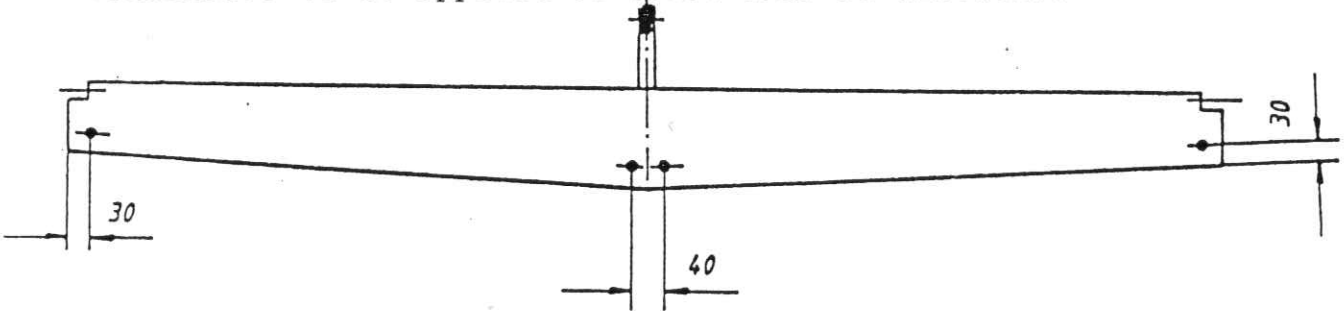
Drillholes to be applied on lower side of elevator:

All holes must have a diameter of 6 mm. Attention is to be paid that the upper side of elevator, aileron or wing must not be pierced (it is recommended to use a terminating stroke for the drill). If the drill hole does not end in the caving of the parts, but in an accumulation of resin, another hole has to be performed approximately 20 mm in front of the first one.

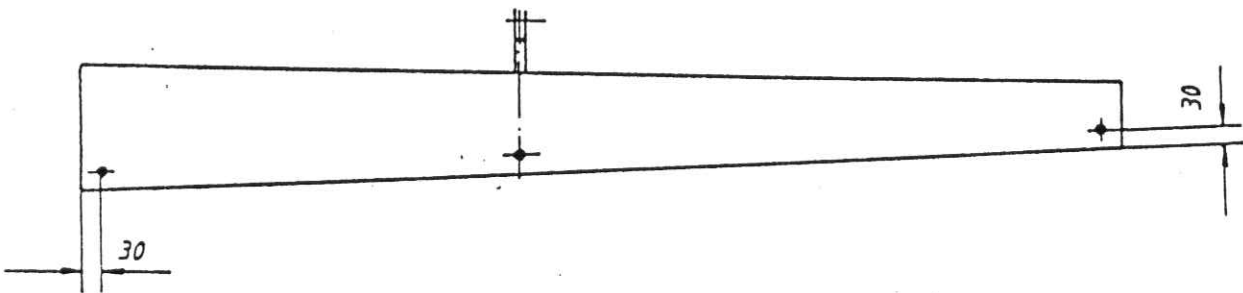
Drillholes to be applied on lower side of ailerons:

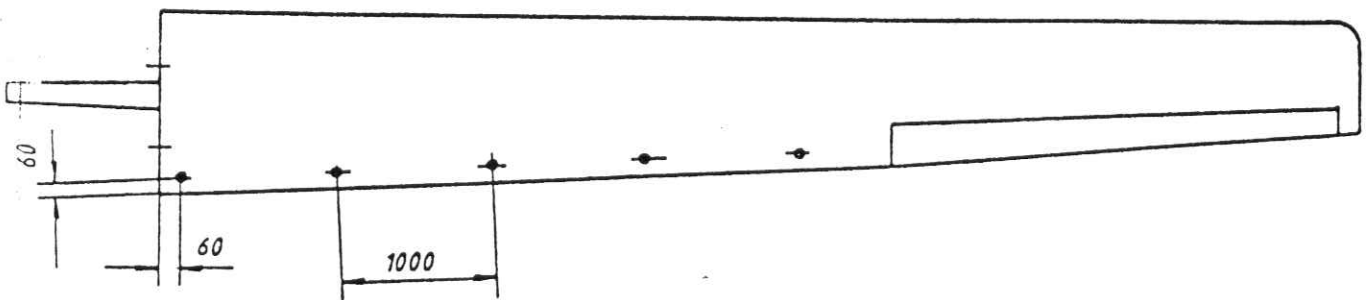
Drillholes to be applied on lower side of wings:
