HOFFMANN AIRCRAFT

Service Bulletin 3E

Affected Aircraft: Motorglider type H-36 DIMONA

Subject: Sandwich shell of the wings

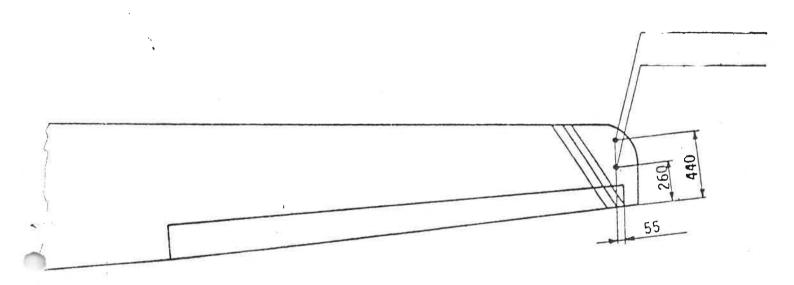
Holes with a diameter of 4 mm are drilled into the upper side and lower side of the wing on the locations D and E which are shown in the sketch below. Threads M 5 are to be cut into these holes. During drilling and cutting of the threads has to be worked exactly in a normal angle for not to disturb the interface between fibre glass and comporting structure lying below. With a ring shaped milling cutter of a diameter of 11 mm (see sketch below) the fibre glass has to be cut through with a low squeeze applied and a speed of 200 rev/min. Then the tie rod will be wound into the boring with 2 revolutions and the force measuring device put over. The tie rod which emerges on the upper edge of the spindle must be tightendet with an M5 nut, whereas a low squeeze should be exerted into the handwheel. Now the handwheel must be turned until failure, and simultanously the scale must be observed.

The maximal observed value must be multiplied by 1.33. The result is the ultimate load expressed in N/cm^2 . If the ultimate load is below 70 N/cm^2 , the wing must be examined in more detail by the manufacturer.

If a sufficient bonding is observed, the locations of measurement must be closed with epoxy resin.
