S E R V I C E B U L L E T I N No. 8 E

Aircraft affected: All SNo's of motorglider H 36 DIMONA

Subject: Aileron deflections

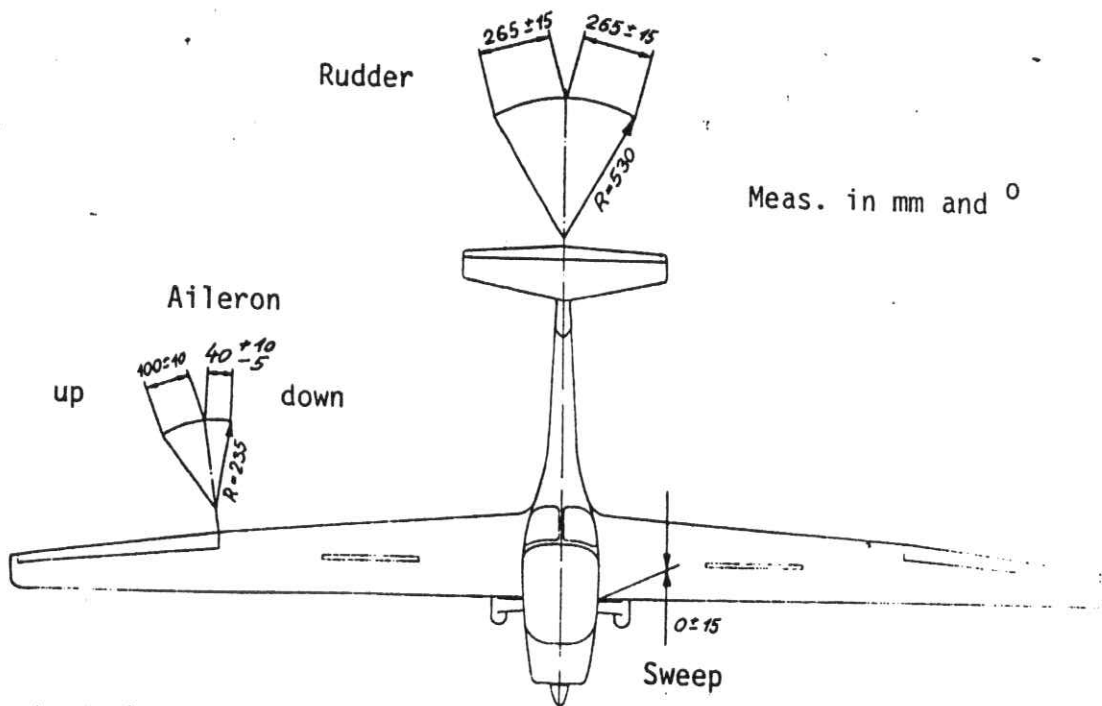
5.2 RIGGING DIAGRAM FOR AILERONS, RUDDER AND WING SWEEP:

Occasion: Due to modifications of the aileron control system (since November 1983 in the serial production), the tolerance of the maximum downward aileron deflection was increased from 40_{-5}^{+5} mm to 40_{-5}^{+10} mm.

The following diagram illustrates the measurements in mm for the rigging. The sweep can be measured from the fuselage side/wing leading edge to ascertain the sweep. Measurements are made at the factory and the sweep should not change, except from a repair or wing change.

1. Replace page 49 of maintenance and repair manual by page 49, dated 15 December 1983.
2. Entry on page 2 of maintenance and repair manual as follows:
