## SERVICE INFORMATION NO. SI 36-115

All H 36 and HK 36 with Limbach engines

SLICK Service Bulletin No. SB1-15A

**SUBJECT:** Potential decreased service life of Slick 4-cylinder magneto distributor gear assemblies. **Based on process and component improvements following the initial release of this service bulletin, the serial number range is being extended in this revision. Magnetos previously returned for compliance to SB1-15 must be returned or inspected for compliance to this revision SB1-15A.**

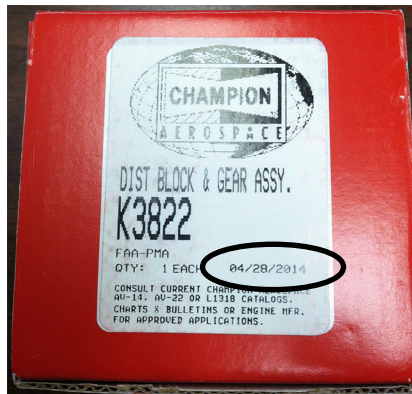
**Figure 1. Replacement Kit Box Label Date Code**

**AFFECTED:** The following 4-cylinder magnetos with serial numbers between **08090001 thru 16071072**, K3822 distributor block replacement kits, and K3008 distributor gear assemblies dated **September 26, 2008 thru September 1, 2016:**

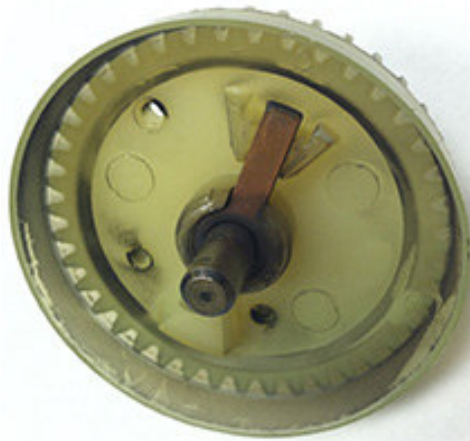
**Figure 3. Affected K3008 Distributor Gear With Copper Electrode**

The initial release of SB1-15 was based on a limited number of field reports and product returns, Champion Aerospace has identified a possible condition in the distributor gear assemblies of 4-cylinder magnetos that can lead to decreased service life. Some of the returned products contained distributor gears exhibiting loosening of the electrode finger. This condition was observed in magnetos with a varying number of service hours. Typical symptoms are unusual RPM drop during magneto check, difficulty starting, and/or rough running engines.

**COMPLIANCE:** REMOVE affected distributor gear assembly in subject magnetos and REPLACE with replacement distributor gear assembly, K3008, as soon as possible, not to exceed the next 50 hours. Document Service Bulletin compliance as written entry in applicable Aircraft and/or Engine logbook.

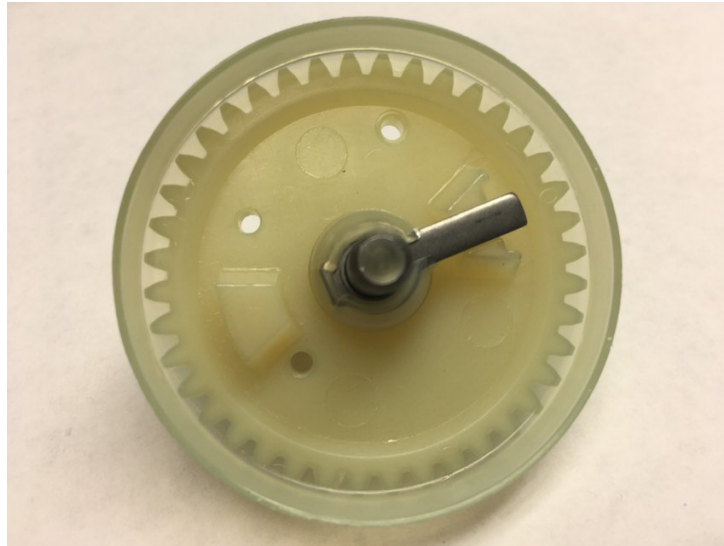
Figure 5. K3008 Distributor Gear With Monel Electrode

**If it is not possible to confirm the version of the distributor gear that is installed in a given magneto from maintenance records, the magneto may be removed from the engine in order to have the housing and distributor block removed to allow visual inspection of the distributor gear. Distributor gears with Copper electrodes must be replaced with distributor gears with Monel electrodes.**
