## TECHNISCHE INFORMATION NR. SI36-037

## SERVICE INFORMATION NO. SI36-037

ATA Code: 72-00  
Engine Crankcase Inspection

## CHECKING OF THE CRANKCASE ON ROTAX® ENGINE TYPE 912 AND 914 (SERIES)

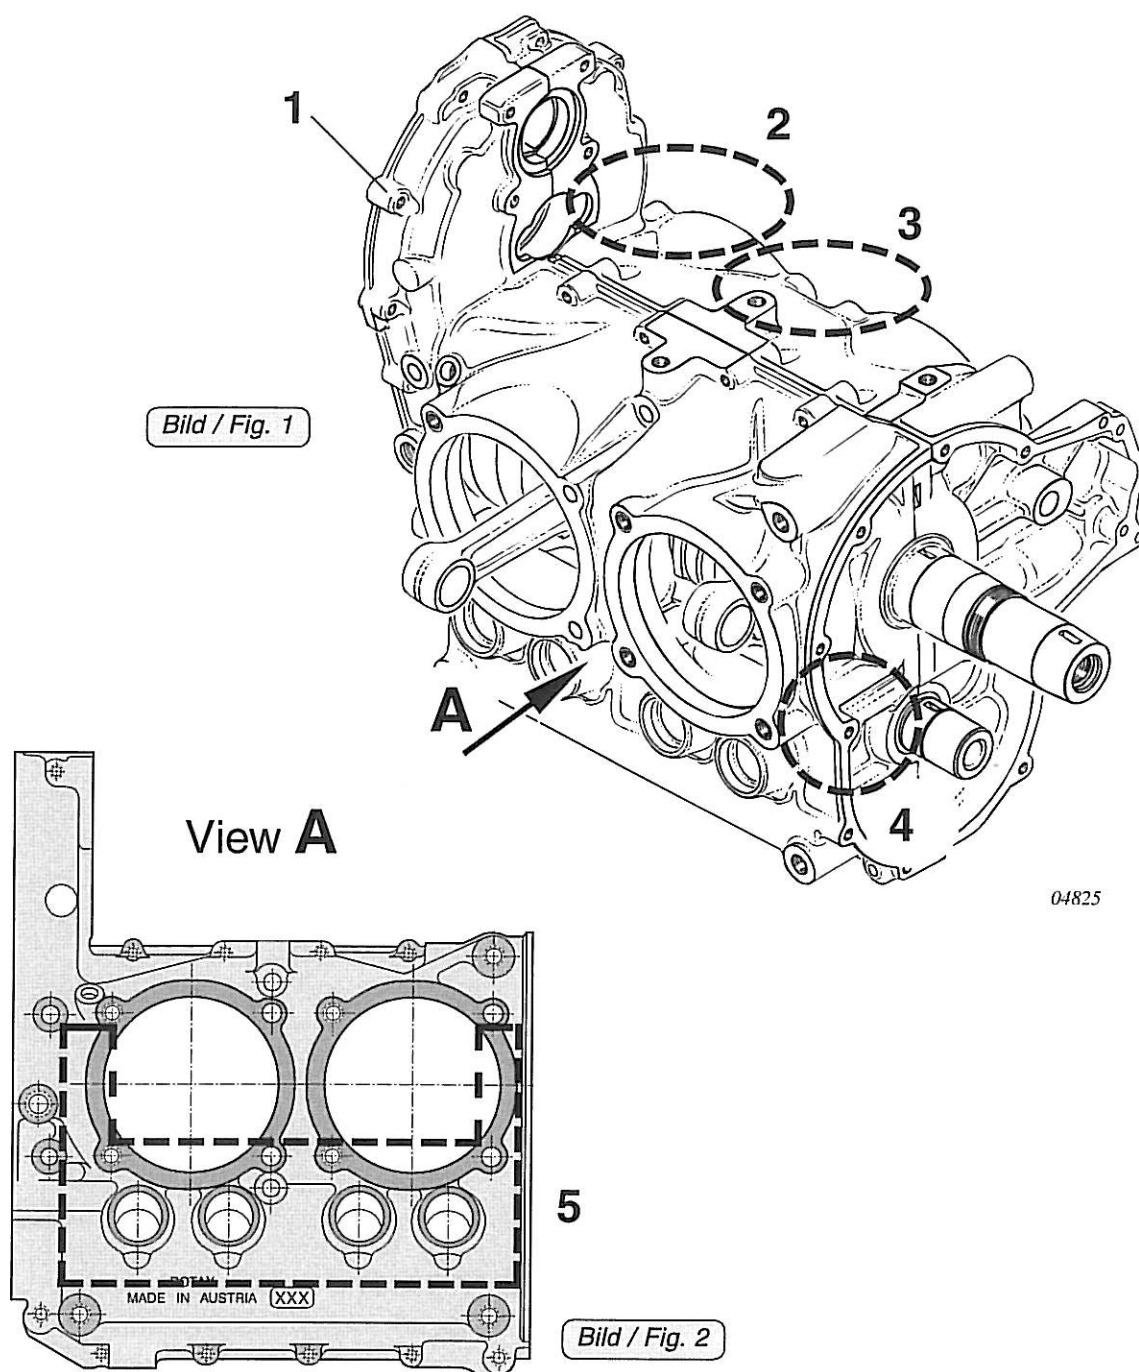
see fig. 1

One or more of the following could result in formation of cracks on the crankcase:

Vibrations, impacts, forces, thermal strain etc. could cause cracks on the crankcase.

- Visually inspect the crankcase (1) and engine suspension for cracks in accordance with the relevant Maintenance Manual.

Visually inspect the crankcase especially:

- in the area of cylinder 1 upper side (2)
- between cylinder 1 and 3 upper side (3)
- in the area of cylinder 4 lower right side (4) and
- detailed inspect in the area (5). See view **A** fig. 2.

For those engines using the ROTAX<sup>®</sup> cooling air baffle. Visually inspect for oil leaks in area (2) and (3). If leaks are found, then further investigation to determine the cause of the oil leak is required. If the exact origin of the leak can not be determined i.e. governor, then removal of the cooling air baffle must be required.

Alternative methods of inspection may be used, i.e. bore scope, to inspect the areas without removal of the shroud.

◆ **NOTE:** If absolutely necessary, and if only a small amount of oil leakage is found, a ferry flight to a maintenance facility is permitted. Before the flight a measurement of the mean crankcase pressure at full load (min. 0,1bar) (min. 1.46 psi.) will be necessary, responsible for proper oil return from crankcase "blow-by gas" to oil tank. At a massive oil leakage replacement of engine without delay will be necessary.

- If cracks are detected the nearest ROTAX<sup>®</sup> Authorized Distributor (see also our official ROTAX-Web-Site: [www.rotax-aircraft-engines.com](http://www.rotax-aircraft-engines.com)) has to be informed and if necessary the engines has to be removed from aircraft and must be returned to a ROTAX<sup>®</sup> Authorized Distributor.
- Reconnect negative terminal of aircraft battery (after installation of engine).
