TECHNISCHE INFORMATION NR. SI36-038

Austausch der Kraftstoffpumpe

ALERT SERVICE BULLETIN

SB-912-053

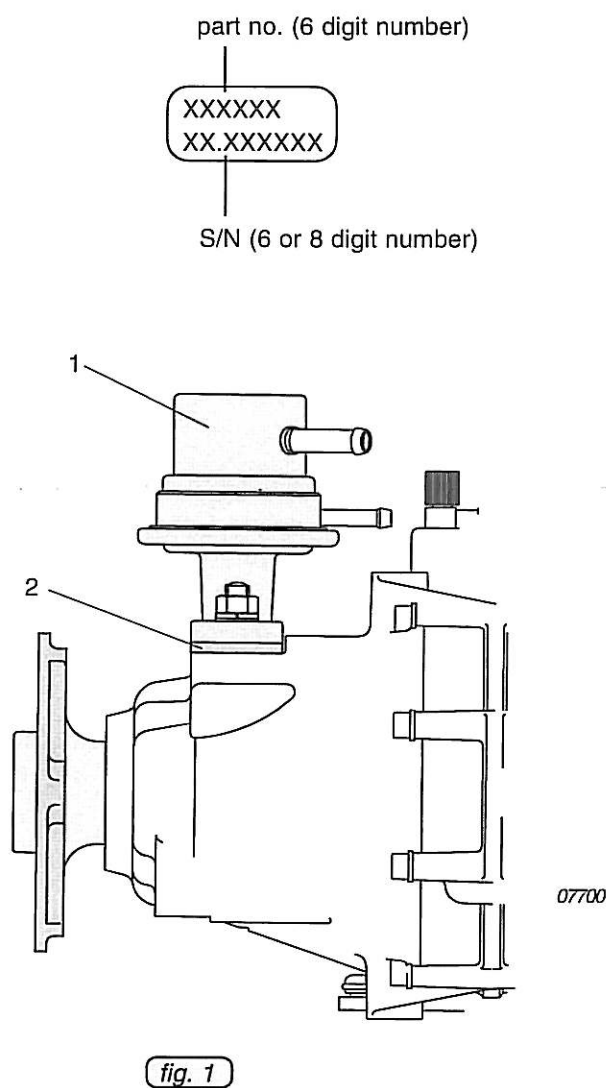
(see Fig.1)

Due to high fuel pressure, caused by exceeding pressure in front of the mechanical fuel pump (e.g. due to an electrical fuel pump), in limited cases a deviation in the fuel supply could occur. This can result in exceeding of the fuel pressure and might cause engine malfunction and/or massive fuel leakage.

1. Remove fuel pump (1).

2. Gasket (2) replaced by new part.

■ **CAUTION:** Install new gasket supplied with new fuel pump. The thickness is different.

3. Install fuel pump. Tightening torque 15 Nm (133 in.lb).

4. Install fuel line.
