## TECHNISCHE INFORMATION NR. SI36-041

ATA Code: 73  
BRP Rotax 912 Series Engines – Fuel Pump  
Replacement

# **SERVICE BULLETIN**

### **SB-912-053**

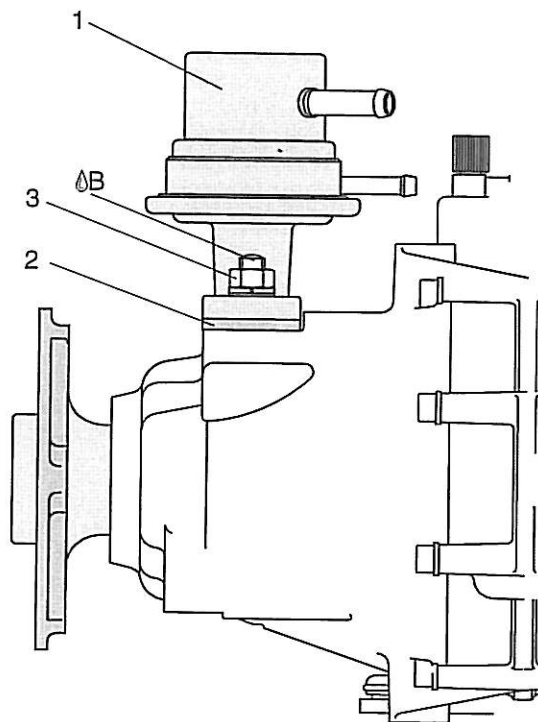
fig. 1

Due to high fuel pressure, caused by exceeding pressure in front of the mechanical fuel pump (e.g. due to an electrical fuel pump), in limited cases a deviation in the fuel supply could occur. This can result in exceeding of the fuel pressure and might cause engine malfunction and/or massive fuel leakage.

1. Remove fuel pump (1).
2. Gasket (2) replaced by new part.

■ **CAUTION:** Install new gasket supplied with new fuel pump. Do not reuse old gasket.

3. Install fuel pump.

4. Tighten uniformly hex. nuts (3) with LOCTITE 243. Tightening torque 15 Nm (133 in.lb).
