TECHNISCHE INFORMATION NR. SI36-042

Checking and Replacement of Flexible Fuel

DAI SI36-042 Page 2 of 2 31-May-2007

CHECKING OR REPLACEMENT OF FLEXIBLE FUEL LINE FOR ROTAX® ENGINETYPE 912 (SERIES) SB-912-054

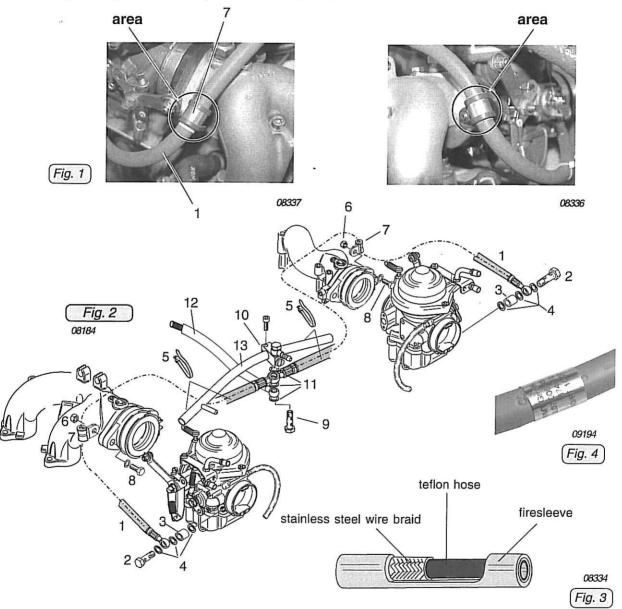
Visual inspection of the fuel line (1) in the area clamp (7) and both ends of the yellow protection cover. (see Fig. 1)

♦ NOTE: A possible crack can be observed by careful bending of the fuel line. If you notice cracks or porosity then you need to replace the fuel line in accordance section 3.1.2.

- ♦ NOTE: See also SI-25-1997 "Running modifications", current issue.
- CAUTION: When removing fuel lines, support them adequately to avoid strain or additional load.
- 1. Unscrew the banjo bolt (2) with distance sleeve (3) and 3 gasket rings (4).
- 2. Cut the cable tie (5).
- 3. Remove hex. nuts M8 (6) together with clamp (7). Held in place by hex. screw (8).
- 4. Remove banjo bolt (9) from clamp block (10) together with 3 gasket rings (11).
- ♦ NOTE: The gasket rings 8x13 (4), used on the banjo bolt of the carburetor, are of different thickness compared to the gasket rings (11), used on the banjo bolt of the clamp block.
- 5. Remove the fuel line (12).

- 1. Install flexible fuel line (1 and 12) and the banjo bolt (9) with new sealing ring (11) on the clamp block (10). Tightening torque of banjo bolt (9) 10 Nm (90 in.lb). Check that the fuel lines are not under strain or tension.
- 2. Install both cable clamp (7) in accordance with Fig.1 on the fuel line.
- 3. Install the fuel line (1) with distance sleeve (3) and sealing ring (4) on the carburetors. Tightening torque of banjo bolt (2) 10 Nm (90 in.lb). Place cable clamp (7) into position.
- For proper support. Install the clamp (7) and hex. nut M8 (6) with LOCTITE 221. Tightening torque
 of hex. nut (6) 15 Nm (133 in.lb).
- ♦ NOTE: Hold the hex. screw (8) when tightening hex. nut (6).
- 5. Fix the fuel line at the compensation tube with 2 cable ties (5).
- Restore aircraft to original operating configuration.
- Connect negative terminal of aircraft battery.
