TECHNISCHE INFORMATION NR. SI36-047

ATA Code: 72
BRP-Rotax Service Bulletin SB-912-051 und
SB-914-034.

SERVICE BULLETIN
CHECKING OF MAGNETIC PLUG
ON ROTAX® ENGINE TYPE 912/914 (SERIES)
SB-912-051
SB-914-034

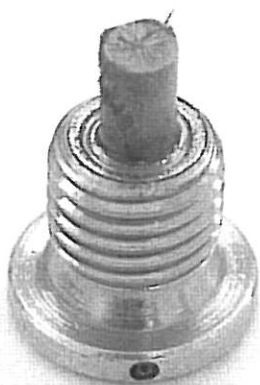
fig. 1

acceptable

1. Remove the magnetic plug according to relevant Maintenance Manual.
2. Inspect magnetic plug in accordance with procedure in relevant Maintenance Manual.

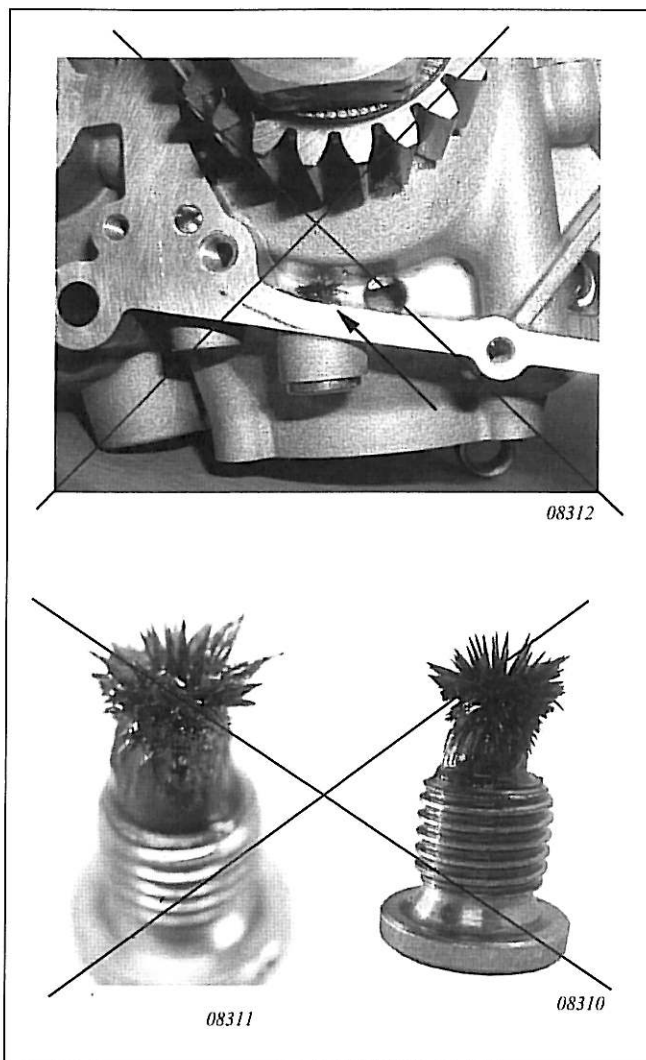
fig. 2

In limited cases increased wear of camshaft/hydraulic valve tappet can occur.

■ **CAUTION:** If a greater quantity of metal particles (more than 3 mm (1/8")) is detected, consultation of an authorized distributor regarding further action is necessary. The engine must not be taken into operation until the cause has been identified and eliminated.

not acceptable
