TECHNISCHE INFORMATION NR. SI36-056

SERVICE INFORMATION NO. SI36-056

****MANDATORY****
SERVICE BULLETIN
NO.: 0921 Rev B

TO: All Garmin Aviation Service Centers
DATE: July 13, 2009
SUBJECT: SL30, SL40, GNS 480 (CNX80) Comm Radio Spurious Emissions

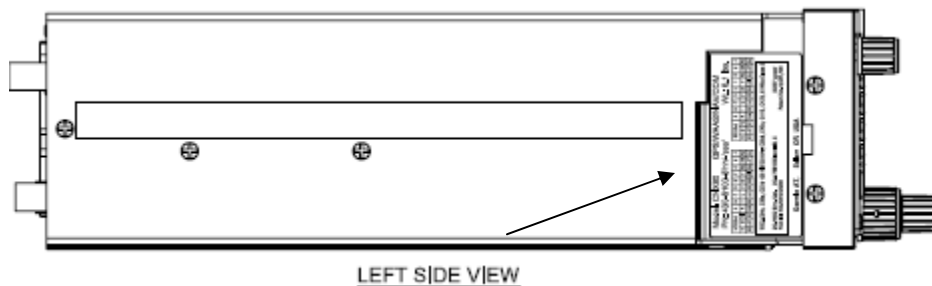
To identify the mod level of a GNS 480 (CNX80) unit:

Remove the unit and locate the nameplate on the left side of the unit. The hardware mod status is indicated in the block on the left side of the nameplate.

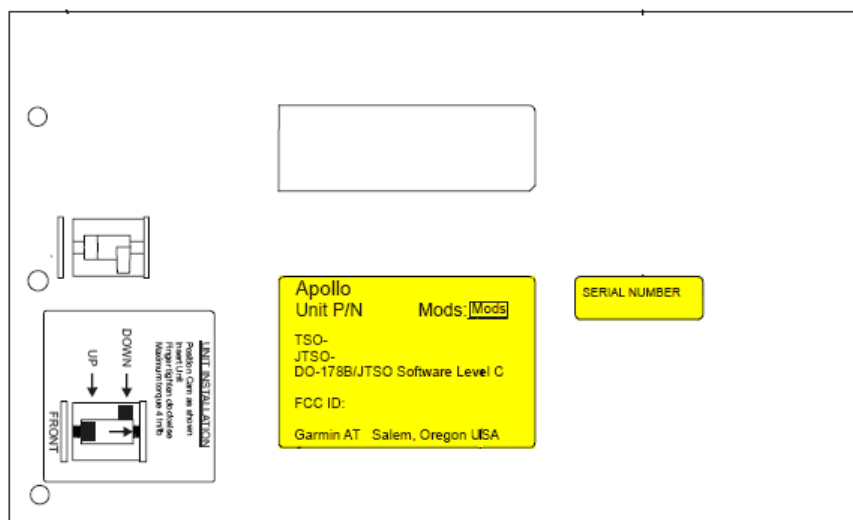
To identify the mod level of an SL30 or SL40 unit:

Remove the unit from the aircraft and locate the nameplate on the bottom side of the unit.
