SERVICE INFORMATION NO. SI 36-060

ATA Code: 72-20
FAA AD 2010-20-23

Airworthiness Directives; Bombardier-Rotax GmbH Type 912 F, 912 S, and 914 F Series Reciprocating Engines

2010–20–23 Bombardier-Rotax GmbH (formerly Rotax, Motorenfabrik):
Amendment 39–16458. Docket No. FAA–2010–0342; Directorate Identifier 2002–NE–08–AD.

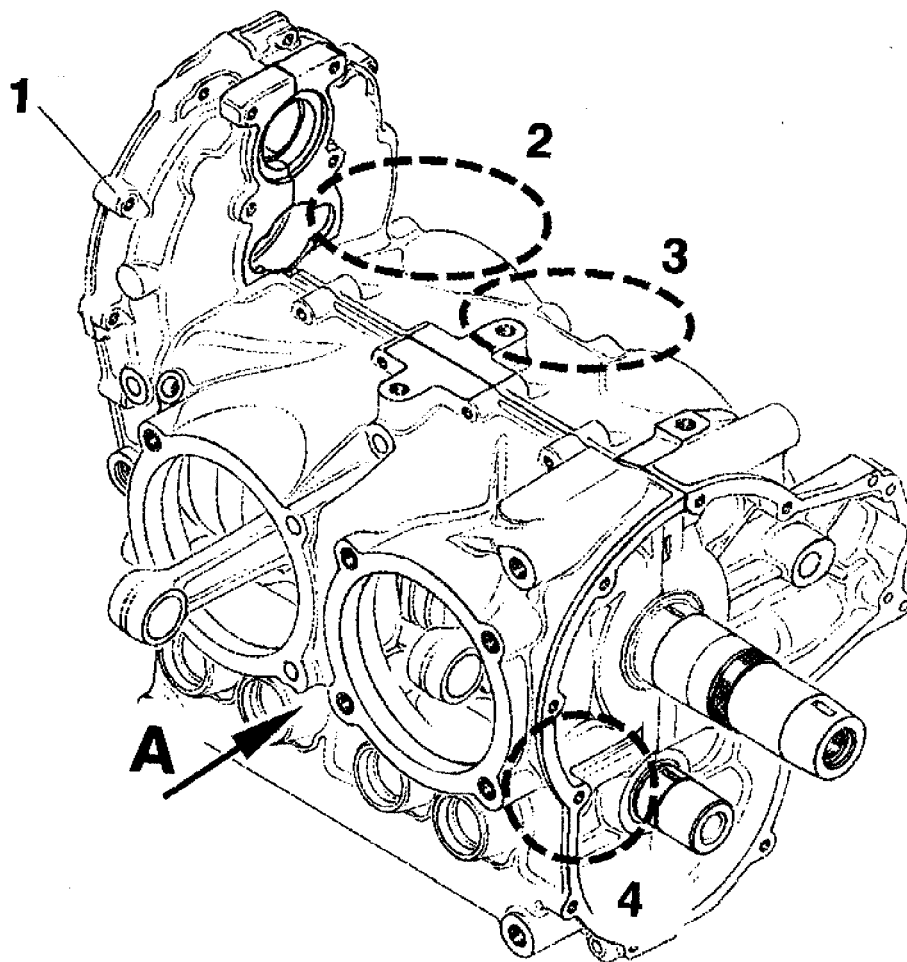
Figure 1. Engine Crankcase Inspection Areas

(d) This AD results from an increase in the affected engine crankcase population. We are issuing this AD to prevent oil loss caused by cracks in the engine crankcase, which could lead to in-flight failure of the engine and forced landing.

- (1) Inspect the engine crankcase (item 1, Figure 1 of this AD) for cracks especially in the area of cylinder 1 upper side (item 2), between cylinder 1 and 3 upper side (item 3), cylinder 4 lower-right side (item 4) and detailed inspection in the area identified in Figure 2 (item 5) of this AD. Information concerning this inspection can be found in Bombardier-Rotax Mandatory Service Bulletins No. SB–912–029, Revision 3, dated July 11, 2006 and No. SB–914–018, Revision 3, dated July 11, 2006.

(2) Cracks in crankcases of engines with a ROTAX cooling air baffle may not be easily visible, and oil leaks may be an indication of cracks. Visually inspect for oil leaks in areas of cylinder 1 upper side (item 2, Figure 1 of this AD) and between cylinder 1 and cylinder 3 upper side (item 3).

(3) If you find oil leaks, determine the source by either using a borescope or removing the object blocking the view such as the air baffle or accessory, and perform the inspection.

(4) If the engine crankcase is cracked, remove the engine from service before further flight.

(h) Visually inspect the engine crankcase (item 1, Figure 1 of this AD) for cracks at each 100-hour, annual, or progressive inspection, or within 110 hours TIS since last inspection, whichever occurs first, in accordance with paragraphs (g)(1) through (g)(4) of this AD.

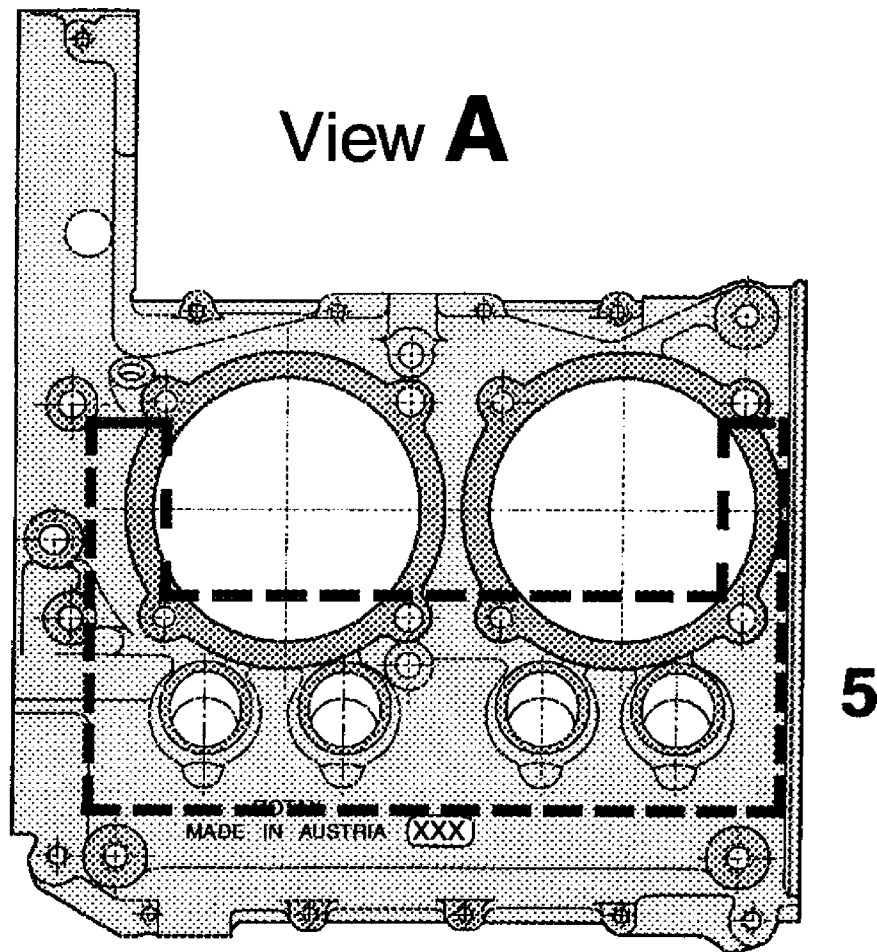
Figure 2. Engine Crankcase Inspection Areas – View A

(f) Determine if your crankcase is affected by looking at the S/N in the area indicated by XXX, following "Made in Austria," as shown on Figure 2 of this AD. The marking is on both crankcase halves.

(k) Installing a crankcase that has a S/N above 27811 terminates the inspection requirements of paragraphs (g)(1) through (g)(4) and (h) of this AD.
