TECHNISCHE INFORMATION NR. SI36-063

SERVICE INFORMATION NO. SI36-063

EASA Emergency AD No: 2011-0067-E

REPLACEMENT OF WASHER PART NO. 944072 (FLY WHEEL HUB) FOR ROTAX® ENGINE TYPE 912 AND 914 (SERIES)

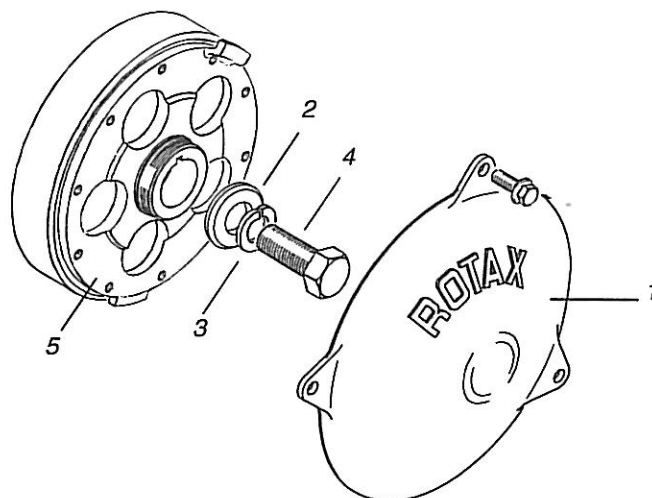
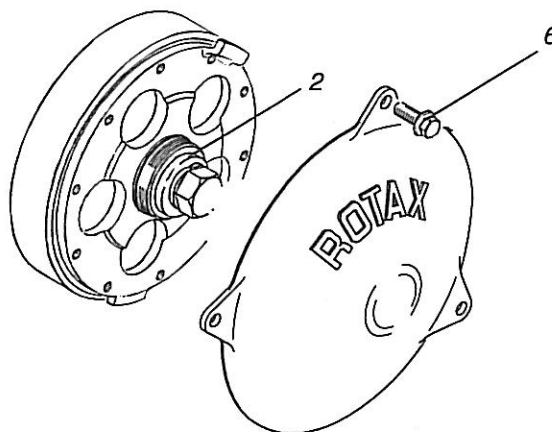
BILD 1

Aufgrund von Abweichungen beim Härteprozess kann es bei einzelnen Scheiben zur Überschreitung der Härte kommen. Diese Abweichung kann zum Bruch der Scheibe und in Folge zum Lösen der Magnetnabe, Zündaussetzer oder Motorstillstand führen.

- 1 Zünderdeckel
- 2 Scheibe 17/36/5
- 3 Speerkantring 16
- 4 Sk-Schraube M16x1,5x40
- 5 Magnethabe
- 6 Sk-Schraube M6x16

1. Zünderdeckel (1) abbauen.
2. Kurbelwelle fixieren gemäß entsprechendem Wartungshandbuch (Line).
3. Demontage der Sk-Schraube (4) gemäß entsprechendem Wartungshandbuch (Heavy).

4. Montage der Sk-Schraube (4). **Anzugsdrehmoment 120 Nm.**

■ ACHTUNG: Bei der Montage ist die neue Scheibe (2) TNr. 944072 zu verwenden.

5. Kurbelwellenfixierung lösen gemäß entsprechendem Wartungshandbuch.
6. Geberspalt kontrollieren, gegebenenfalls erneuern gemäß entsprechendem Wartungshandbuch.
7. Zünderdeckel (1) montieren. Sk-Schrauben (6) mit Loctite 221 sichern.
Anzugsdrehmoment 5 Nm.

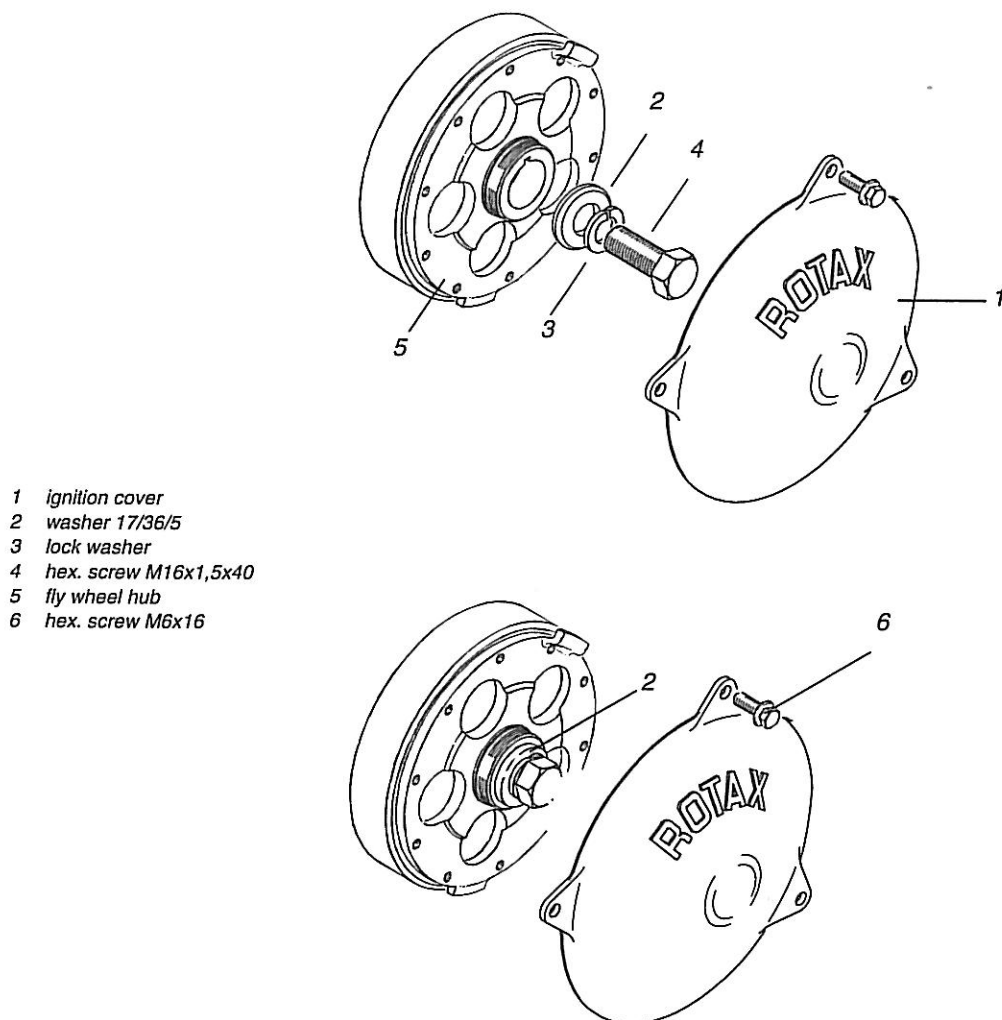
Fig. 1

A deviation in hardening process could cause an exceeding of hardness of certain washer. This deviation could lead to cracks in the washer and could cause loosening of fly wheel, ignition failure or engine damage.

magneto ring, fly wheel hub, ignition cover

1. Remove ignition cover (1).
2. Lock the crankshaft in accordance with the relevant Maintenance Manual (Line).
3. Remove hex. screw (4) in accordance with the relevant Maintenance Manual (Heavy).

■ CAUTION: If the fly wheel hub has loosened during the disassembly and/or in case of doubt, then remove, clean and install the fly wheel hub in accordance with the relevant Maintenance Manual. In this case the tightening torque is 45 Nm (33.2 ft.lb) + 180° angle to rotation.

4. Install hex. screw (4). **Tightening torque 120 Nm (89 ft.lb).**

■ CAUTION: During installation the new washer (2) part no. 944072 must be used.

5. Remove locking pin of crankshaft in accordance with the relevant Maintenance Manual.
6. Check trigger coil gap, if necessary adjust it in accordance with the relevant Maintenance Manual.
7. Install ignition cover (1). The hex. screws (6) are locked with Loctite 221. Tightening torque 5 Nm (44 in. lb.).
