SERVICE INFORMATION NO. SI36-066

Airworthiness Directives; Various Aircraft Equipped With Rotax Aircraft Engines 912 A Series Engine

REPLACEMENT OF WASHER PART NO. 944072 (FLY WHEEL HUB) FOR ROTAX® ENGINE TYPE 912 AND 914 (SERIES)

SB-912-058

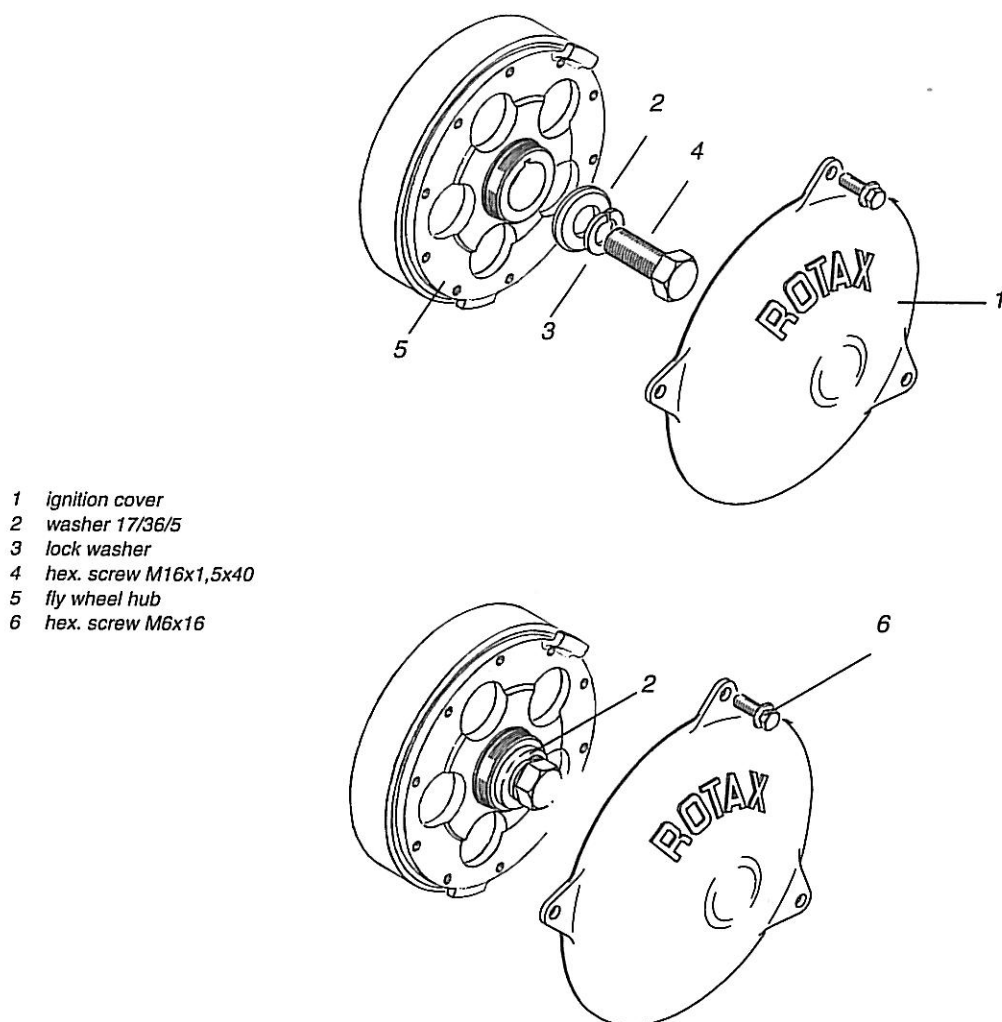
See fig. 1.

A deviation in hardening process could cause an exceeding of hardness of certain washer. This deviation could lead to cracks in the washer and could cause loosening of fly wheel, ignition failure or engine damage.

- 1 ignition cover
- 2 washer 17/36/5
- 3 lock washer
- 4 hex. screw M16x1,5x40
- 5 fly wheel hub
- 6 hex. screw M6x16

- ◆ NOTE: Fly wheel hub does not have to be removed unless it has become loose.

■ CAUTION: If the fly wheel hub has loosened during the disassembly and/or in case of doubt, then remove, clean and install the fly wheel hub in accordance with the relevant Maintenance Manual. In this case the tightening torque is 45 Nm (33.2 ft.lb) + 180° angle to rotation.

4. Install hex. screw (4). **Tightening torque 120 Nm (89 ft.lb).**
