SERVICE INFORMATION NO. SI 36-091

EASA Notfall Lufttüchtigkeitsanweisung Nr. 2013-0117-E

Rotax Alert Service Bulletin ASB-912-062R2 und ASB-914-044R2

Checking of the cylinder head assy. (2/3) for ROTAX® Engine Type 912 and 914 (Series)

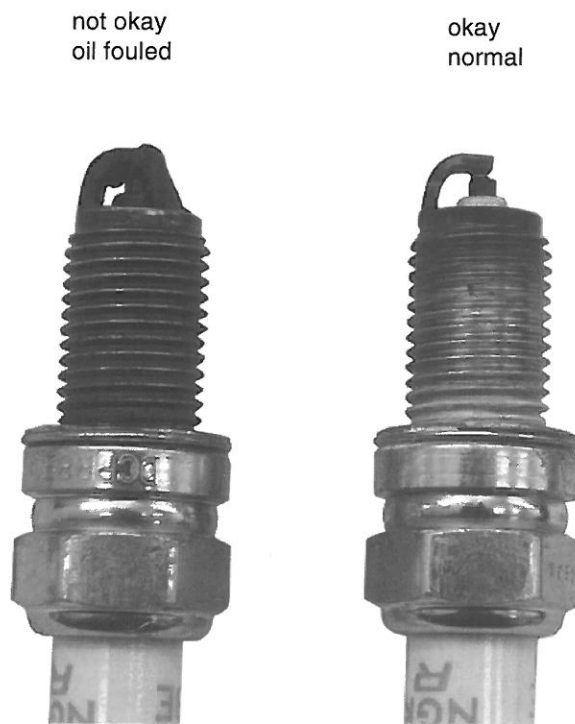
Fig. 1
spark plug

NOTE: Unusual deposits (excessive carbon or oil) on the spark plugs are an indication of a defective cylinder head which must be replaced. Figure 1 shows comparison between a used spark plug in normal condition and one that is not.

Affected spark plugs with such deposits shown in chapter 4 Fig. 1, have to be removed and can not be reinstalled.

If excessive deposits (oil or carbon) are found on the spark plugs the cylinder head must be replaced in accordance with the relevant Maintenance Manual (Heavy) and any relevant aircraft manufacturer instructions.

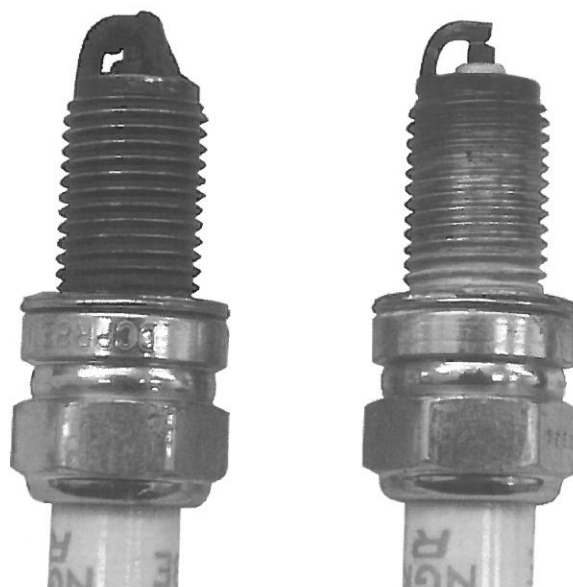
Bild 1
Zündkerzen

Nicht in Ordnung
Öblagerungen

In Ordnung
