## TECHNISCHE INFORMATION NR. SI 36-105

## SERVICE INFORMATION NO. SI 36-105

**AD No.:** 2016-0144

## ATA 73 – Engine Fuel and Control – Float – Inspection / Replacement

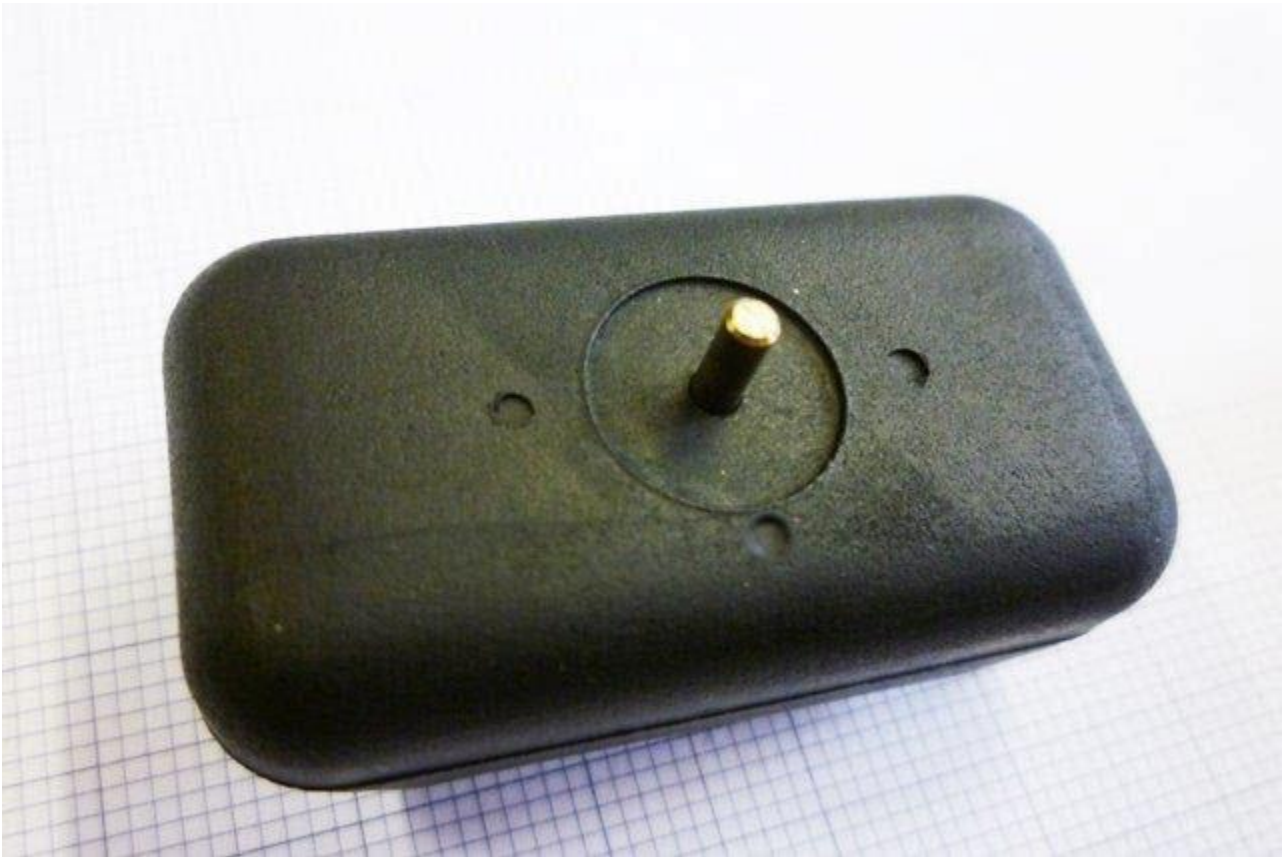
Appendix 3 – Float with 3 dots

Note 2: For the purpose of this AD, an affected float is float having P/N 861185, that has been initially delivered on a date between 09 May 2016 and 17 July 2016 (inclusive), and that does not have 3 dots. Certification documents (e.g., Form 1), delivery document or record of previous installation of the float are acceptable to determine an initial delivery on or before 08 May 2016. An example of a serviceable float having 3 dots is shown in Appendix 3 of this AD.

- (2) For any affected engine, before next flight after the inspection as required by paragraph (1) of this AD, replace any affected float with a serviceable float (see Note 2 and Appendix 3 of this AD) in accordance with the instructions of the ASB.
