SERVICE INFORMATION NO. SI 36-120

ATA Code: 79-00
Limbach L 2000 and L 2400

Limbach Flugmotoren GmbH issued Technical Bulletin No. 13.6 mandating the inspection of the cylinder head valves or the replacement of the cylinder head if wear limits are exceeded.

Subject: Cylinder Heads

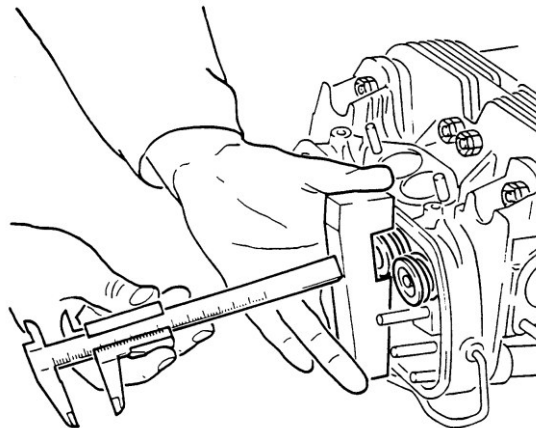
Background information: After engine operating times between 500 to 600 hrs. cases of excessive wear on the sealing surfaces of the valves and valves seats has been observed occasionally.

- Compliance:**
1. Remove valve cover from cylinder head on both sides.
 2. Remove rocker arm shafts from both sides (4 Nuts M8).
 3. Position measuring device (P/N 803.001.130.000) as pictured over each valve. Measure the distance to the end of the valve with a depth gage.

Type series	Valve shaft projection length for inlet and outlet valves	
	still acceptable*)	wear limit**)
L 1700	24,50 mm	24,00 mm
L 2000		
L 2400 EE, EB		
L 2400 EF, DF L 2400 ET, DT L 2400 DX, DS	23,80 mm	23,30 mm

**) Once the wear limit has been reached, the cylinder head must be replaced.

4. Assembly in opposite sequence.
5. Apply sealing compound REINZOSIL SI 300 (P/N 708.413.070.000) to the sealingsurfaces of the support bosses for the rocker arm shafts before assembling.
Torque M8 nuts (property class 10) to 25 Nm. Check valve clearance, adjust if necessary.
