SERVICE INFORMATION NO. SI 36-126

All HK 36 R, TS, TC , TTS, TTC, and TTC-ECO airplanes.

BRP-Rotax GmbH & Co KG Service Bulletin SB-912-078 / SB-914-059

Exchange of propeller shaft on ROTAX® Engine type 912 / 914 (Series) and 912 i (Series)

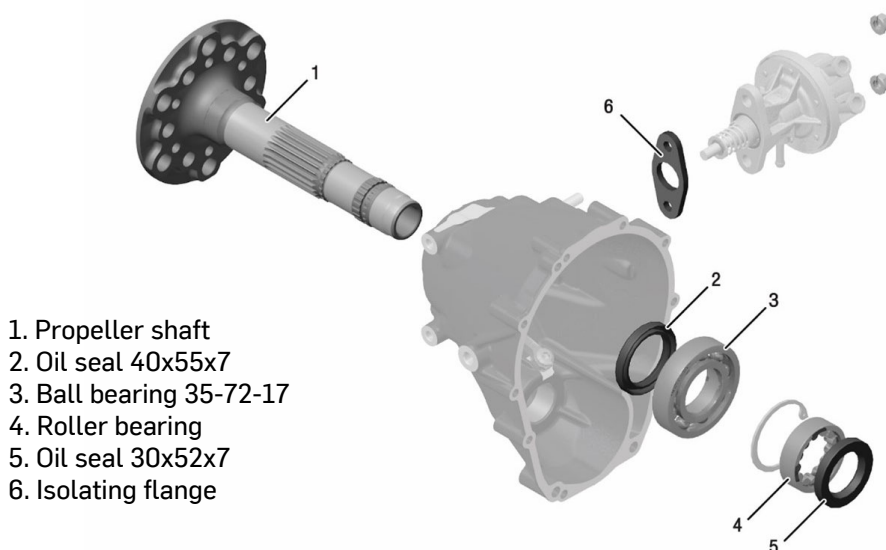
Fig. 1

See Fig. 1.

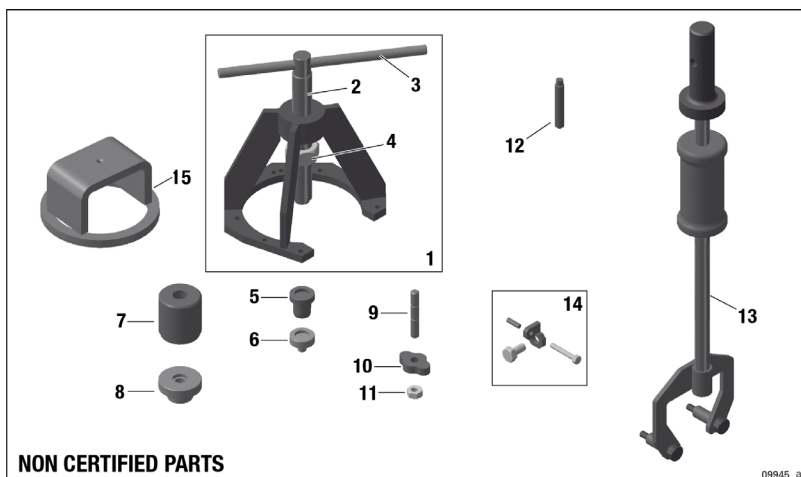
Fig. 2

See [Fig. 2.](#)

1. Extractor assy.
2. Pull-in spindle M24x 1.5
3. Bolt 12x250
4. Hex. screw M24x1.5
5. Press-out mushroom
6. Press-out mushroom.
7. Press-in jig
8. Press-in mushroom
9. Stud M10x45/20
10. Pull-out plate
11. Hex. nut M10
12. Thread bolt M8x50
13. Puller assy.
14. Pushing jig assy.
15. Mounting yoke
