### **TECHNISCHE INFORMATION NR. SI 36-130**

### **SERVICE INFORMATION NO. SI 36-130**

# Inspection and/or replacement of expansion tank assy. for ROTAX. 912, 914, 912 i, 915 i and 916 i (Series) Aircraft Engines

ATA System: 75-20-00 Expansion Tank

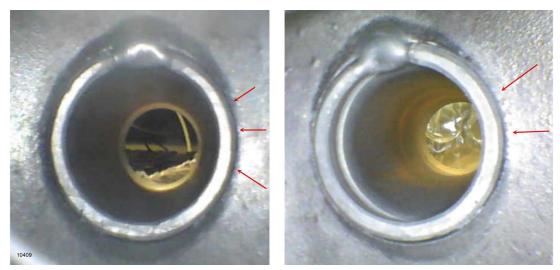
Due to a deviation in the manufacturing process, the individual components of the expansion tank assy. may not be sufficiently welded. Sealing of the assy. may be compromised and coolant leakage and subsequently an overheating of the engine may occur.

Fig. 6: BAD Welding - total view / BAD Welding - side view

Step	Procedure
1	If necessary, clamp closed the hose to the coolant overflow bottle.
2	Remove the radiator cap from the expansion tank.
3	Drain coolant until bottom of the expansion tank assy. is clearly visible.
4	Perform an internal visual inspection of the expansion tank assy. using a bore-scope or similar optical device.
5	If the visual inspection shows consistent welding, the expansion tank assy. is serviceable (See Fig. 5), continue with step 7.
6	If any connection has inconsistent or missing welds, the expansion tank assy. is unserviceable and must be replaced (See Fig. 6), continue with section 3.5.2).
7	Refill coolant into the expansion tank. See Maintenance Manual Line Chapter 12-10- 00 section Coolant check/replenish. See also SI-912 i-001,SI-912-016,SI-914-019, SI-915 i-001,SI-916 i-001, current issue.
	<b>NOTE</b> : If the engine is equipped with a thermostat valve, follow the manufactur- er's instructions.
